STRUCTURES INSPECTION FIELD REPORT

SPECIAL MEMBER INSPECTION

B.I.N.
5CT

BR. DEPT. NO.
A-13-026

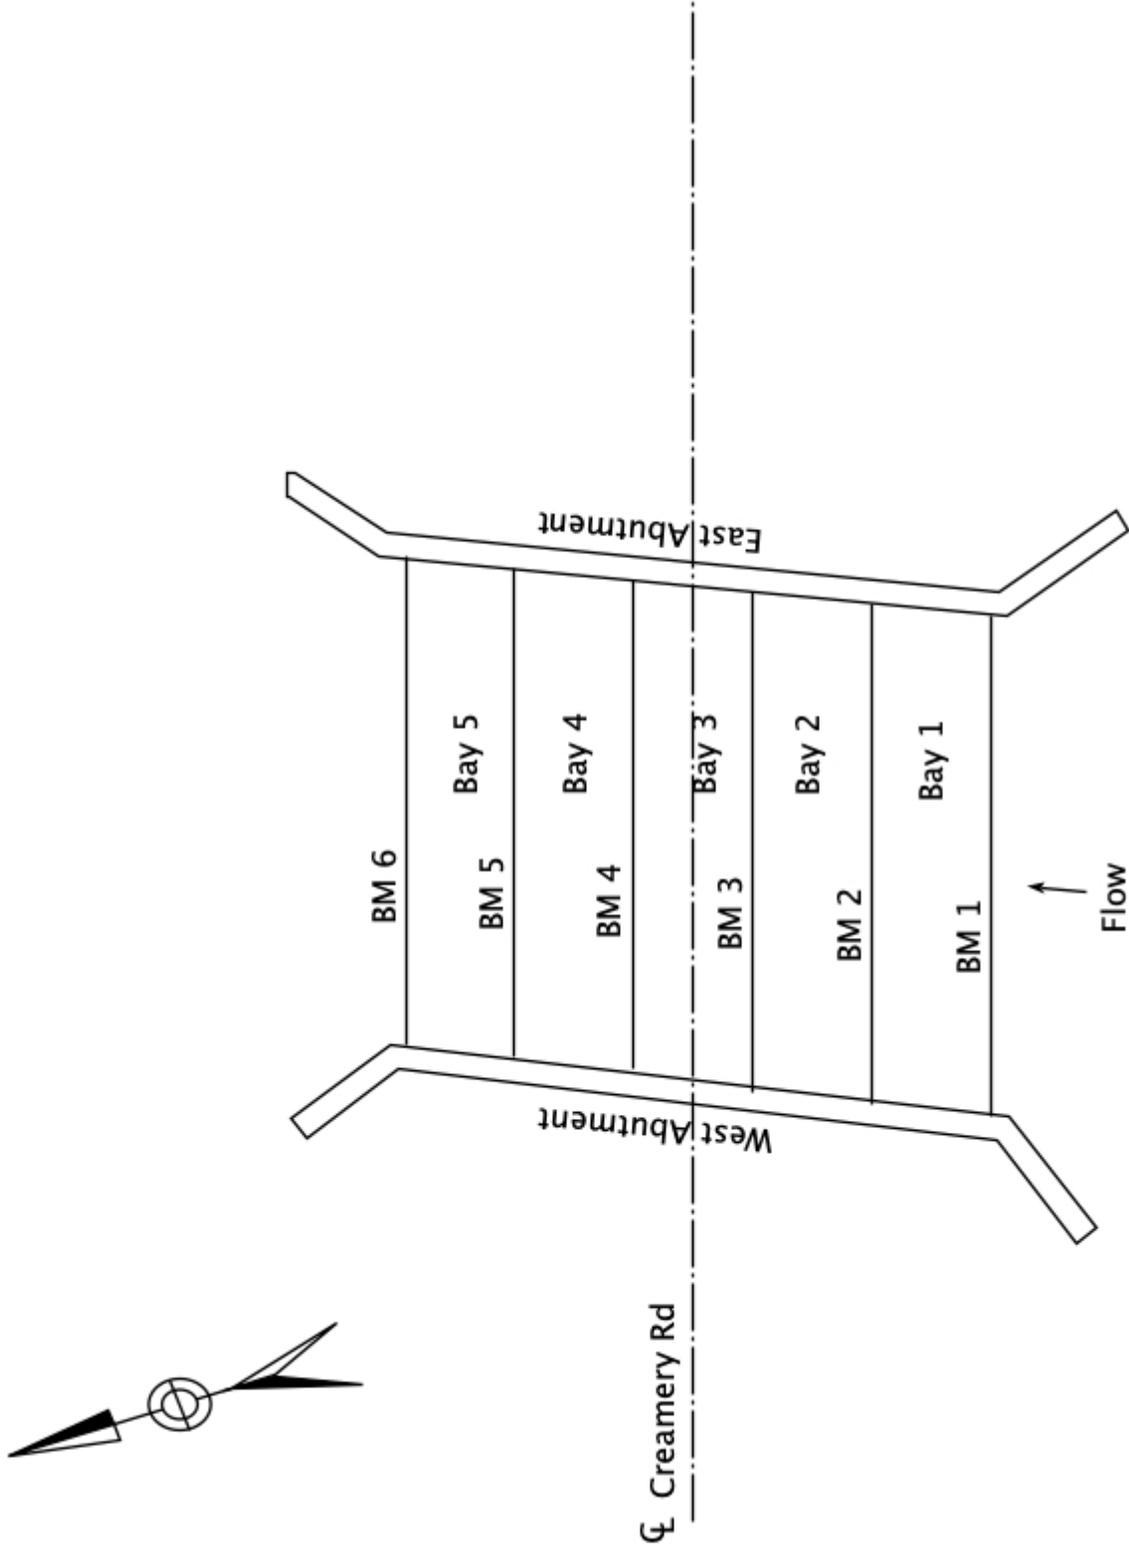
Sketch 1: Framing plan.

Creamery Road travels west and east. Creamery Brook flows from south to north. This single span structure consists of six steel beams supporting a cast in place concrete deck with an asphalt wearing surface. Report notes are taken from south to north, upstream to downstream, in accordance with the 2015 Bridge Inspection Handbook. **See Sketch 1 and Photos 1 & 2.**

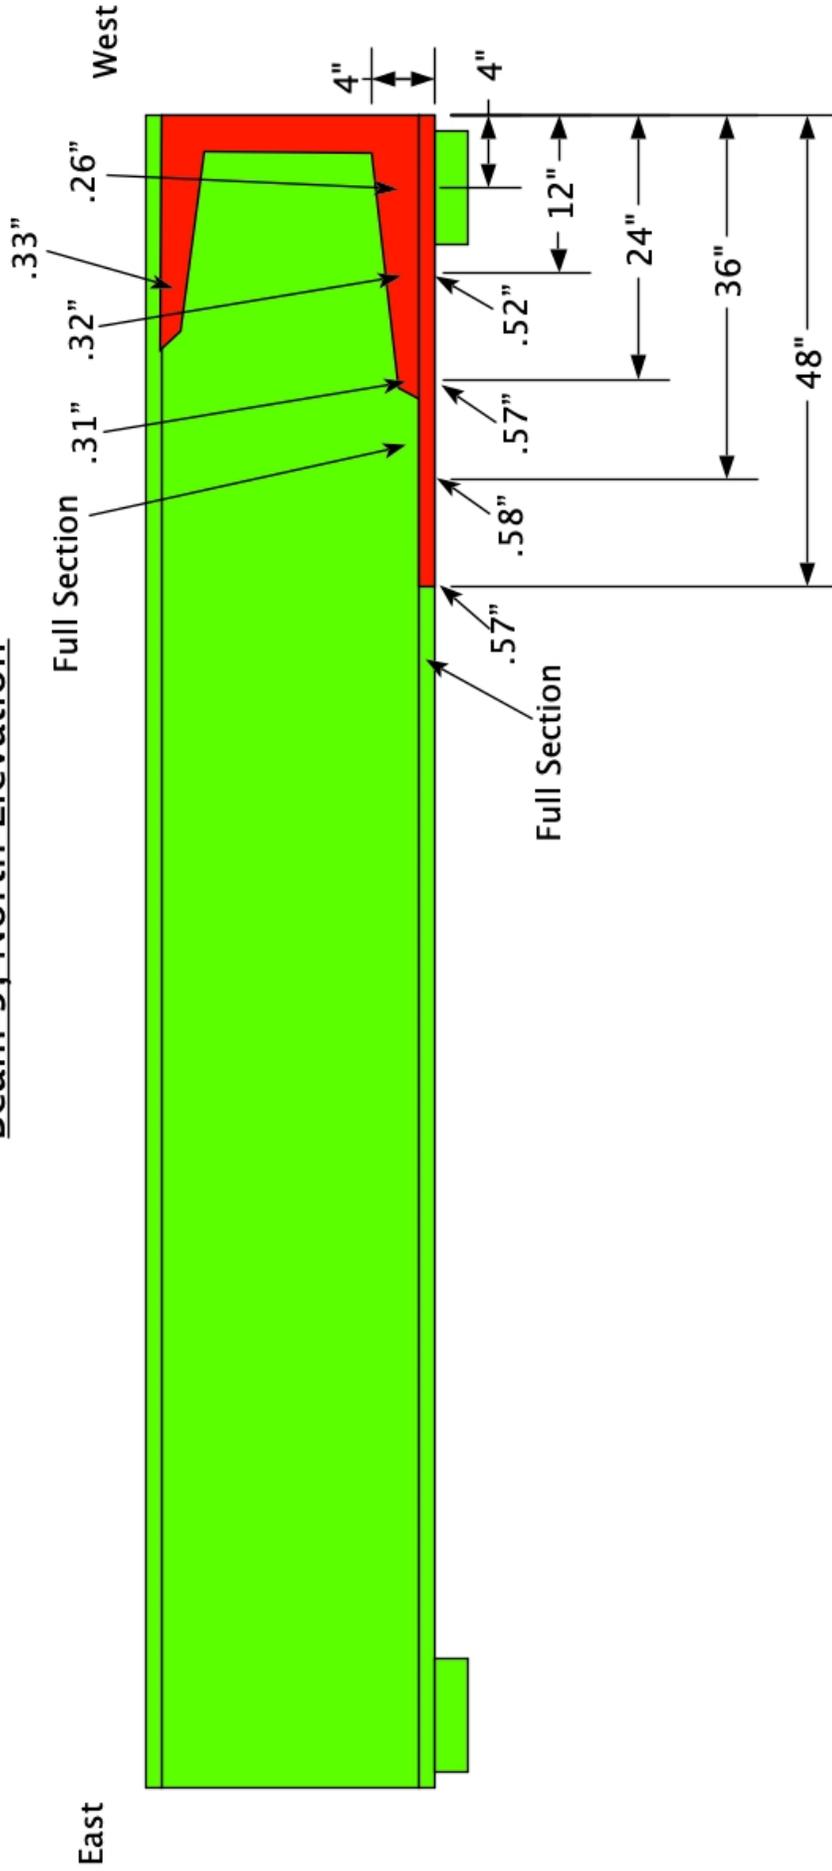
Sketch 4: Beam 5 section loss.

Beam 5, at the west end, has minor section loss. **See Sketch 4 and Photo 7.**

Original section = 12WF50
 Flange = 0.640"
 Web = 0.370"

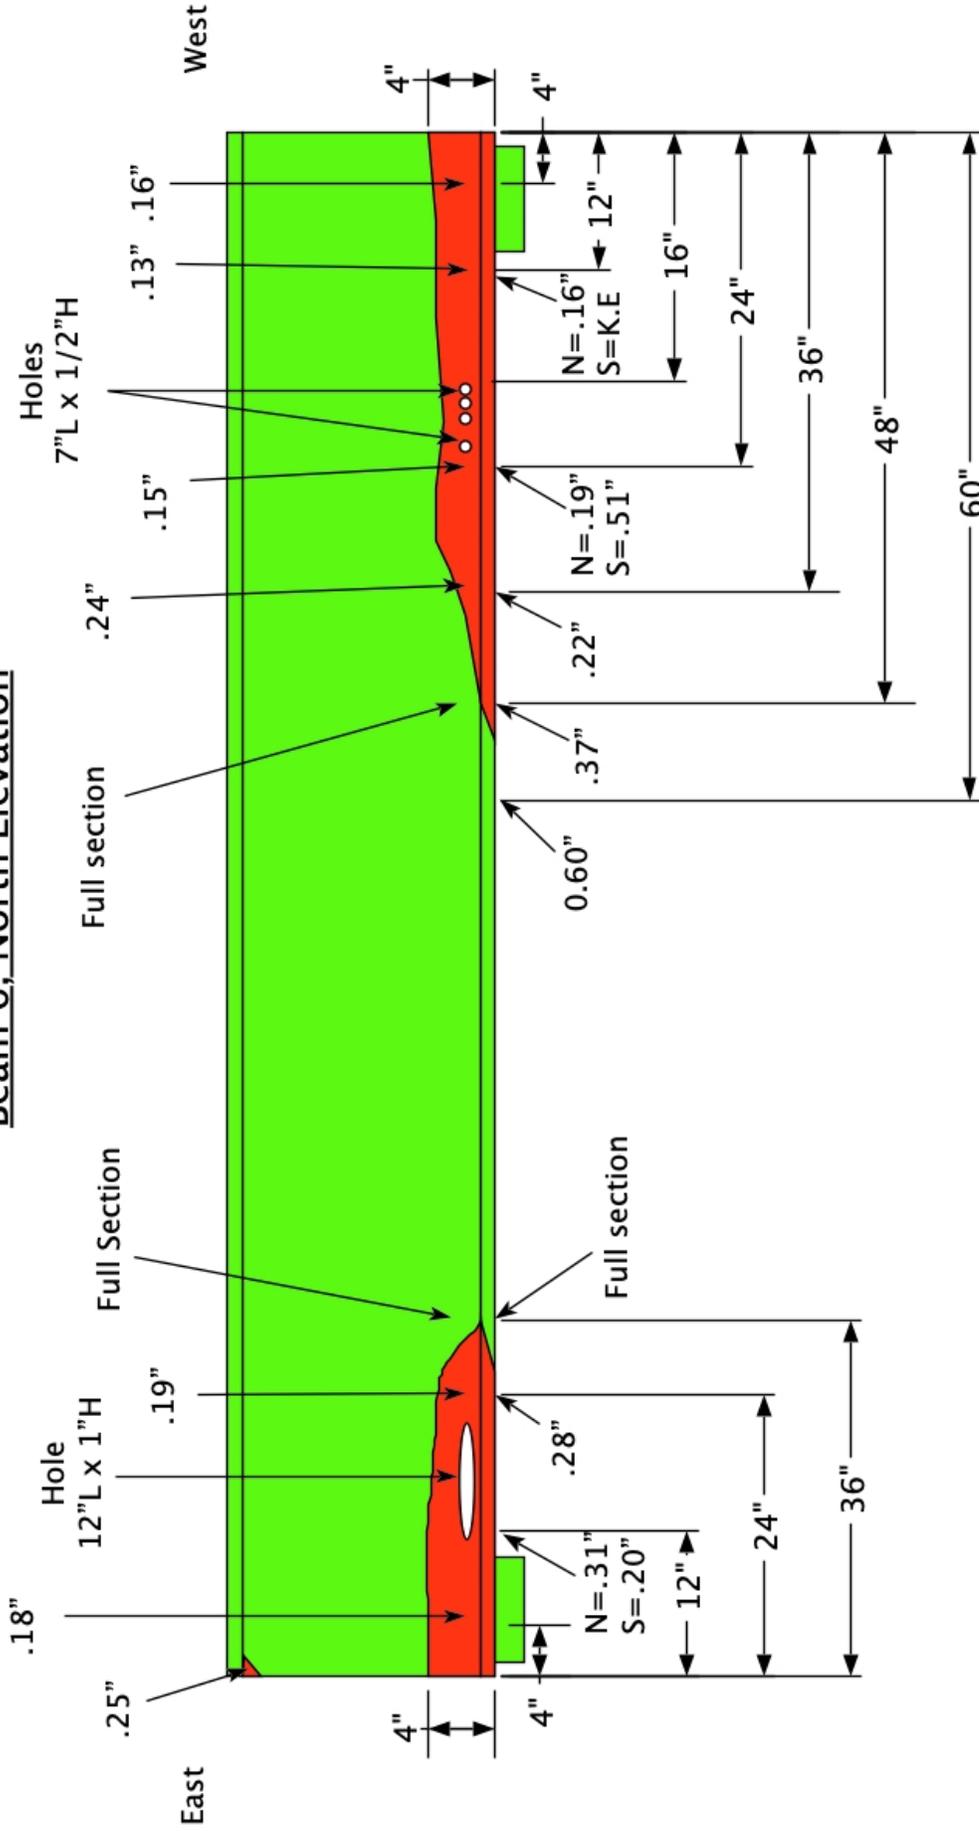
Sketch 5: Beam 6 section loss.

Beam 6, at both ends, has severe section loss. **See Sketch 5 and Photos 8 & 9.**

Original section = 12WF50
 Flange = 0.640"
 Web = 0.370"

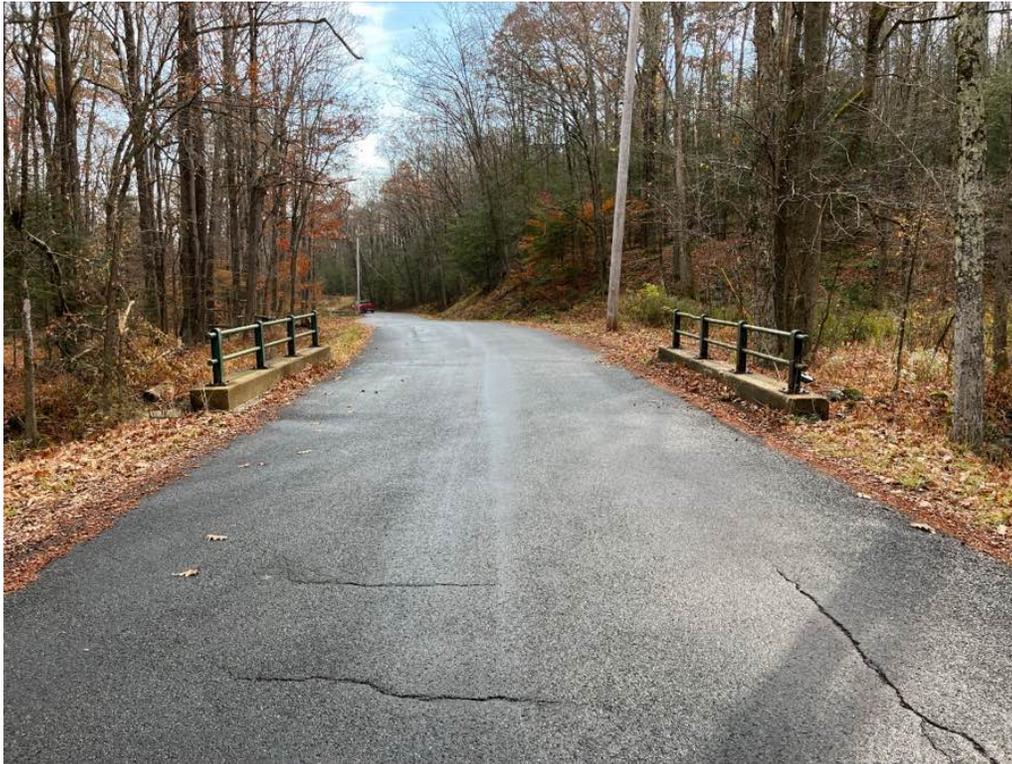
Photo 1: General topside, looking east.

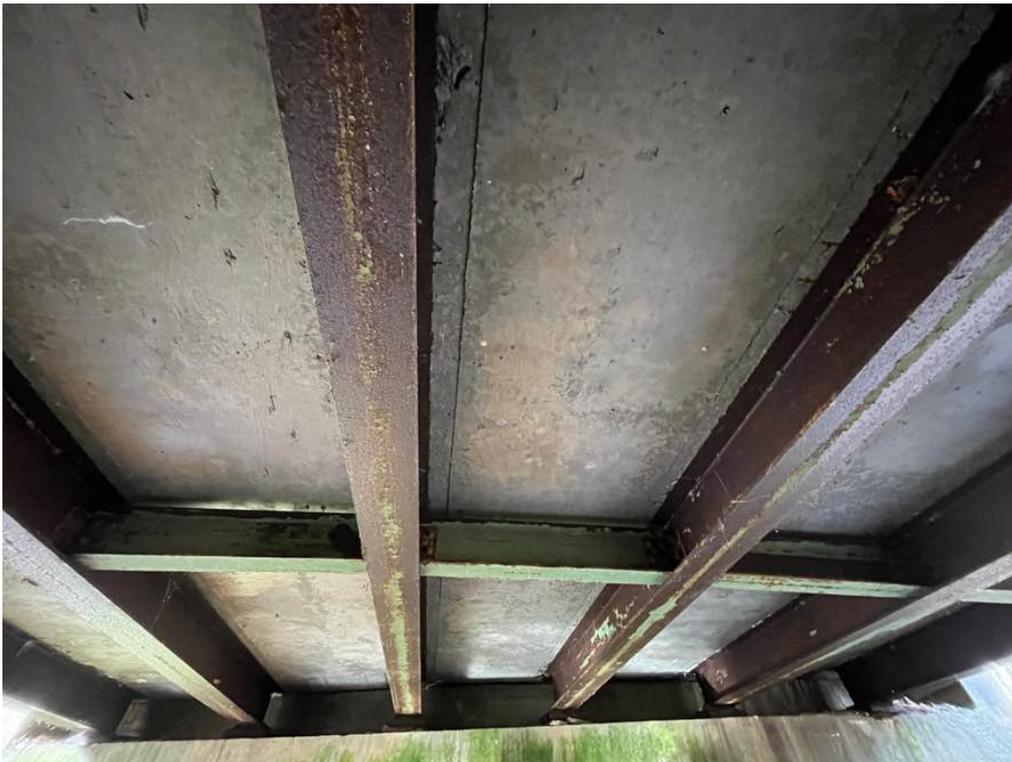
Photo 2: General underside, looking west.

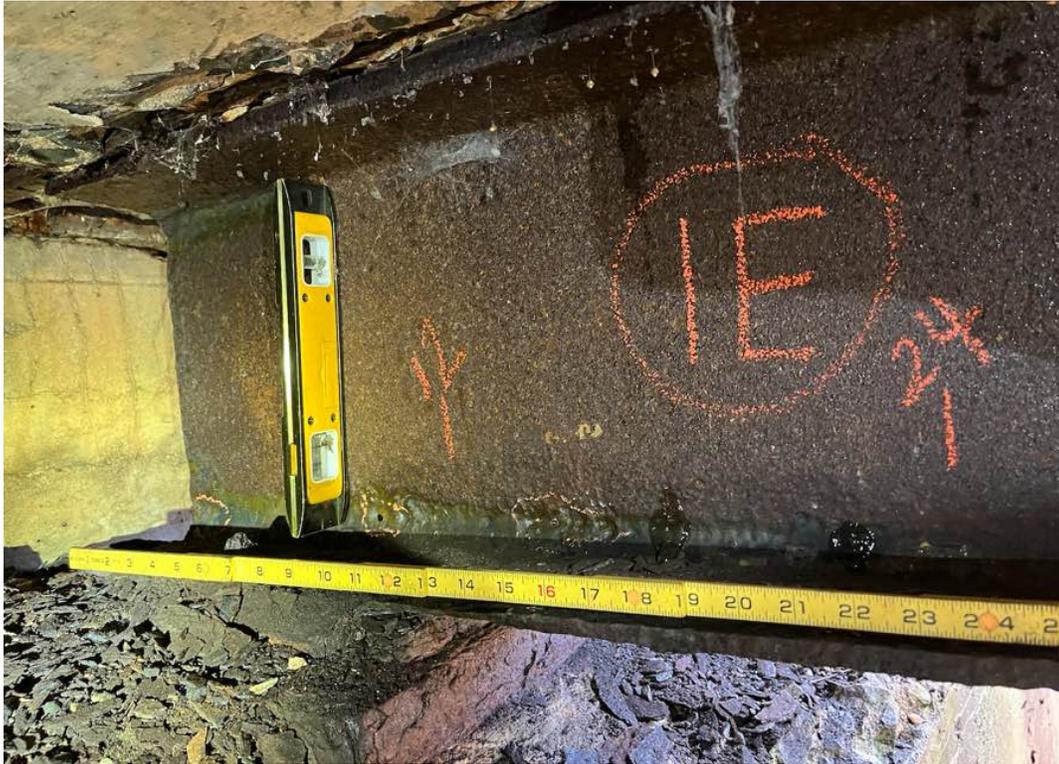
Beam 1, at both ends, has severe section loss. **See Sketch 2 and Photos 3 & 4.**

Photo 3: Beam 1, east end, section loss.

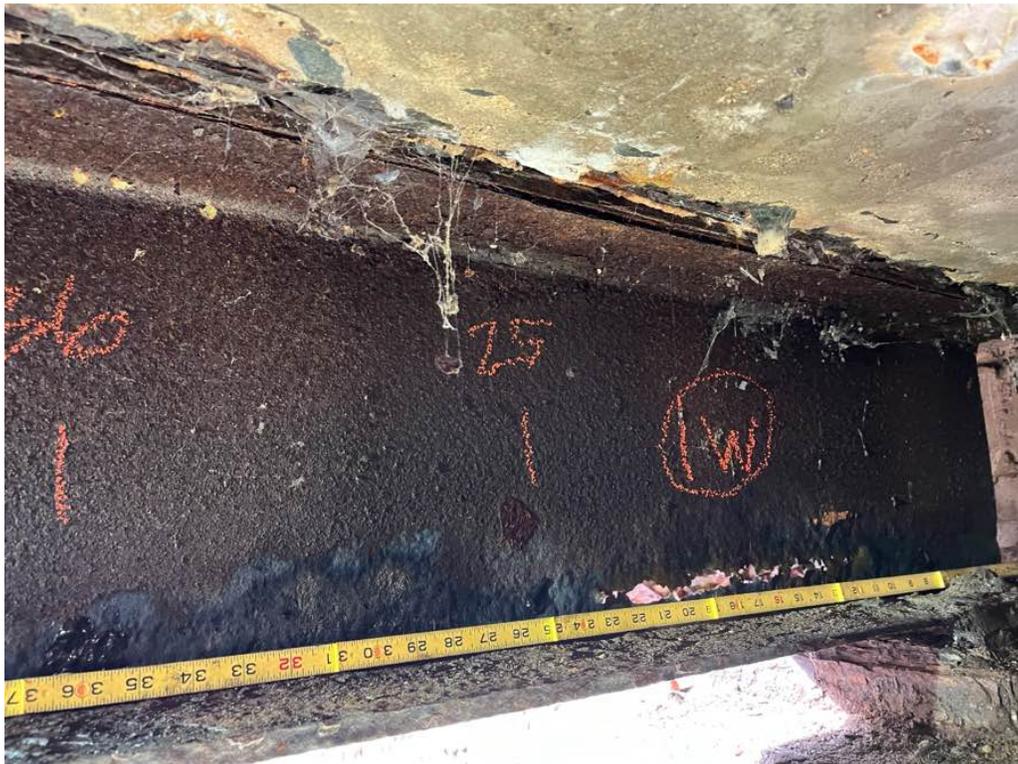
Photo 4: Beam 1, west end, section loss.

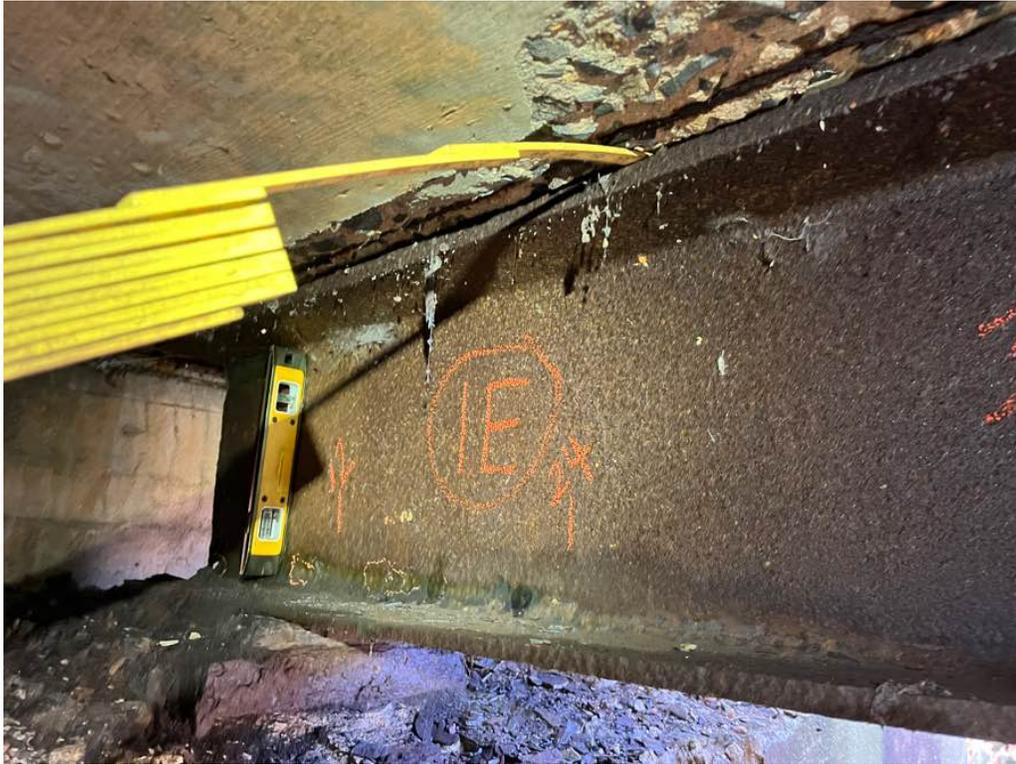
Beam 1, at the east end, has a gap between the top of beam and deck, 4' long x up to 1/2" high. **See Photo 5.**

Photo 5: Beam 1, east end, gap between top of beam and deck.

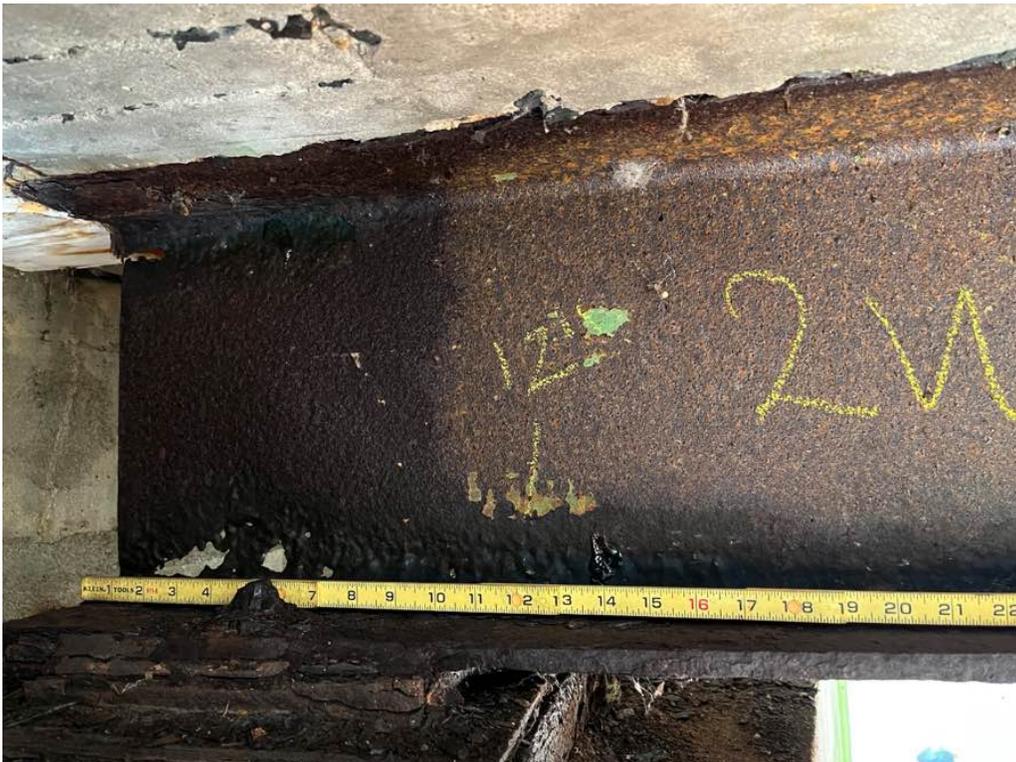
Beam 2, at the west end, has severe section loss and appears to be beginning to buckle. **See Sketch 3 and Photo 6.**

Photo 6: Beam 2, west end, section loss.

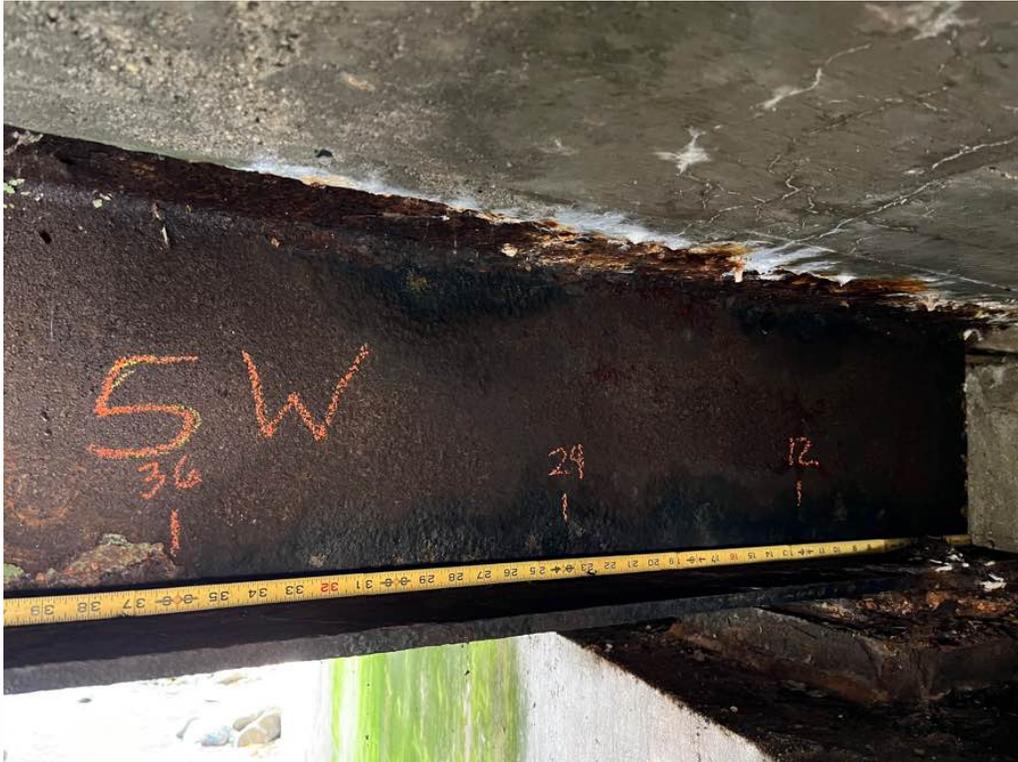
Photo 7: Beam 5, west end, section loss.

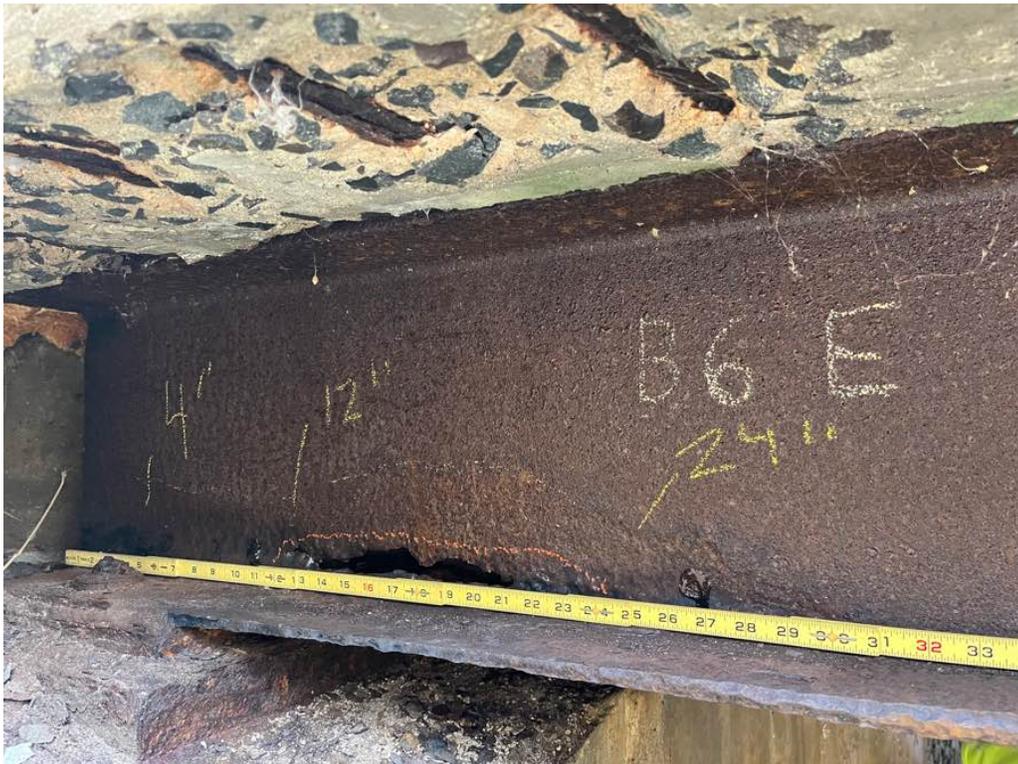
Photo 8: Beam 6, east end, section loss.

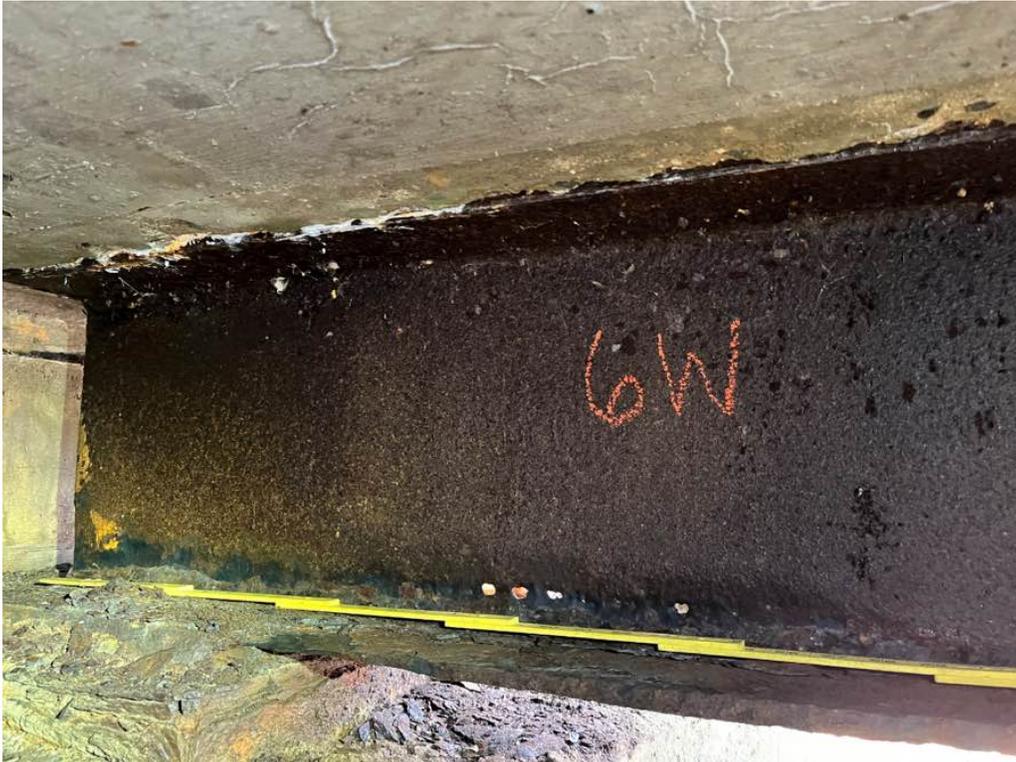
Photo 9: Beam 6, west end, section loss.
