STRUCTURES INSPECTION FIELD REPORT

SPECIAL MEMBER INSPECTION

B.I.N.
5CT

CITY/TOWN ASHFIELD	8.-STRUCTURE NO. A13026-5CT-MUN-BRI	11-Kilo. POINT 000.000	90-ROUTINE INSP. DATE Jan 30, 2024	93*-SPEC. MEMB. INSP. DATE Mar 20, 2025
07-FACILITY CARRIED HWY CREAMERY RD	MEMORIAL NAME/LOCAL NAME	27-YR BUILT 1938	106-YR REBUILT 0000	*YR REHAB'D (NON 106) 0000
06-FEATURES INTERSECTED WATER BR CREAMERY BROOK	26-FUNCTIONAL CLASS Rural Local	DIST. BRIDGE INSPECTION ENGINEER <i>Michael P. McCabe</i> M. P.E. McCabe		
43-STRUCTURE TYPE 302 : Steel Stringer/Girder	22-OWNER Town Agency	21-MAINTAINER Town Agency	TEAM LEADER R. Mancari <i>Reed Mancari</i>	
107-DECK TYPE 1 : Concrete Cast-in-Place	WEATHER P. Cloudy	TEMP. (air) 6°C	TEAM MEMBERS E. GEMINDER <i>E. Geminder</i>

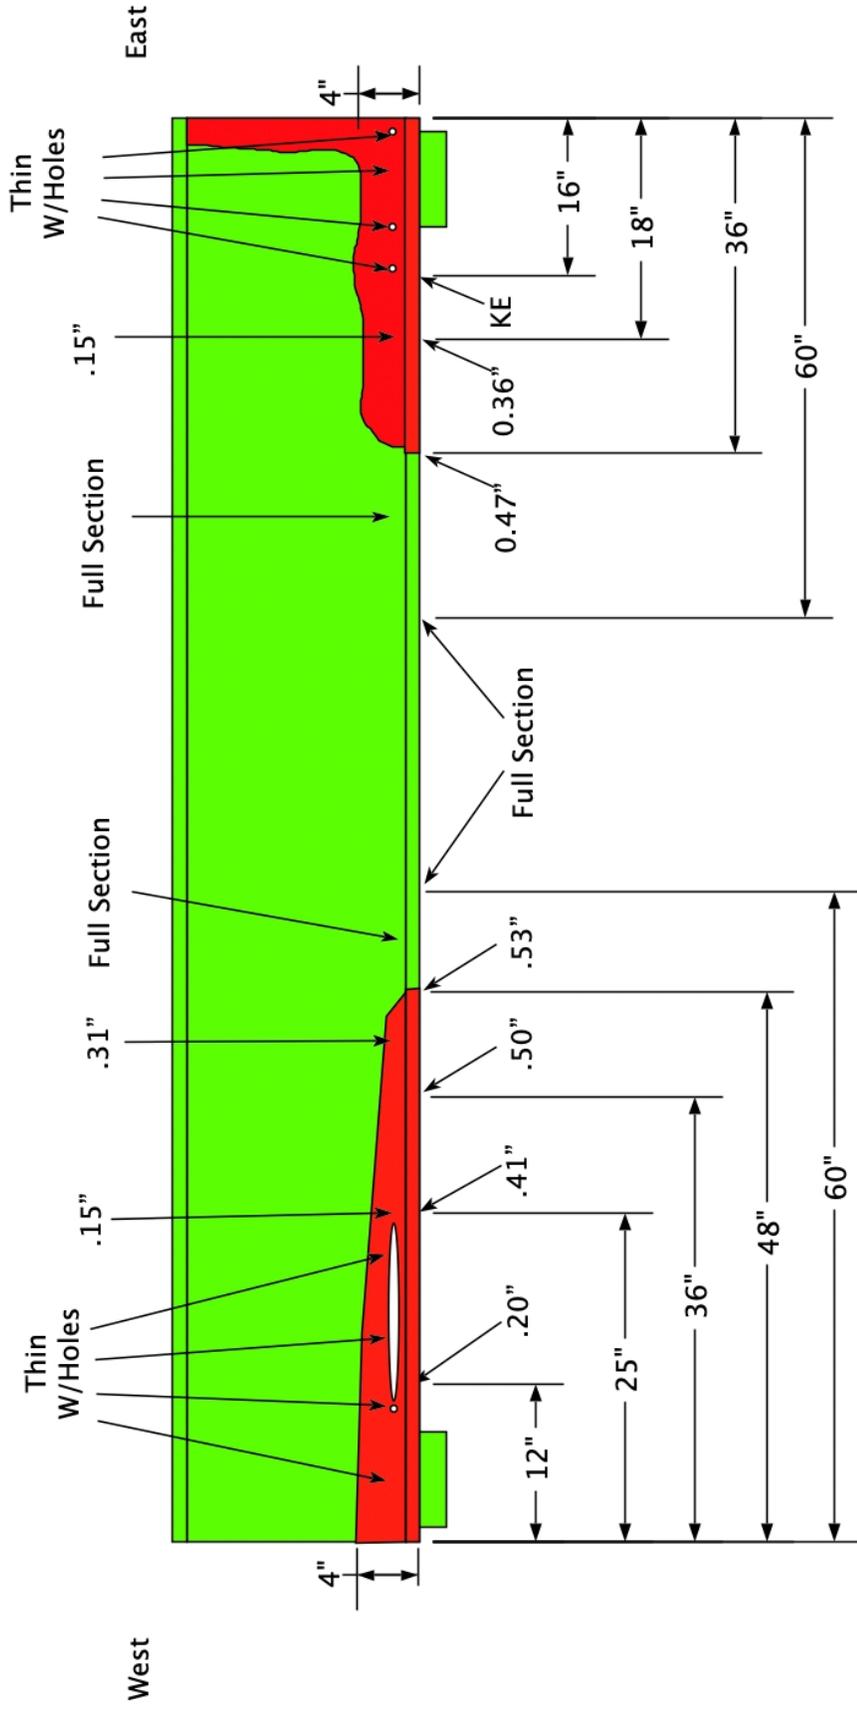
Sketch 2: Beam 1 section loss.

Beam 1, at both ends, has severe section loss. **See Sketch 2 and Photos 3 & 4.**

Original section = 12WF50
 Flange = 0.640"
 Web = 0.370"

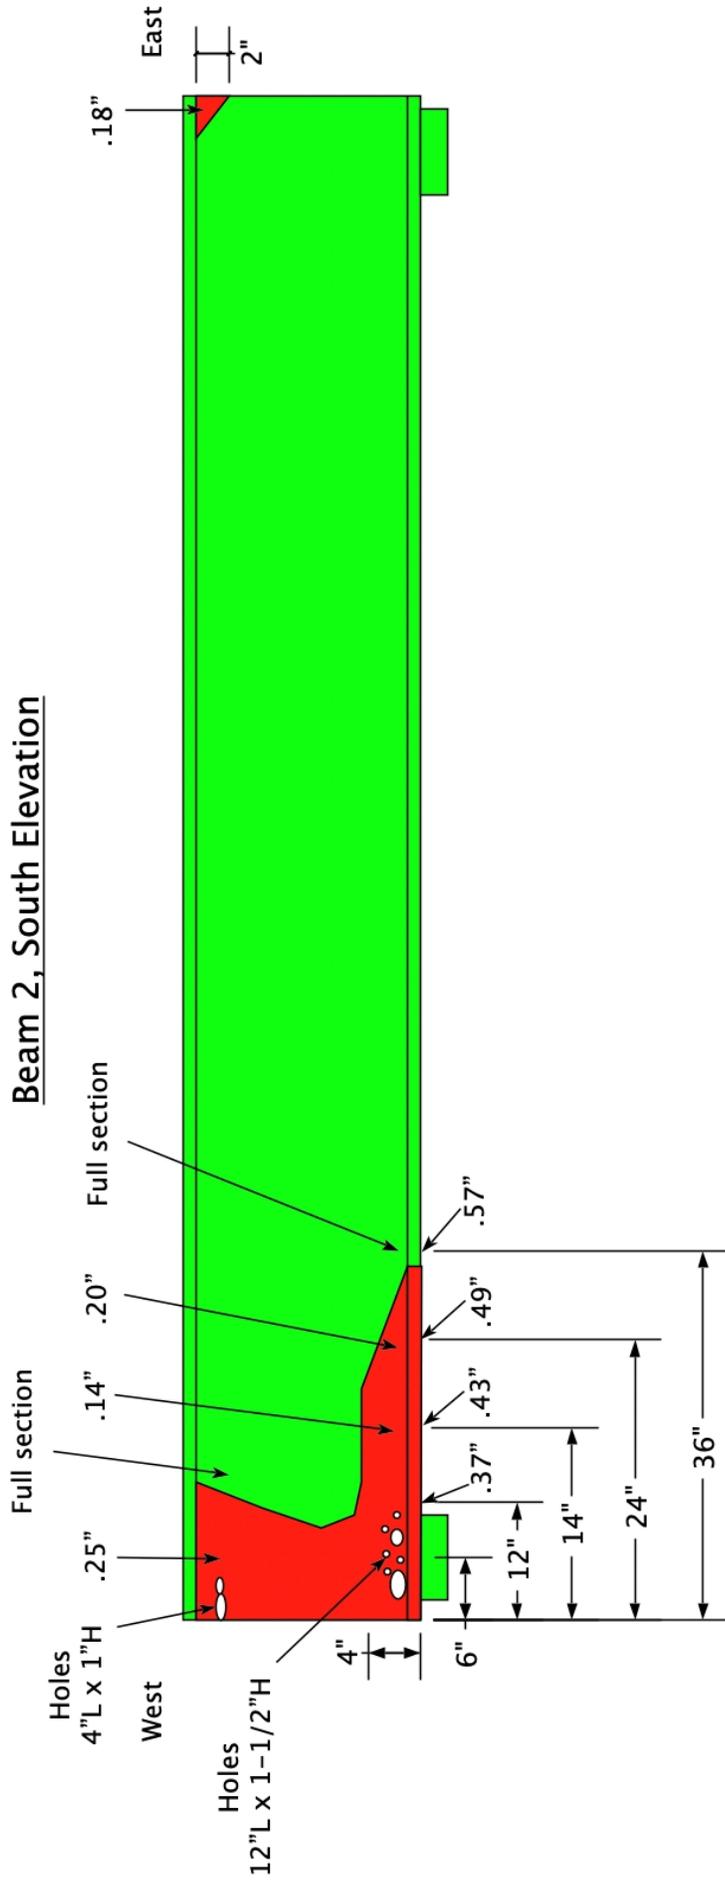
Sketch 3: Beam 2 section loss.

Beam 2, at the west end, has severe section loss and appears to be beginning to buckle. **See Sketch 3 and Photo 6.**

Original section = 12WF50
 Flange = 0.640"
 Web = 0.370"

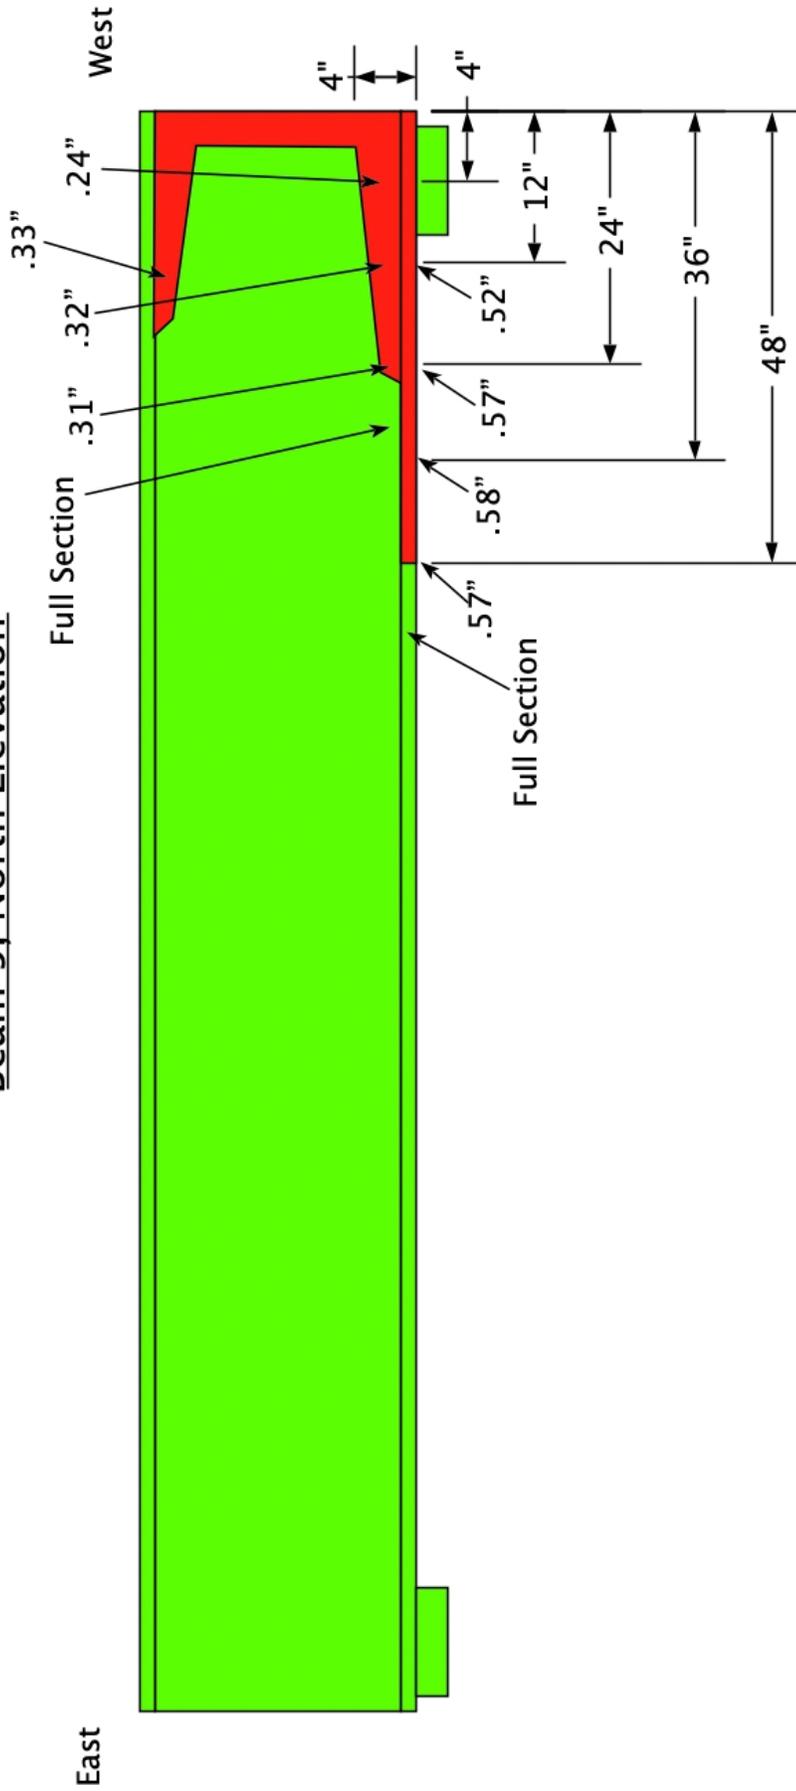
Sketch 4: Beam 5 section loss.

Beam 5, at the west end, has minor section loss. **See Sketch 4 and Photo 7.**

Original section = 12WF50
 Flange = 0.640"
 Web = 0.370"

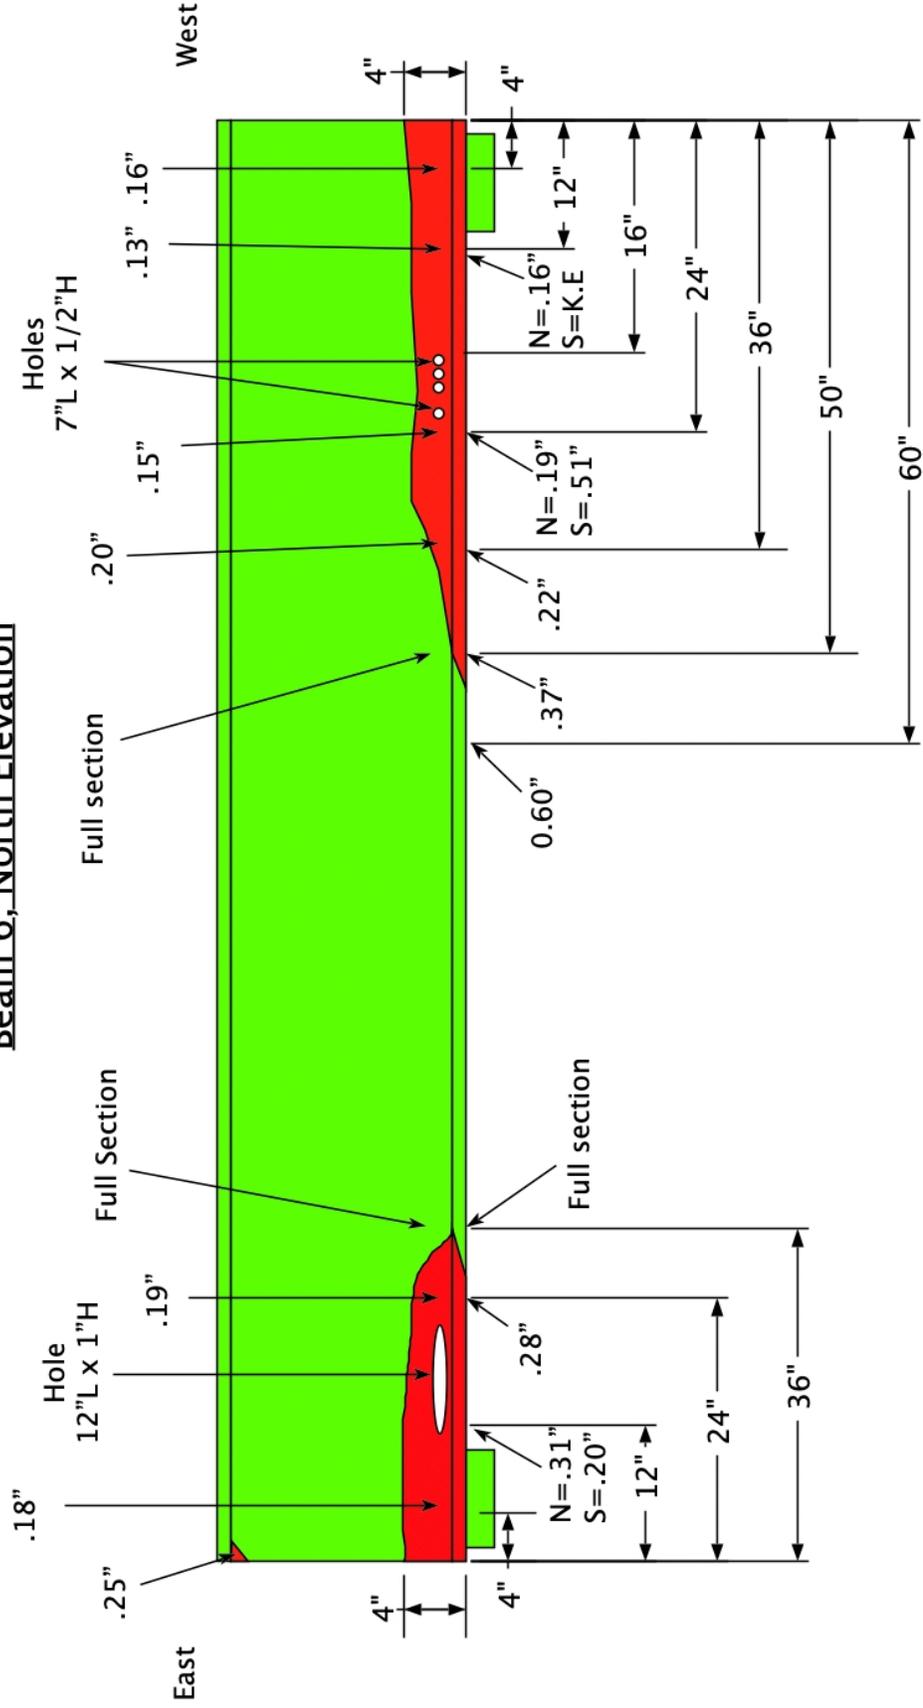
Sketch 5: Beam 6 section loss.

Beam 6, at both ends, has severe section loss. **See Sketch 5 and Photos 8 & 9.**

Original section = 12WF50
 Flange = 0.640"
 Web = 0.370"

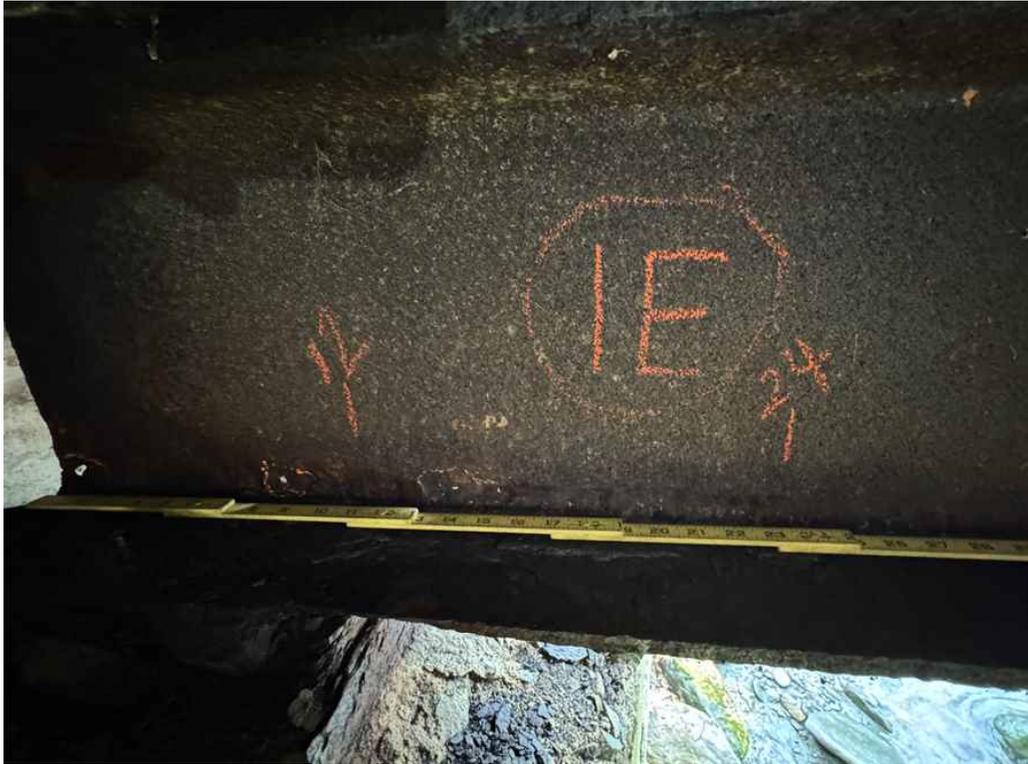
Photo 3: Beam 1, east end, section loss.

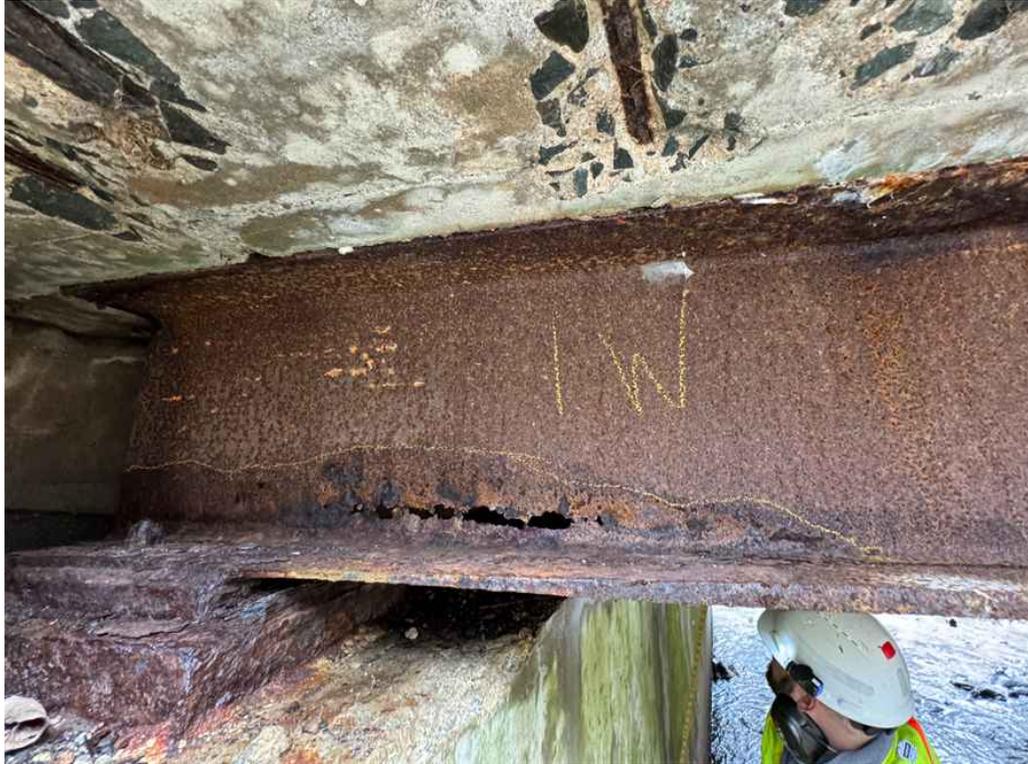
Photo 4: Beam 1, west end, section loss.

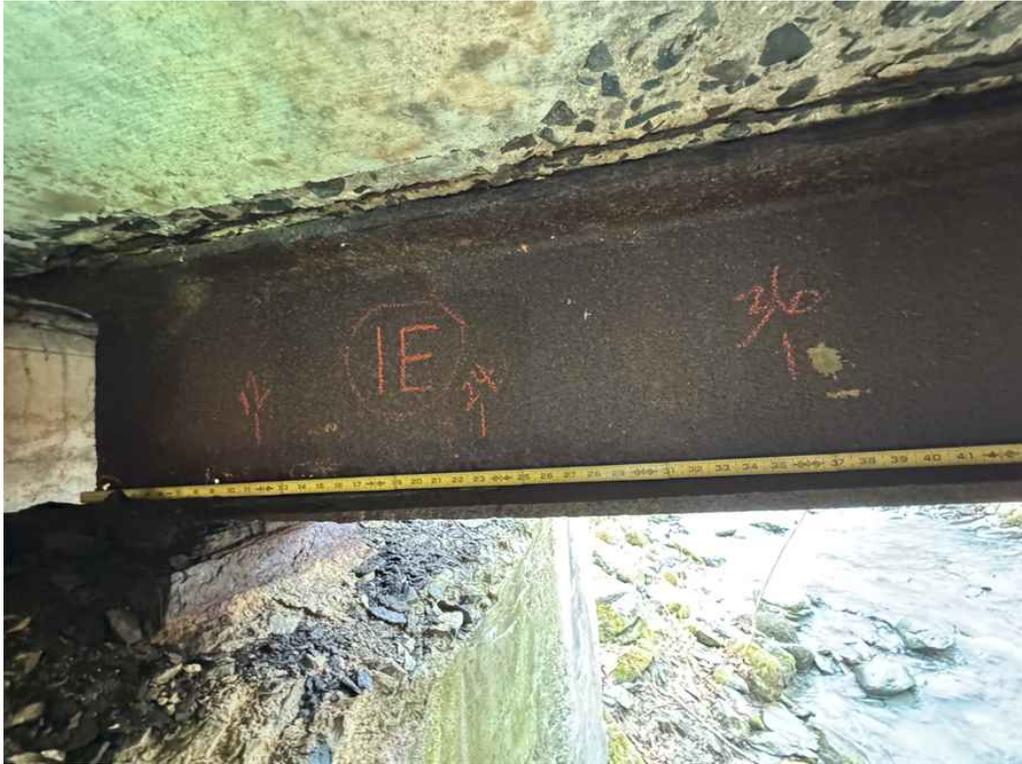
Beam 1, at the east end, has a gap between the top of beam and deck, 4' long x up to 1/8" high (previously 1/2"). **See Photo 5.**

Photo 5: Beam 1, east end, gap between top of beam and deck.

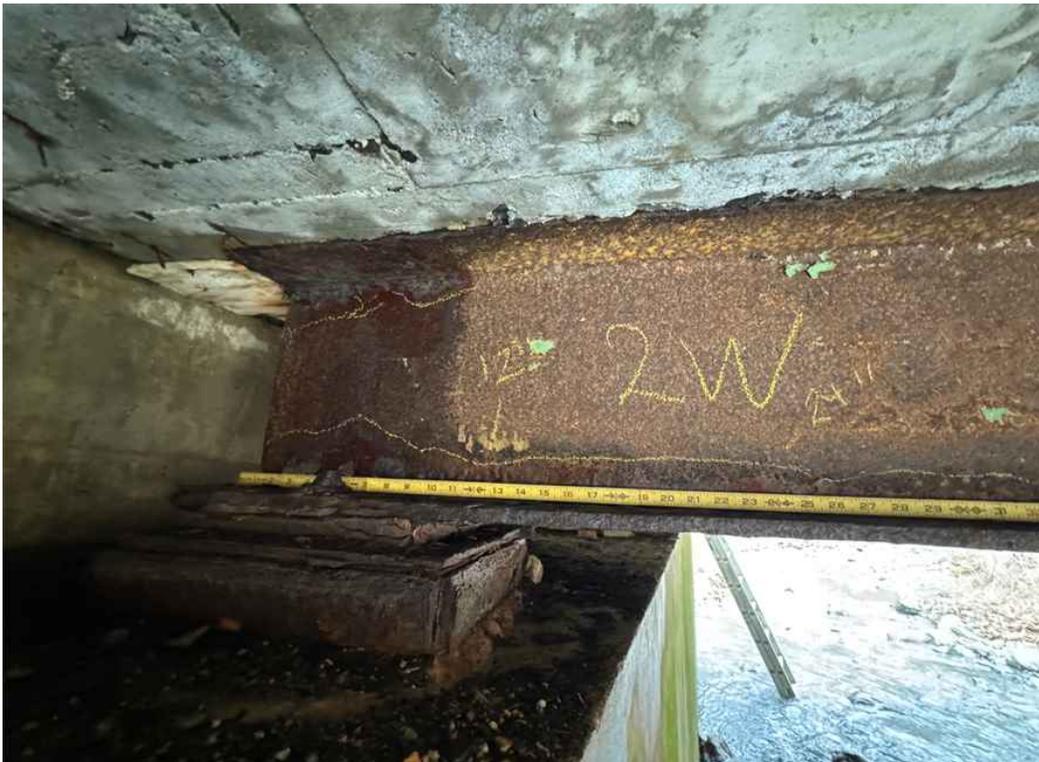
Photo 6: Beam 2, west end, section loss.

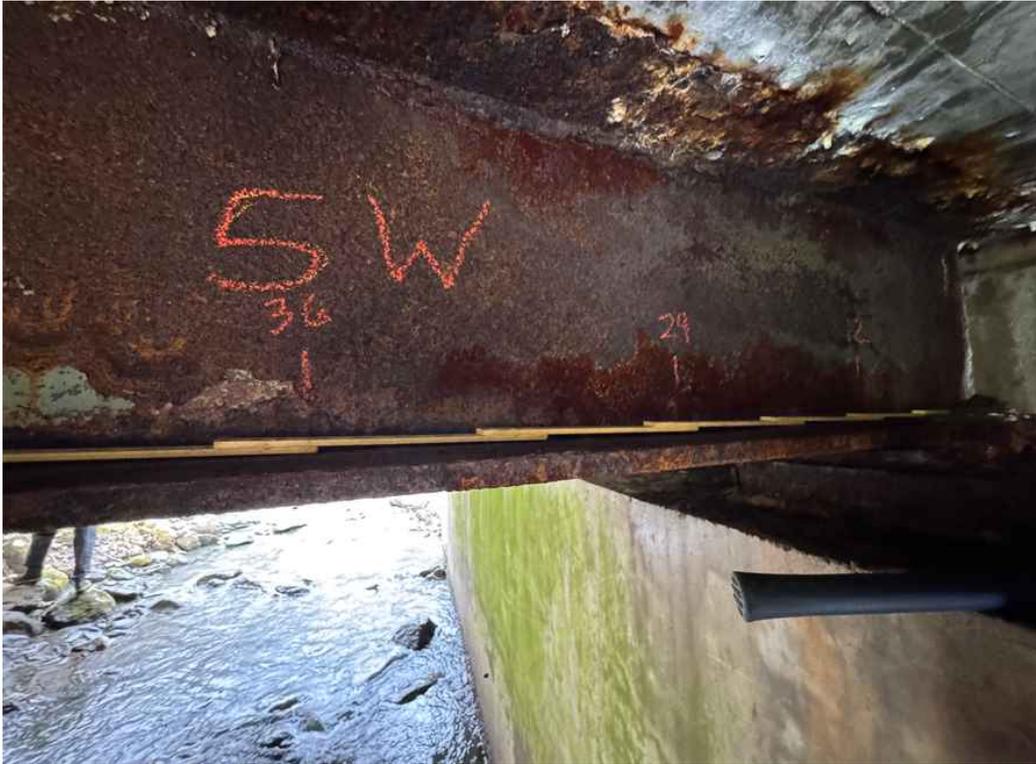
Photo 7: Beam 5, west end, section loss.

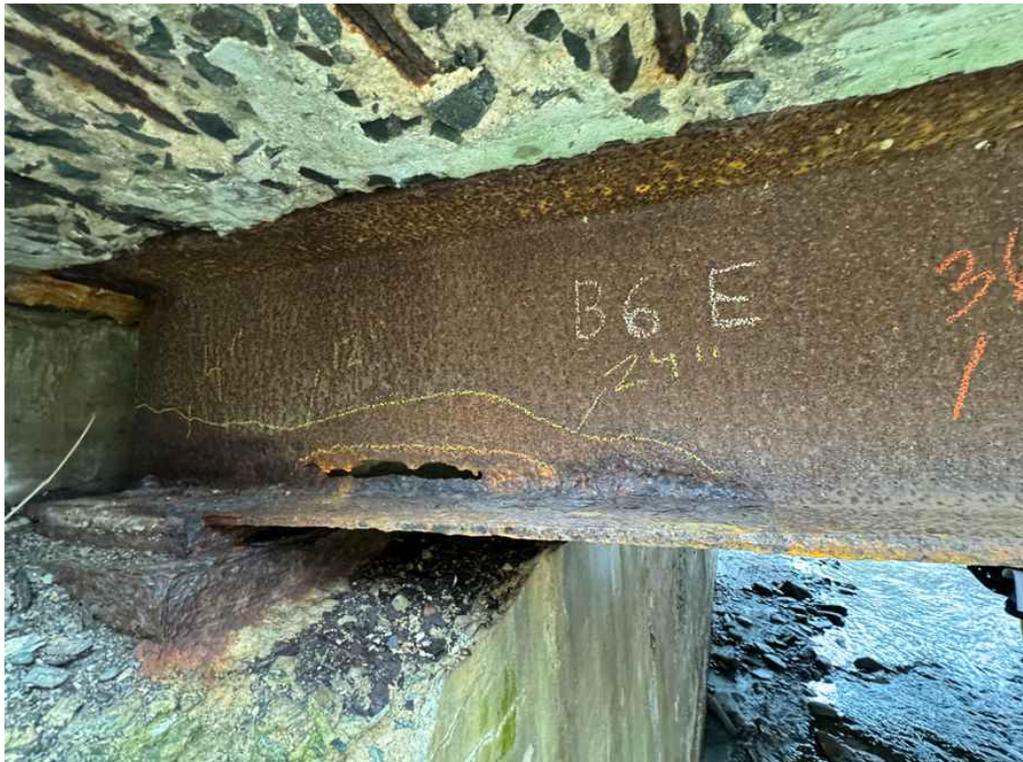
Photo 8: Beam 6, east end, section loss.

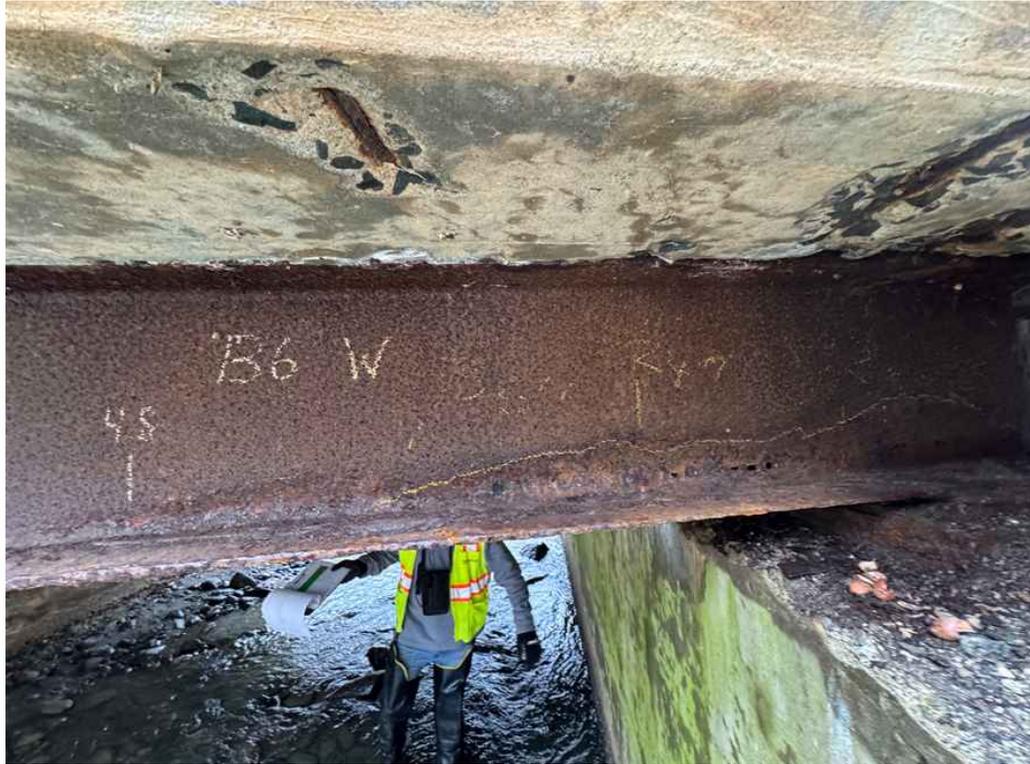
Photo 9: Beam 6, west end, section loss.
