STRUCTURES INSPECTION FIELD REPORT

B.I.N.  
5CQ

BR. DEPT. NO.  
A-13-018

CITY/TOWN <b>ASHFIELD</b>	8.-STRUCTURE NO. <b>A13018-5CQ-MUN-BRI</b>	11-Kilo. POINT <b>000.000</b>	90-ROUTINE INSP. DATE <b>Jan 12, 2024</b>	INSPECTION DATE <b>Jul 23, 2024</b>
07-FACILITY CARRIED <b>HWY PFERSICK RD</b>	MEMORIAL NAME/LOCAL NAME	27-YR BUILT <b>1990</b>	106-YR REBUILT <b>0000</b>	*YR REHAB'D (NON 106) <b>0000</b>
06-FEATURES INTERSECTED <b>WATER BEAR RIVER</b>	26-FUNCTIONAL CLASS <b>Rural Local</b>	DIST. BRIDGE INSPECTION ENGINEER <i>Michael P. McCabe</i> M. P.E. McCabe		
43-STRUCTURE TYPE <b>119 : Concrete Culvert</b>	22-OWNER <b>Town Agency</b>	21-MAINTAINER <b>Town Agency</b>	TEAM LEADER R. Mancari <i>Reed Mancari</i>	
107-DECK TYPE <b>N : Not applicable</b>	WEATHER <b>Cloudy</b>	TEMP. (air) <b>21°C</b>	TEAM MEMBERS <b>M. RANZONI</b> <i>Matthew Ranzoni</i>

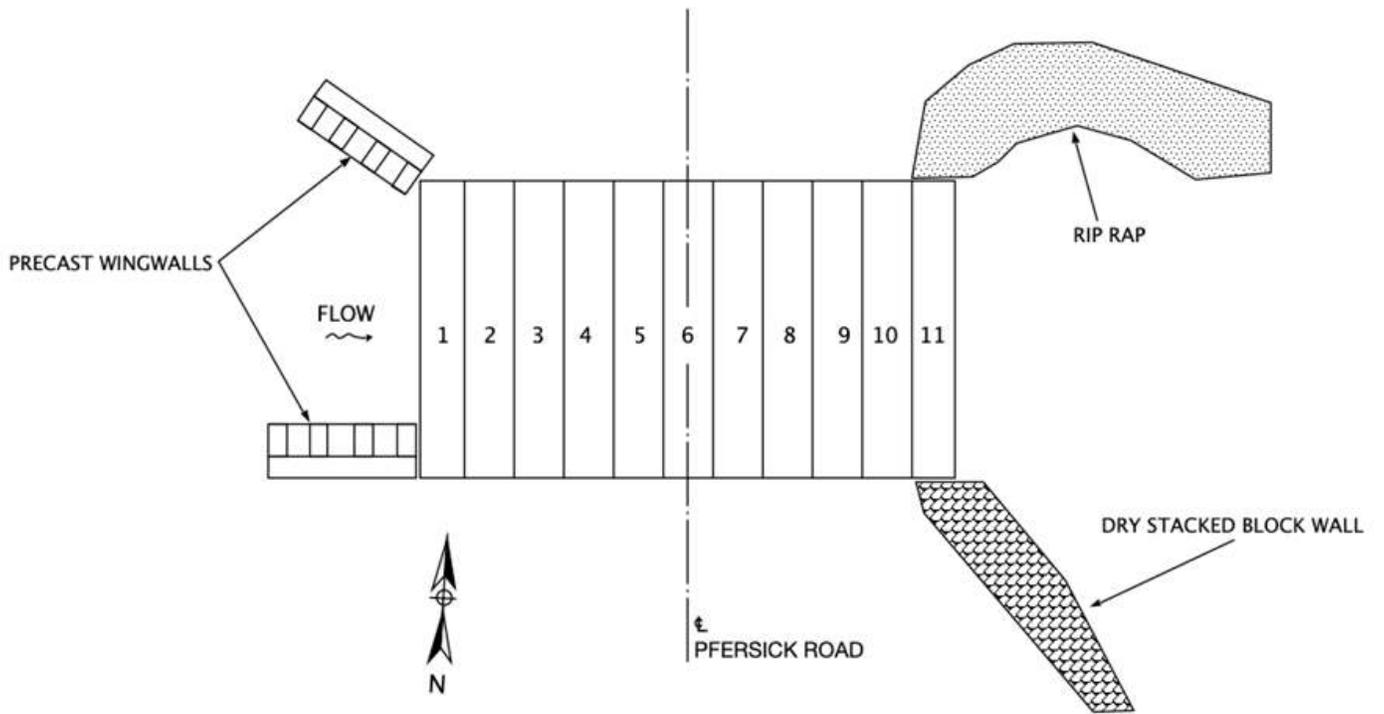
Sketch 1: Framing plan.

Pfersick Road travels north and south. The Bear River flows from west to east. This culvert is a single box, which consists of eleven precast concrete sections, with no fill and an asphalt wearing surface. Sections are numbered from west to east, upstream to downstream, in accordance with the 2015 Bridge Inspection Handbook. See sketch 1 and photos 1 & 2.

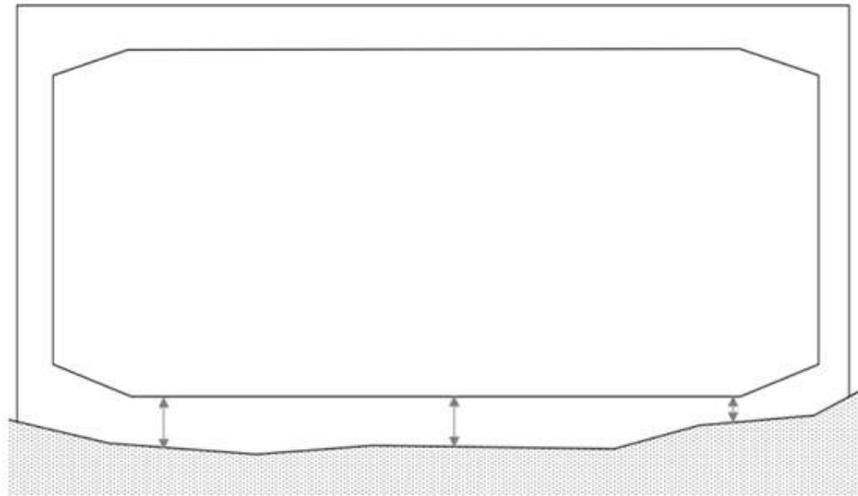
**Chart 1: Channel profile readings.**

For channel profile readings, refer to chart 1.

A13018 Channel Profile Readings						
	West Fascia			East Fascia		
DATE	South Wall	1/2 span	North Wall	South Wall	1/2 span	North Wall
1/12/2024	0.4	0.3	0.3	2.4	2.0	3.5
7/23/2024	0.5	0.3	0.4	1.6	0.9	2.3

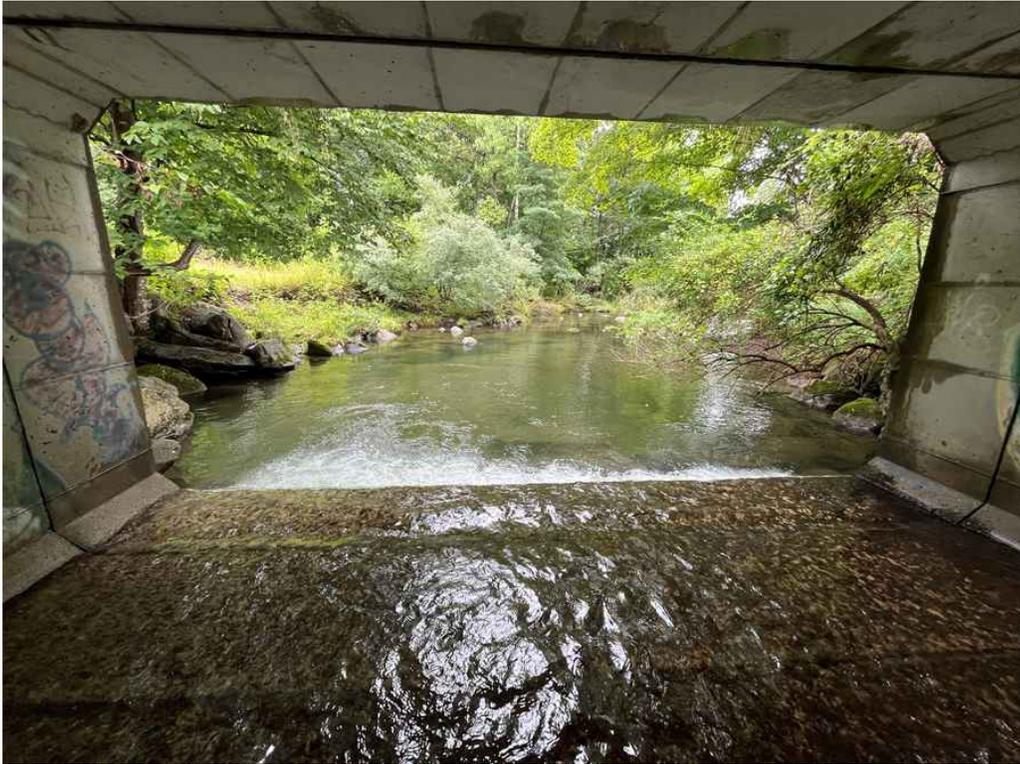
At the downstream opening, there is a large plunge pool, approximately 40' diameter x 4' deep. See photo 3.

**Photo 3: Downstream plunge pool.**
