STRUCTURES INSPECTION FIELD REPORT

B.I.N.
C42

CULVERT INSPECTION

BR. DEPT. NO.
A-13-043

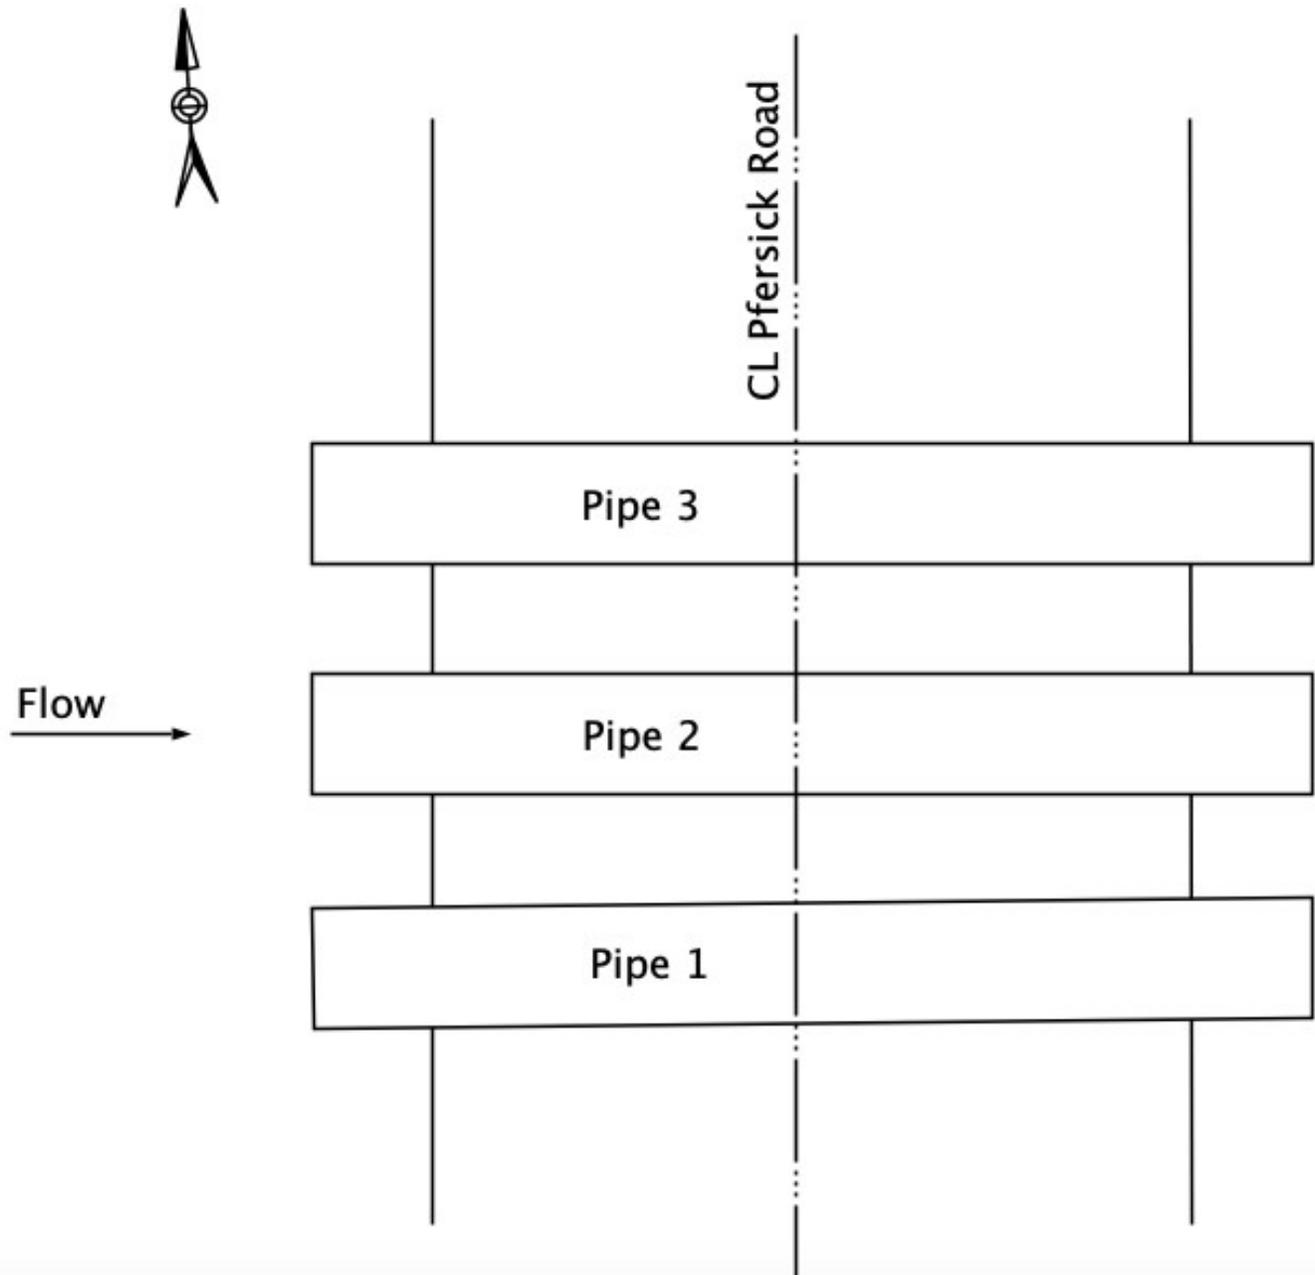
Sketch 1: Framing Plan.

Pfersick Road travels north and south. Sids Brook flows from west and east. This culvert consists of three corrugated steel pipes, each 3' diameter, supporting fill with an asphalt wearing surface. The pipes are numbered from south to north, and report notes are taken from west to east, upstream to downstream, in accordance with the 2015 Bridge Inspection Handbook. **See sketch 1 and photos 1 & 2.**

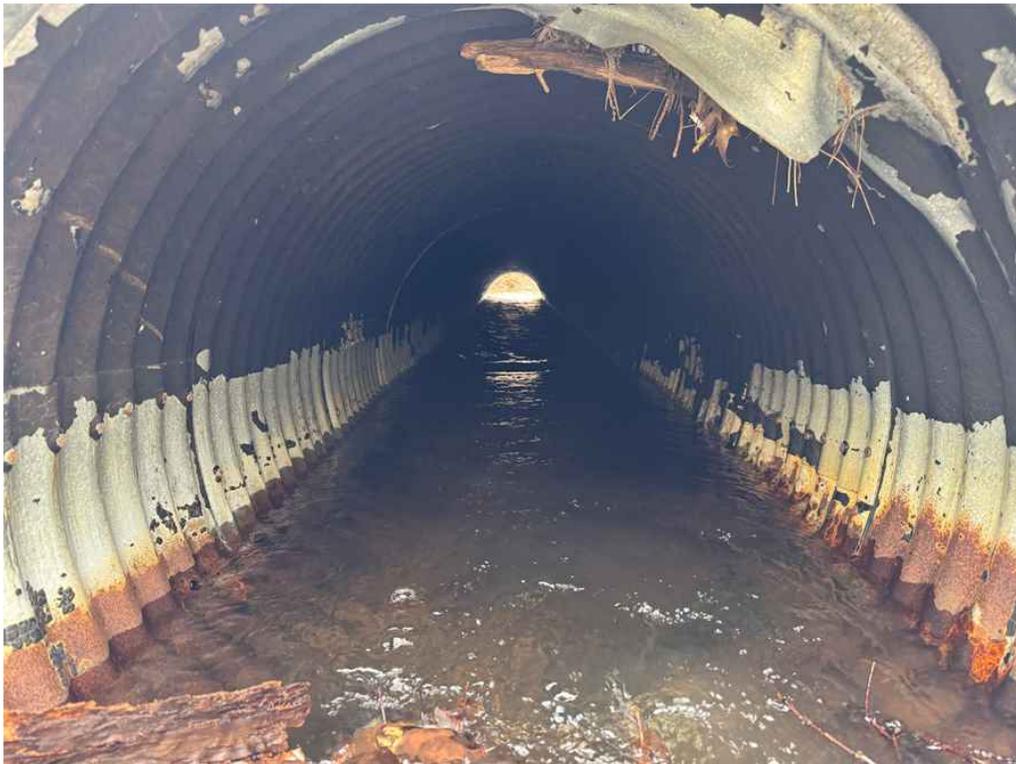
Photo 2: General underside, looking west, pipe 2 shown.

In the bottom half of the pipe, the coating has failed. **See photo 2.**

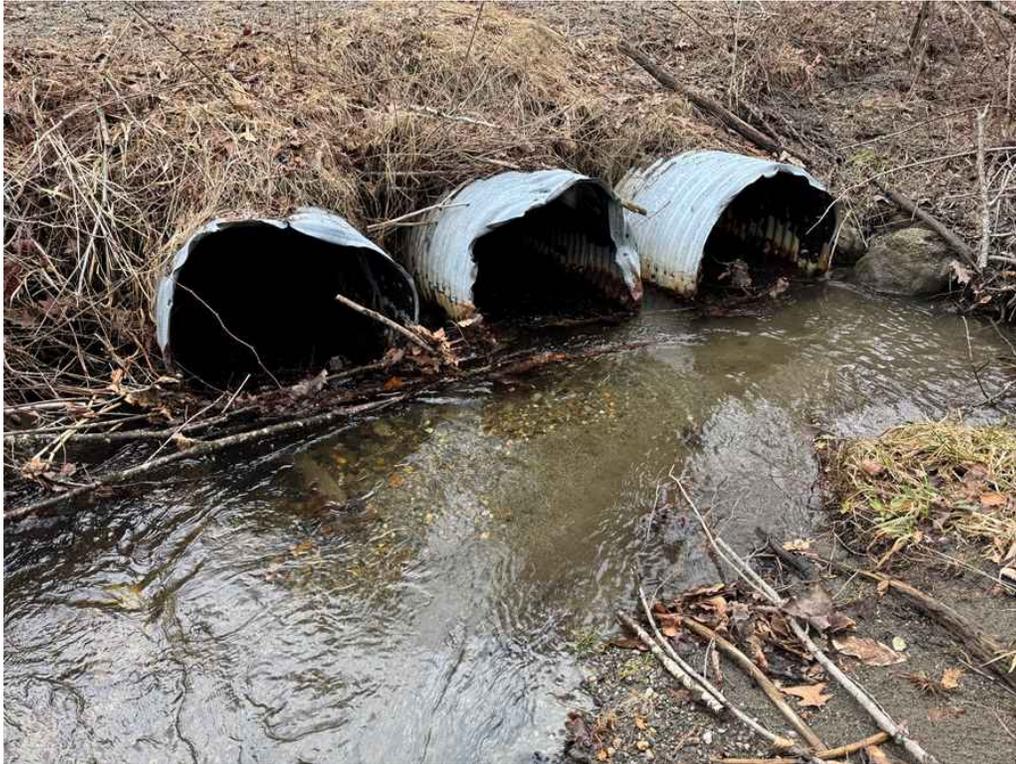
All pipes, at the west end, have impact damage, 2' long. **See photo 3.**

At the west end of the pipes, there is a buildup of debris. **See photo 3.**

Photo 3: West end of the pipes with impact damage and debris buildup.
