STRUCTURES INSPECTION FIELD REPORT

ROUTINE & SPECIAL MEMBER INSPECTION

BR. DEPT. NO.
A-13-024

CITY/TOWN ASHFIELD	8-STRUCTURE NO. A13024-0EF-MUN-NBI	11-Kilo. POINT 000.000	41-STATUS P:POSTED	90-ROUTINE INSP. DATE MAR 21, 2025
07-FACILITY CARRIED HWY WILLIAMSBURG	MEMORIAL NAME/LOCAL NAME	27-YR BUILT 1938	106-YR REBUILT 0000	YR REHAB'D (NON 106) 0000
06-FEATURES INTERSECTED WATER CREAMERY BROOK	26-FUNCTIONAL CLASS Major Collector	DIST. BRIDGE INSPECTION ENGINEER <i>Michael P. McCabe</i> M.P.E. McCabe		
43-STRUCTURE TYPE 302 : Steel Stringer/Girder	22-OWNER Town Agency	21-MAINTAINER Town Agency	TEAM LEADER T. Franciosa <i>[Signature]</i>	PROJ MGR Michael Baker Intl Inc <i>[Signature]</i>
107-DECK TYPE 1 : Concrete Cast-in-Place	WEATHER Cloudy	TEMP. (air) 0°C	TEAM MEMBERS M. MAZZU

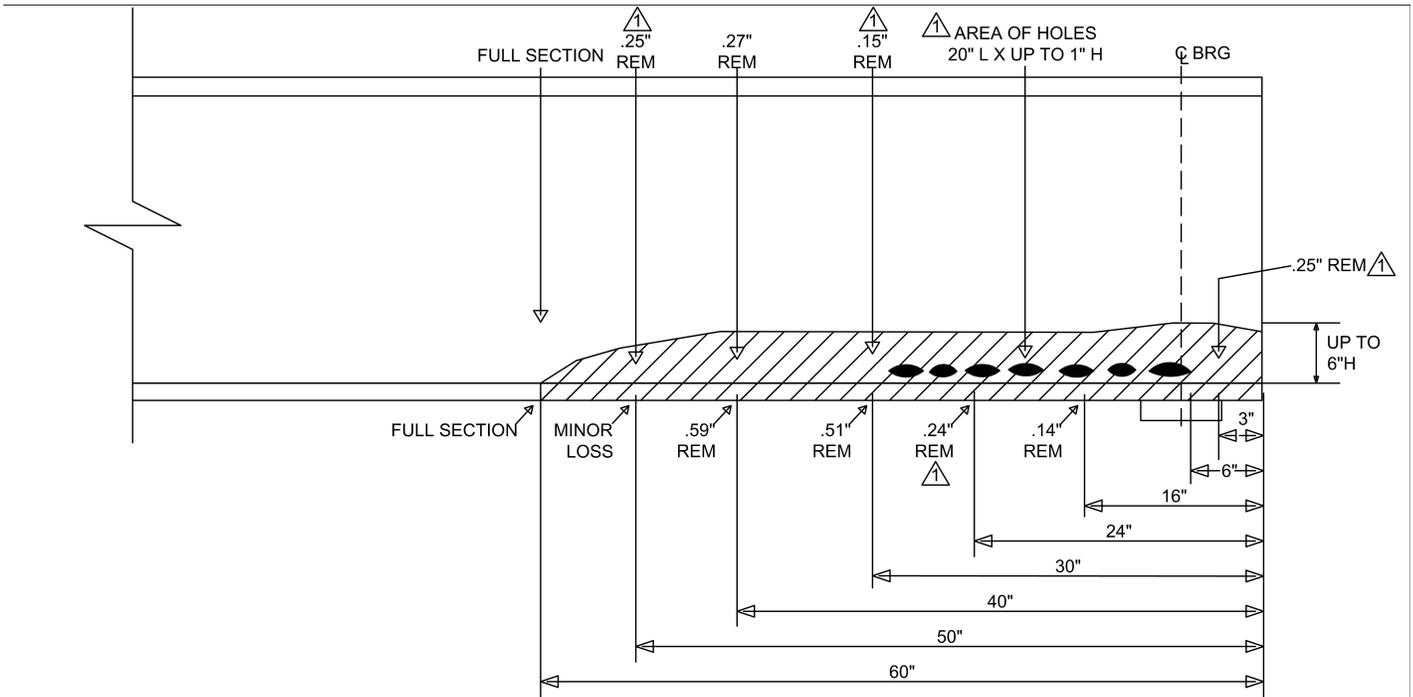
BEAM 6 AT NORTH ABUTMENT
EAST ELEVATION
(N.T.S.)

- Moderate to heavy rust up to full length.

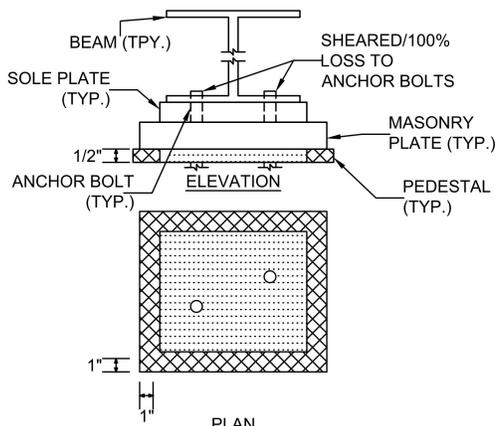
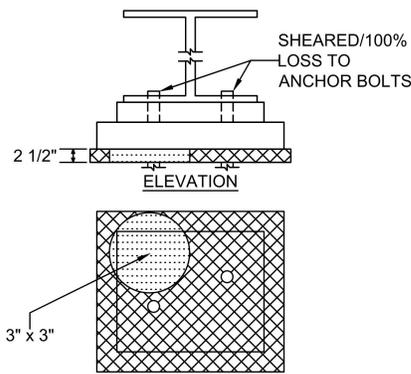
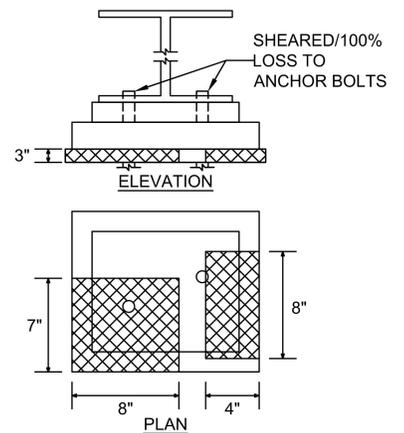
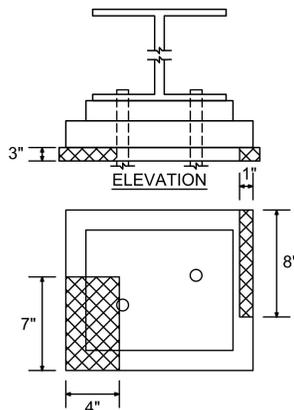
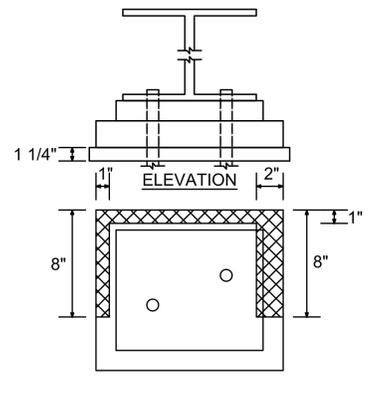
BEARINGS WITH BEARING AREA LOSS

- Bearing 1: West anchor bolt nut with 100% section loss, east anchor bolt sheared off. Bearing assembly with up to 1/16" section loss. Bearing area 100% undermined **(Photo 19)**.
- Bearing 2: Both anchor bolts sheared. Bearing area 100% undermined **(Photo 20)**.
- Bearing 3: Both anchor bolts sheared. Up to 1/2" thick pack rust between sole plate and masonry plate. Bearing area 50% undermined.
- Bearing 4: Bearing undermined 20%.
- Bearing 5: Bearing undermined 20%.
- Bearing 6: Sole plate over-expanded 1/2" beyond masonry plate at 32 degrees F. West anchor bolt nut with 100% section loss.

- Bearings 1, 2 and 5: Bearing with heavy rust and up to 1/16" section loss.
- Bearings 1 and 6: East anchor bolt nut with 100% section loss.
- Bearing 2: Bearing undermined 6%.
- Bearings 3 and 4: Up to 1/2" thick pack rust between sole plate and masonry plate.
- Bearing 5: East anchor bolt missing.

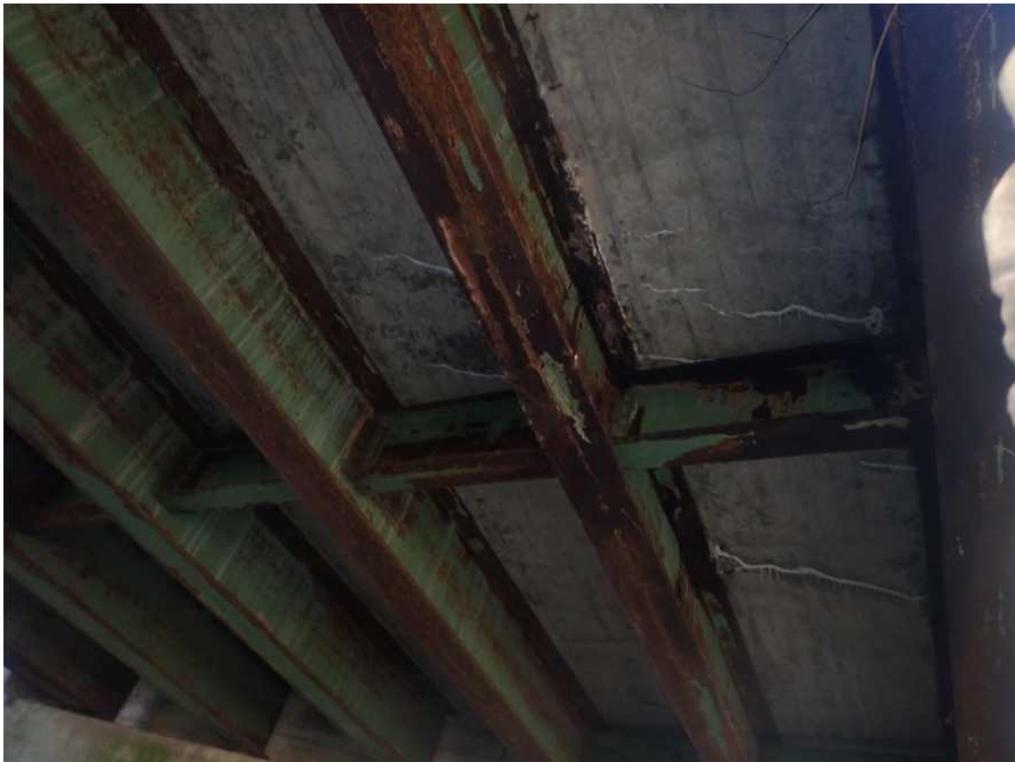
- West Overhang to Beam 3 at South Abutment: Deck not in contact with beam top flanges for up to 10'-0" long.
- Bays 1 and 2 between Diaphragms 1 and 3: Several diagonal hairline cracks with efflorescence and stalactites (**Photo 12**).
- Bay 2 between Diaphragms 1 and 2: 5" long x 3" wide x 1/2" deep spall with exposed rebar and 4" long x 8" wide delamination.
- Bay 1 near North Abutment: 1'-0" long x 2'-4" wide delamination with a 5" diameter x 1" deep spall with exposed rebar.
- Bay 1 adjacent to Beam 1 near North Abutment: Three (3) up to 2'-0" long x 7" wide x 1" deep spalls with exposed rebar.

Photo 12: Underside of deck at Diaphragm 2 in Bay 1 and 2 with diagonal hairline crack with efflorescence.

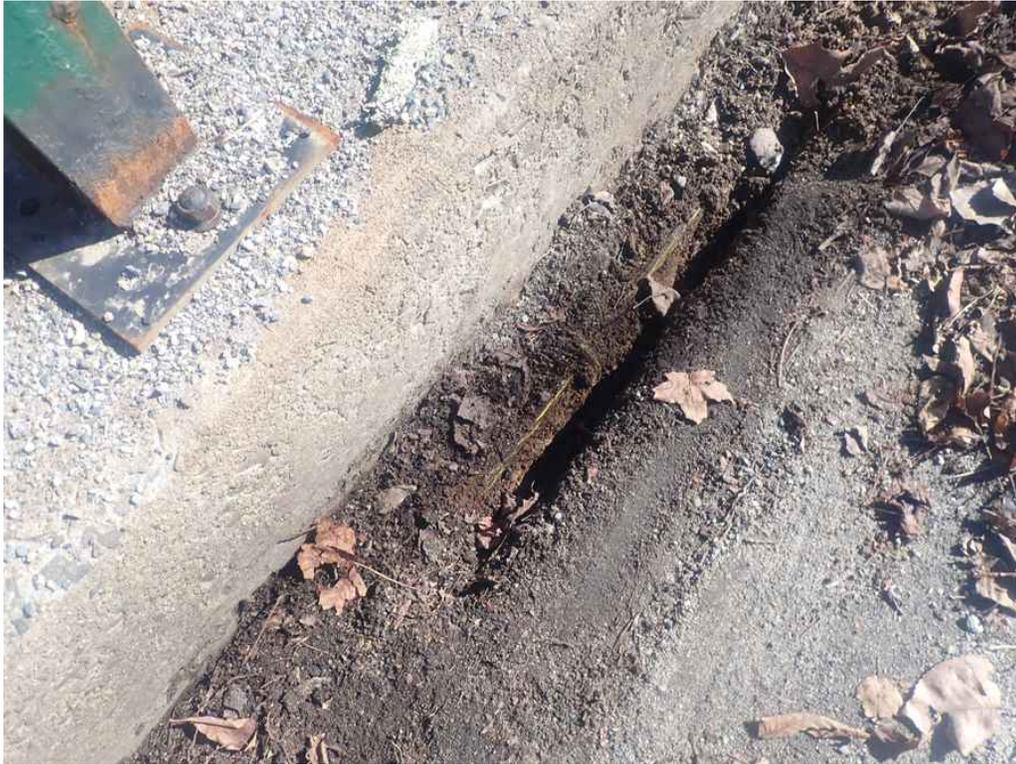
The wearing surface is paved flush with the curbs. Typically, the curbs are hidden by debris build up along the edge of the roadway. The east curb near midspan has a full width spall with exposed rebar (**Photo 13**).

Photo 13: East Curb Line at mid-span with spall and exposed rebar. Note: wearing surface paved flush with curb line.

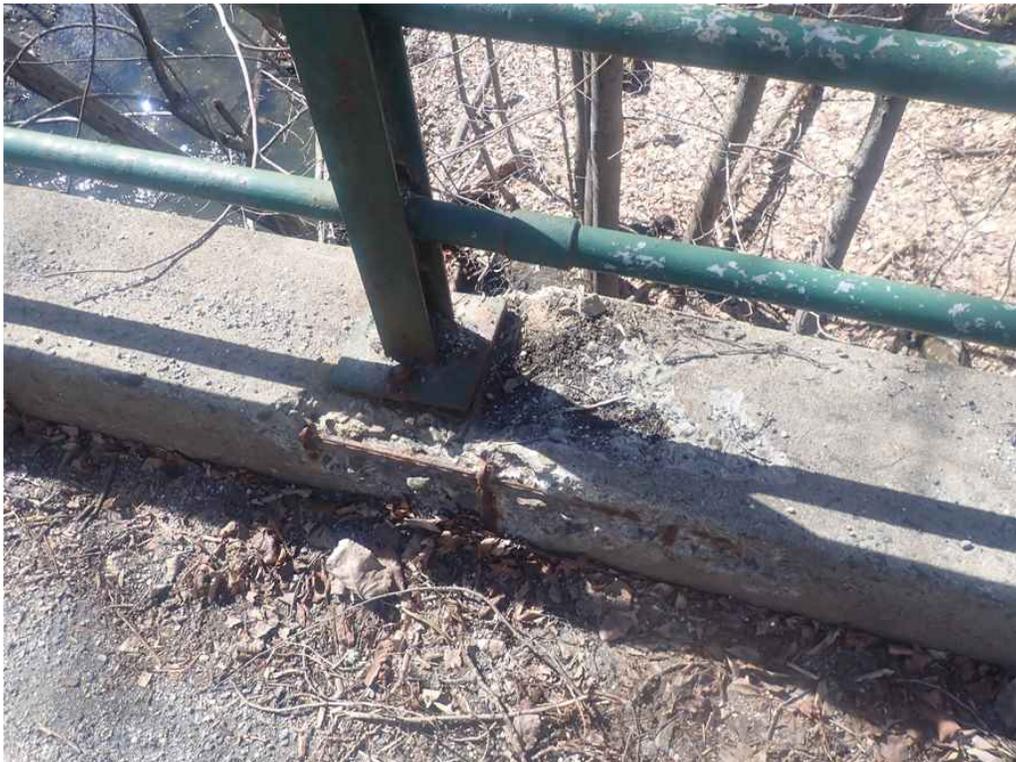
- First five posts from the south: Tipped to the south.
- Rail base at third post from north: 3'-2" long x 8" high x 3" deep spall with exposed rebar that extends 5" onto the west face (**Photo 14**).

Photo 14: West Bridge Railing at 3rd post from north with spall and exposed rebar.

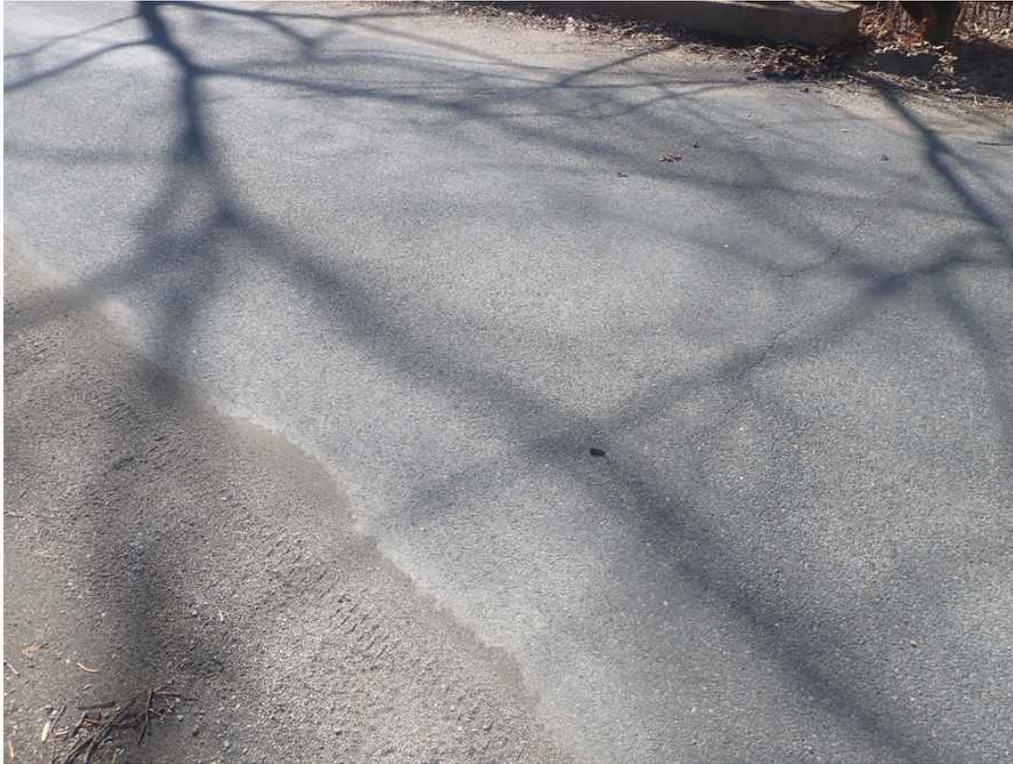
There are up to 1/4" wide x up to full length transverse cracks in the North and South Approaches at the abutments (**Photo 15**).

Photo 15: Transverse crack in Approach Pavement at North Abutment.

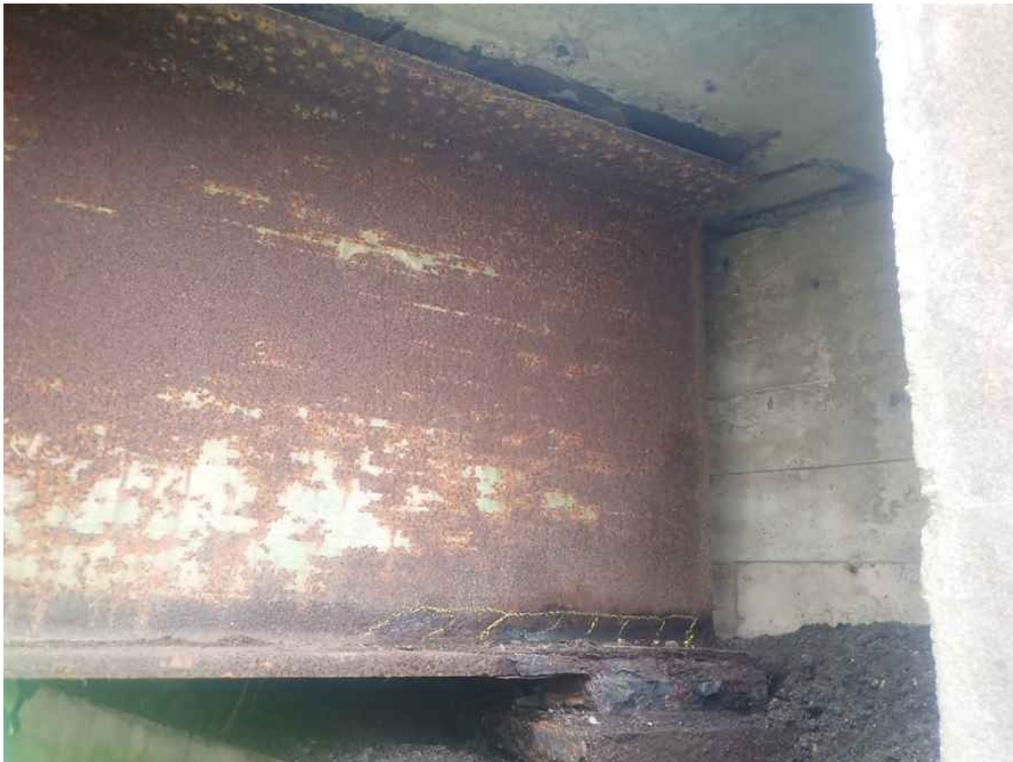
Photo 16: Beam 1 West Face at South Abutment with section loss. Note: separation between deck and top flange and 100% loss to concrete pedestal.

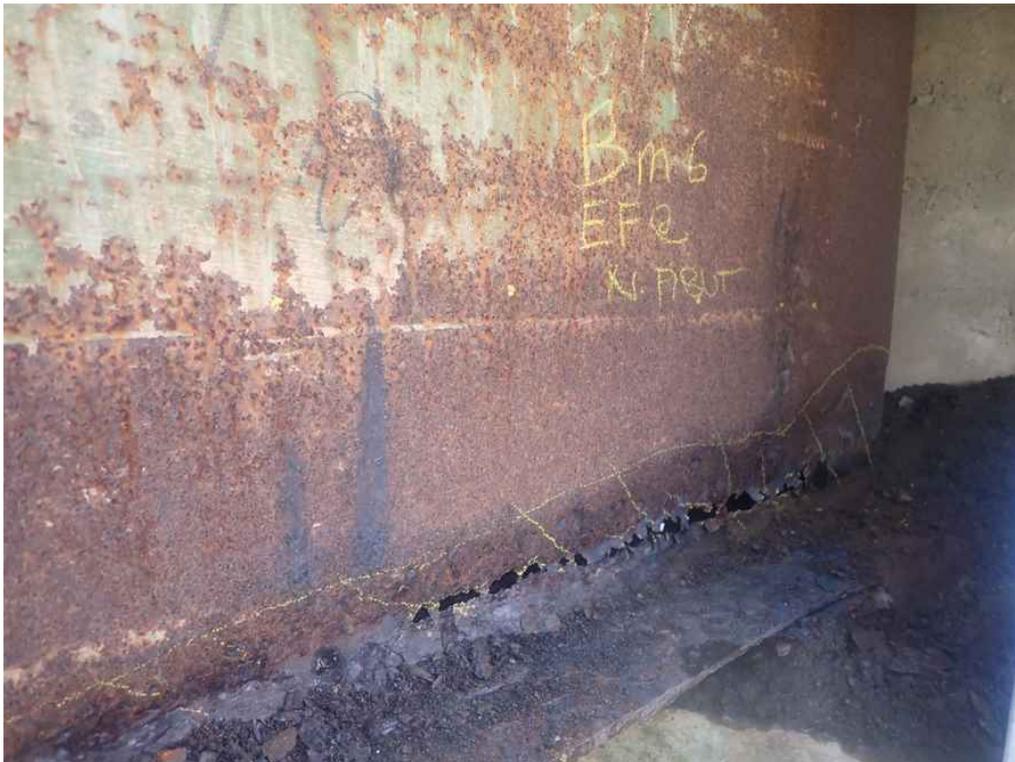
Photo 18: Beam 6, East Face, at North Abutment with advanced section loss.

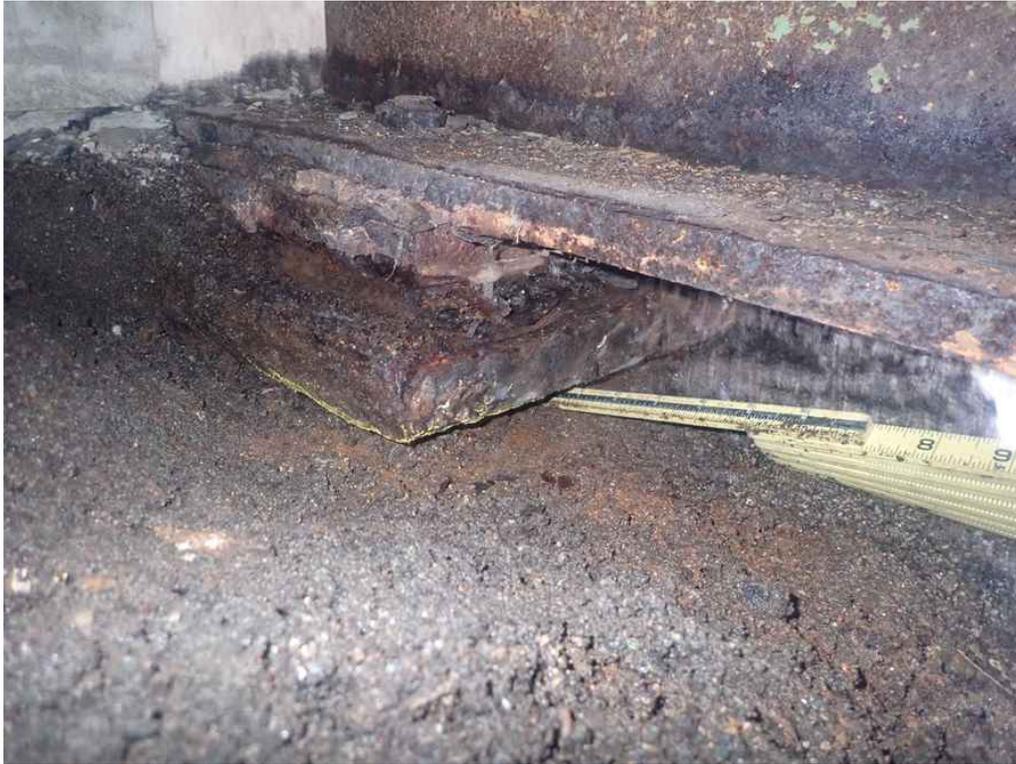
The pedestals at the South Abutment are typically spalled with punky concrete up to full width x up to full length (Sketch 5 and Photos 19-20).

Photo 19: Bearing 1, East Face, at South Abutment pedestal spall with punky concrete.

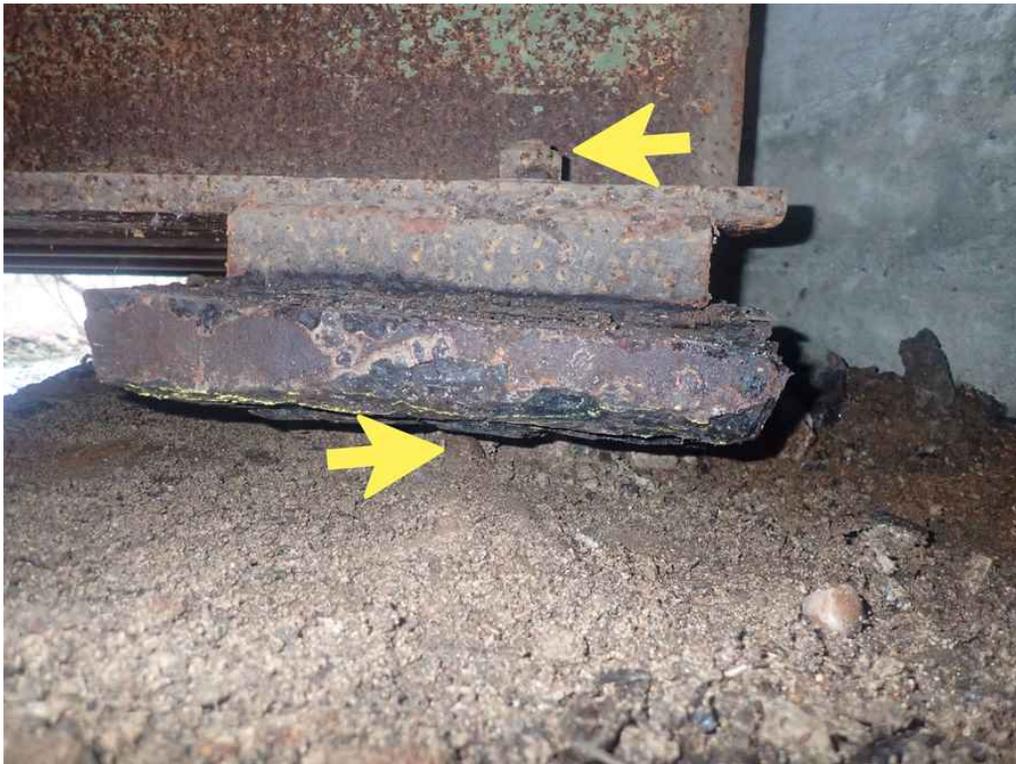
Photo 20: Bearing 2, West Face, at South Abutment with pedestal spall and sheared anchor bolt.

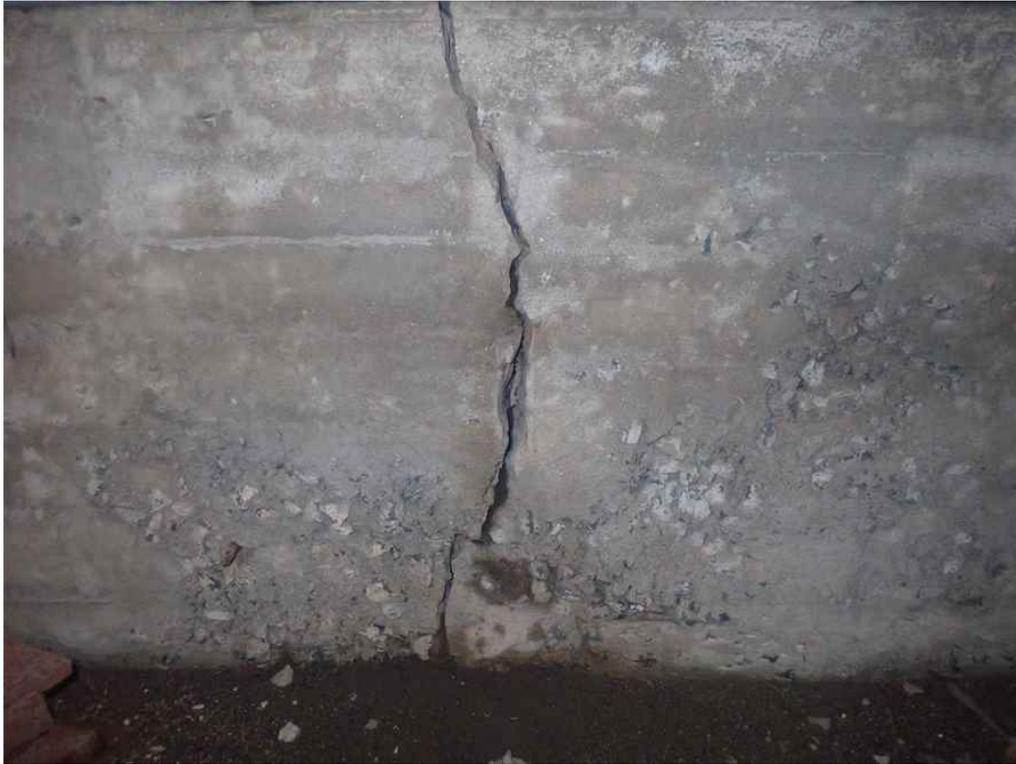
- Bay 1: 8" long x 5" high x 3/4" deep honeycomb area.
- Bay 3, over the construction joint: 5/8" wide x full height vertical crack with an adjacent 3'-6" long x up to 2'-0" high x up to 1" deep honeycomb area (**Photo 21**).

Photo 21: North Abutment, Backwall, below Bay 3 with full height wide crack.

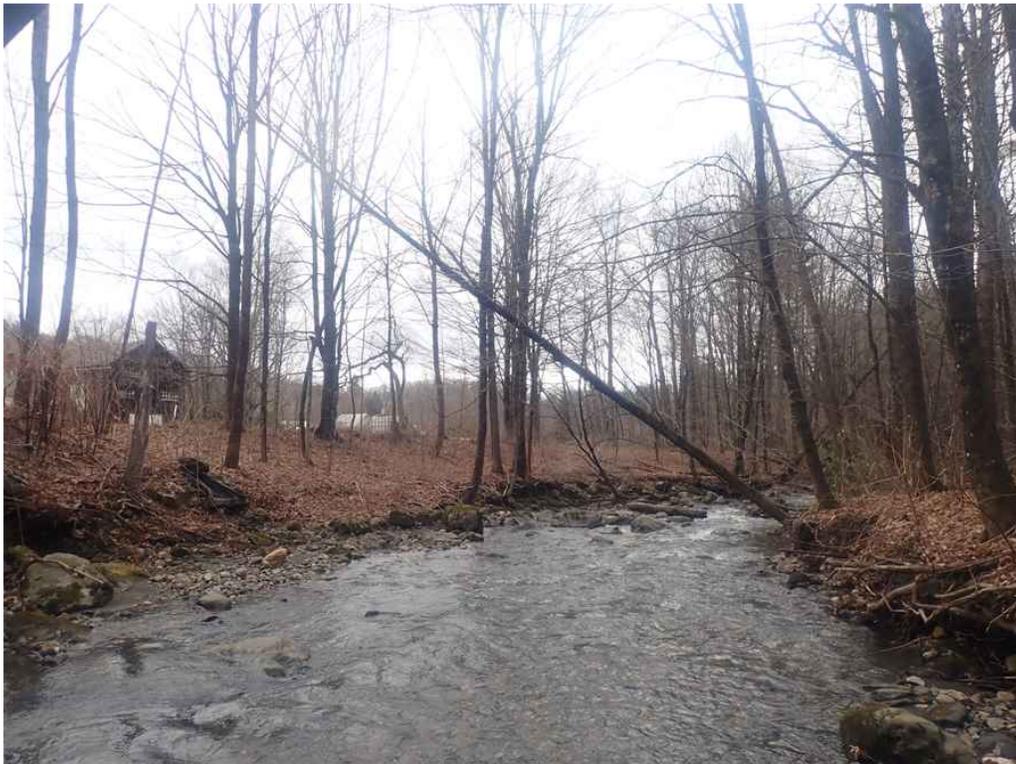
The downed trees in the upstream channel noted in the previous Routine Inspection (3/10/23) are no longer present. There are isolated trees in the downstream channel (**Photo 22**).

Photo 22: Isolated tree, downstream, looking east.

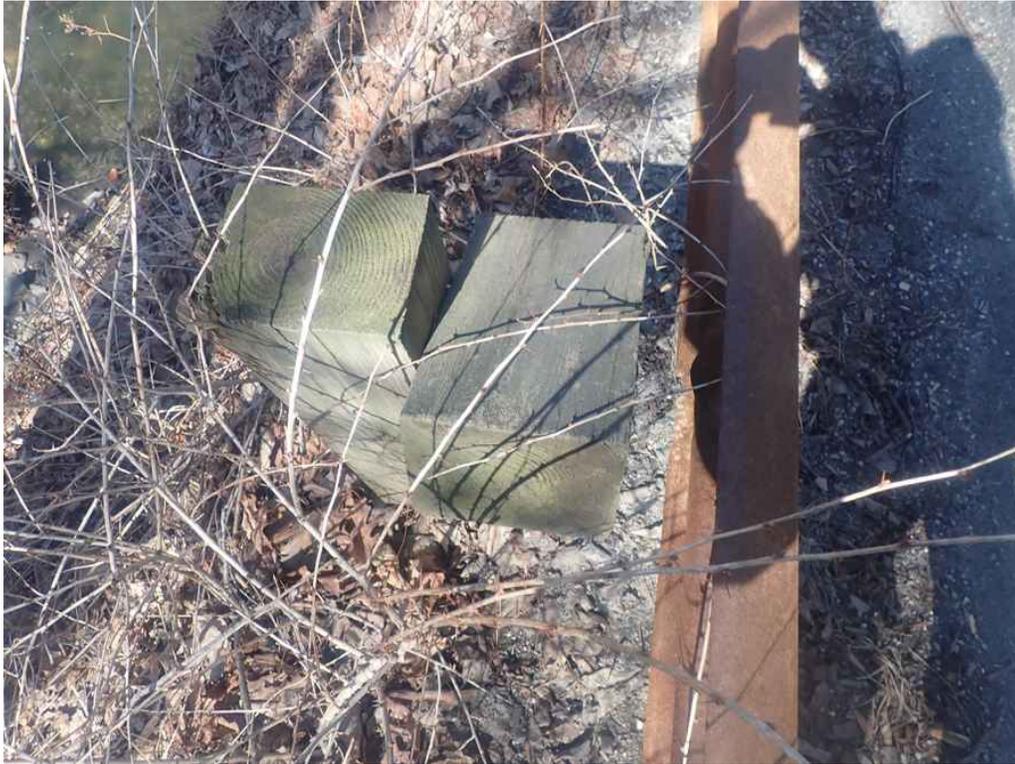
Photo 23: Southwest Approach Guardrail 2nd post from Bridge with rotated block disconnected from approach guardrail.
