STRUCTURES INSPECTION FIELD REPORT

SPECIAL MEMBER INSPECTION

B.I.N.
5CK

BR. DEPT. NO.
A-13-035

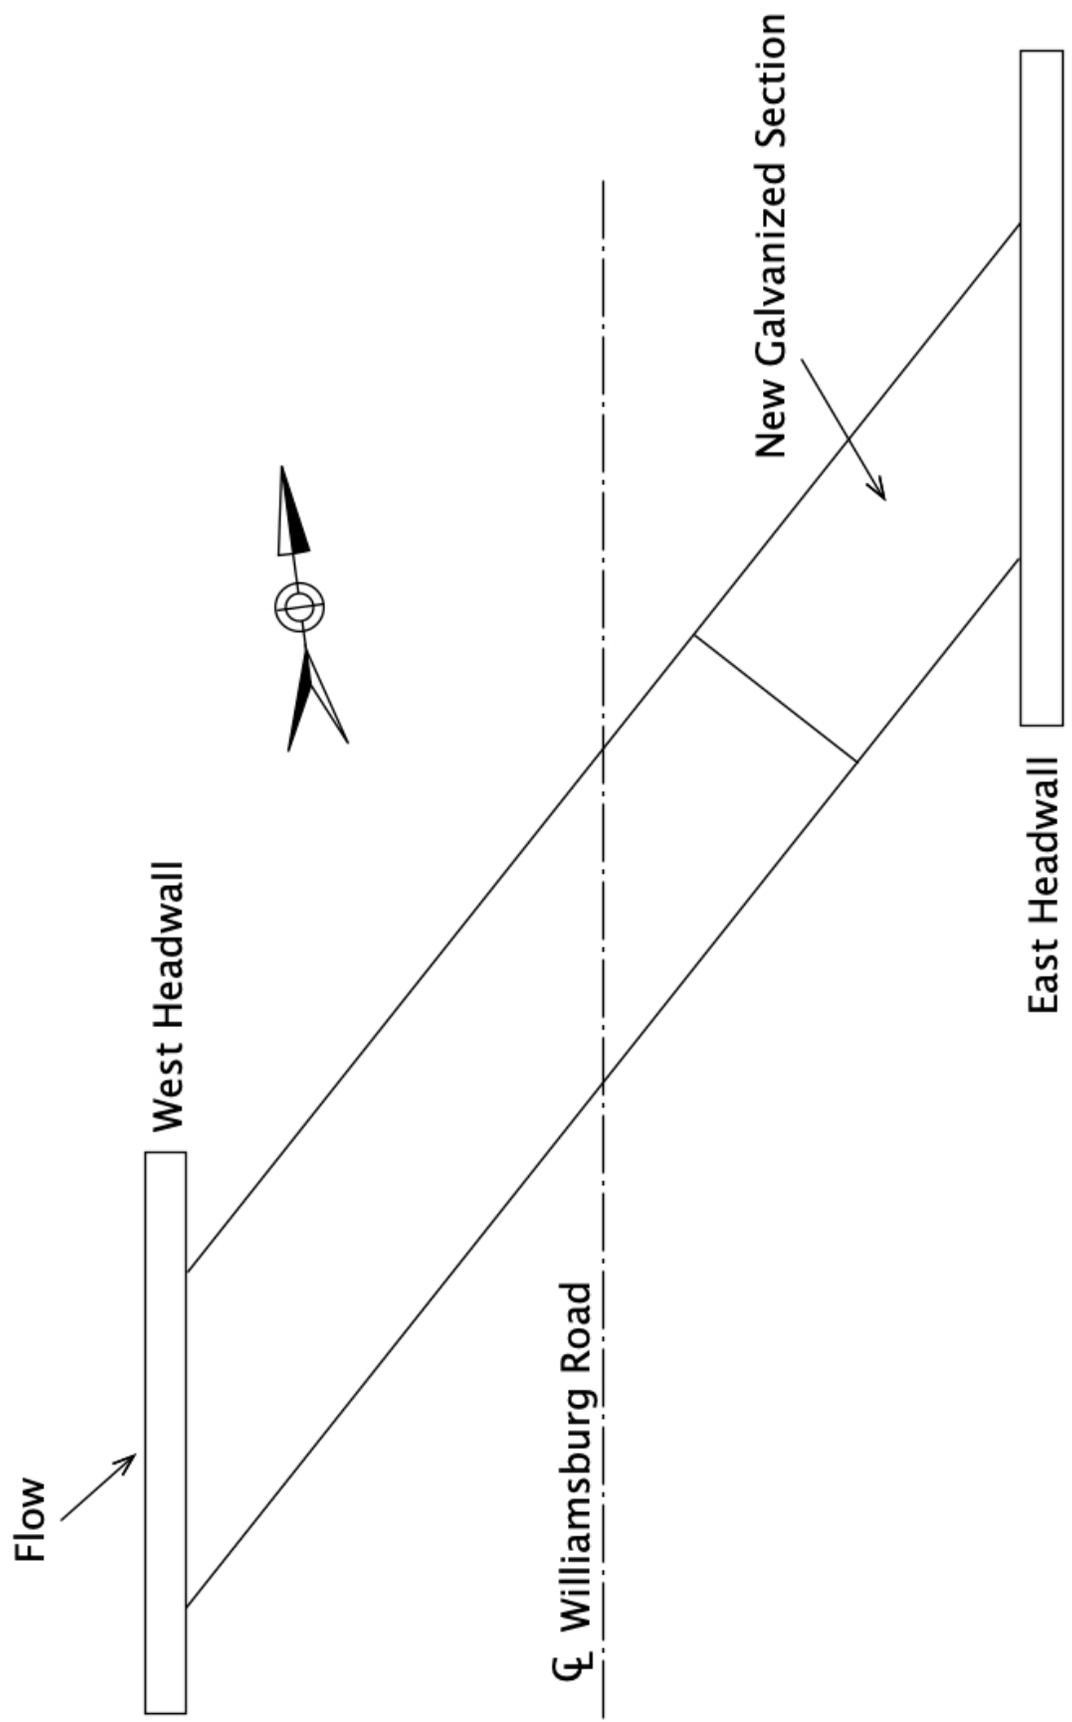
Sketch 1: Framing plan.

Williamsburg Road travels north and south. Chapel Brook flows from west to east. This single barrel culvert consists of a corrugated galvanized steel pipe, supporting fill with an asphalt wearing surface. Report notes are from west to east, upstream to downstream, in accordance with the 2015 Bridge Inspection Handbook. See sketch 1 and photos 1 & 2.

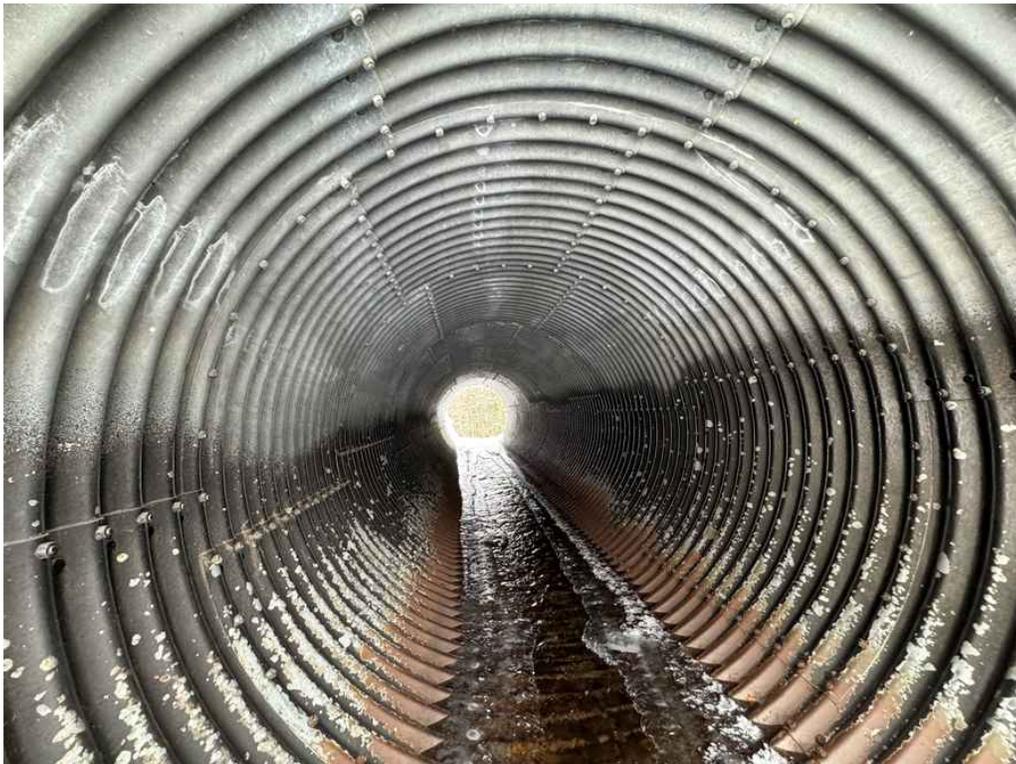
Photo 2: General underside, looking west.

The structure appears to have been widened to the east, with the east 20' of the pipe being galvanized (original / west portion is 50' long). See photo 2.

Along and below the waterline, there is rusting, full length. See photo 2.

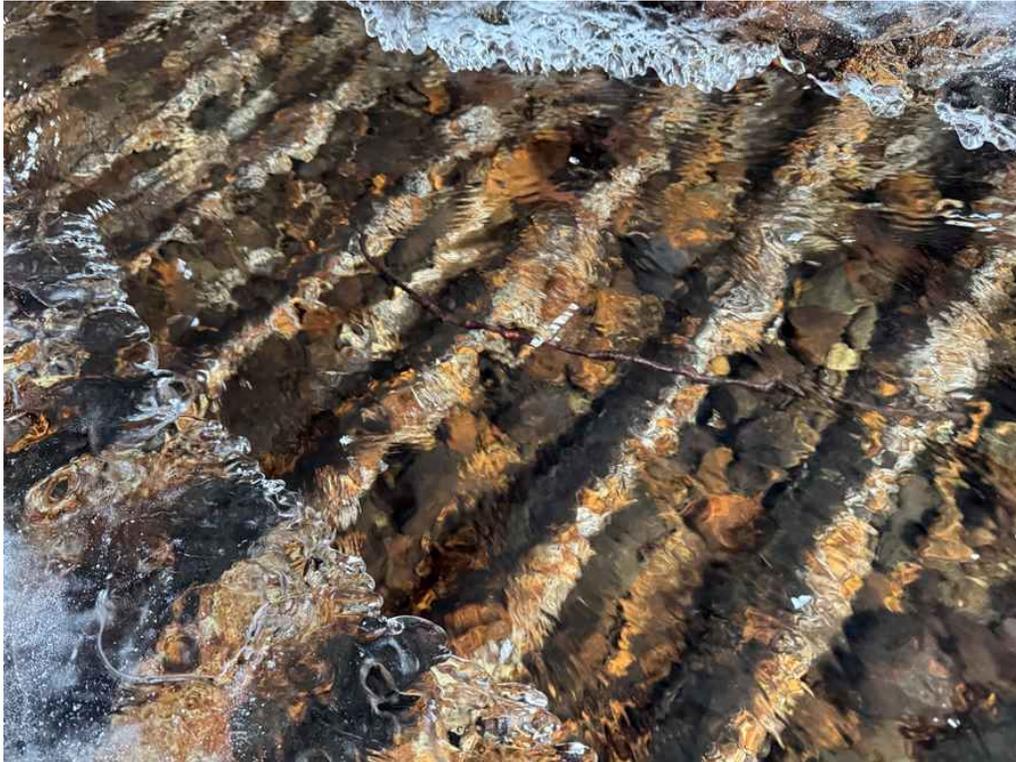
The upstream (west) portion of the pipe (original section), along the invert, has widespread severe rusting with section loss and perforations, 50' long x up to 30" wide. Gravel and voids are visible through the holes. See photo 3.

Photo 3: Holes throughout the invert of the pipe.

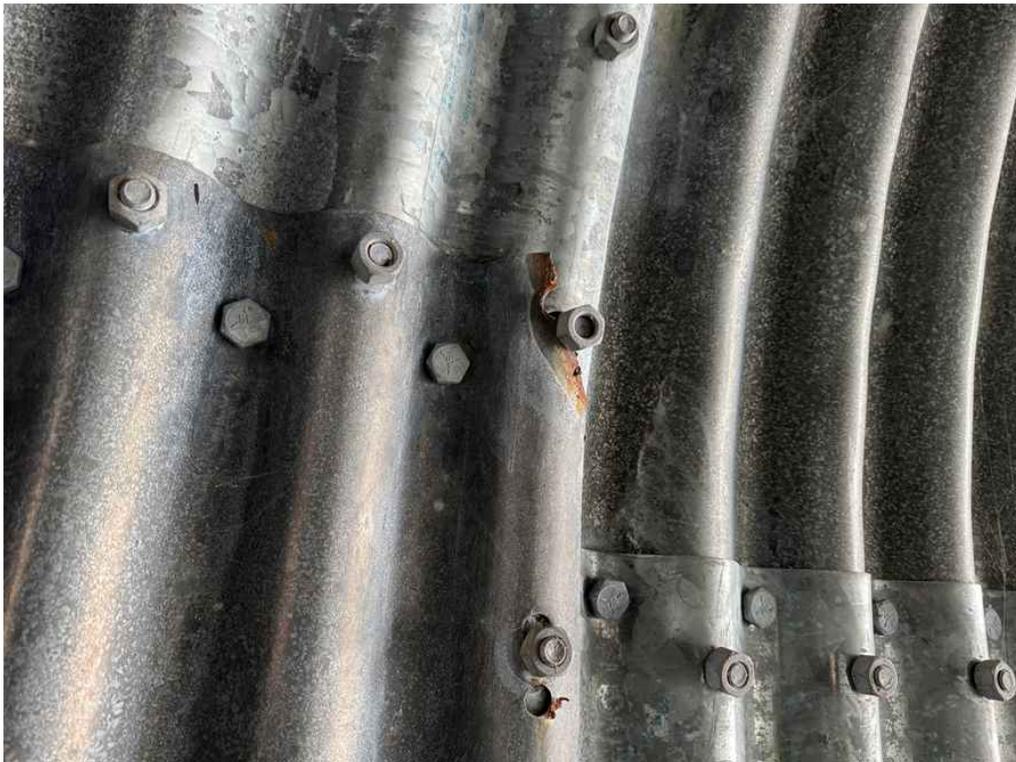
At the splice between sections, near the top, there is a bolt not tightened down and part of the pipe is cut away. This appears to be an as built defect. See photo 4.

Photo 4: Pipe section peeled away at splice.
