STRUCTURES INSPECTION FIELD REPORT

ROUTINE & SPECIAL MEMBER INSPECTION

BR. DEPT. NO.
A-13-014

Structure A-13-014 (0FN) carries Apple Valley Road over the Upper Branch of Clesson Brook in the Town of Ashfield (**Sketch 1**). The bridge is a simple single span structure comprised of six (6) steel beams, supporting a reinforced concrete deck overlaid with an asphalt wearing surface.

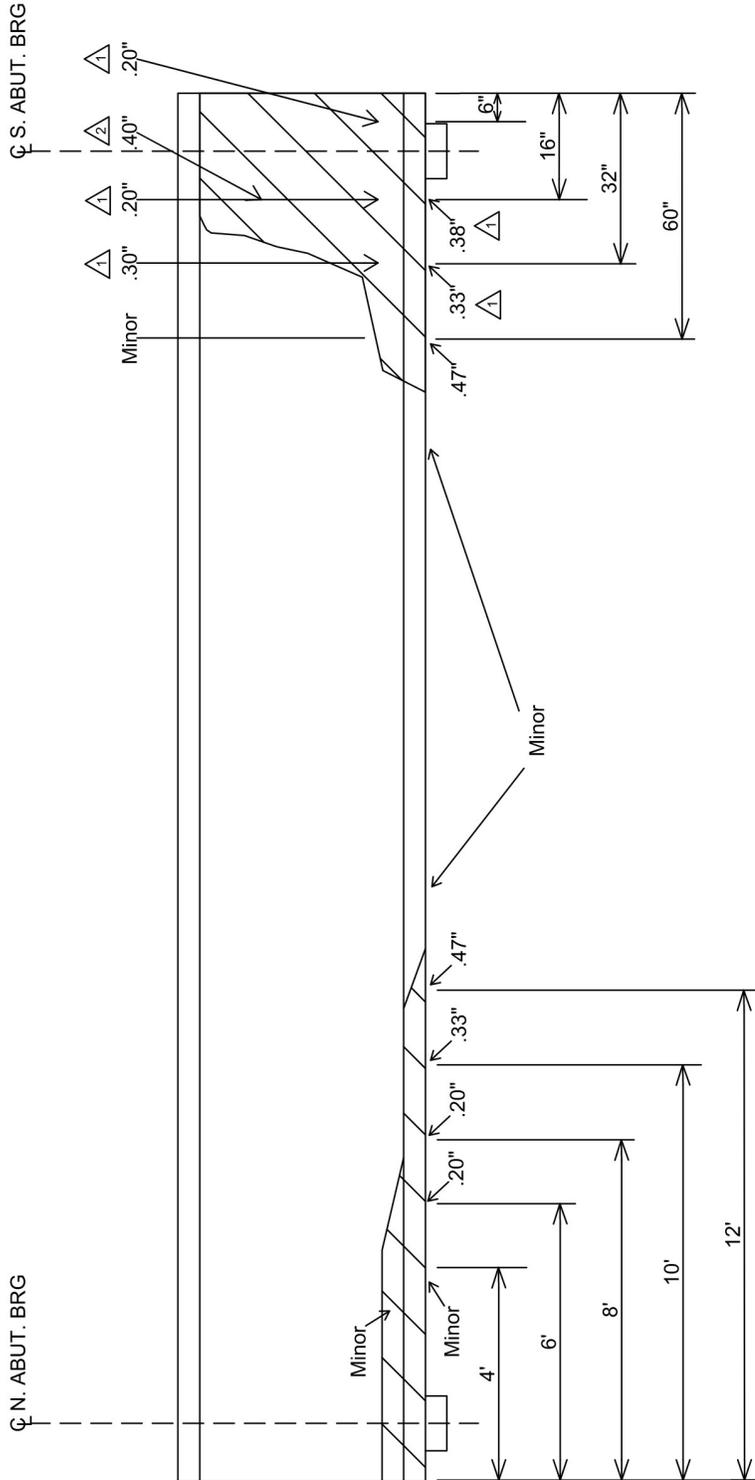
BEAM 1
WEST ELEVATION
(N.T.S.)

DEF = S-A: Beams 1 & 6 have isolated areas of up to heavy rust with up to 100% section loss over the abutments.

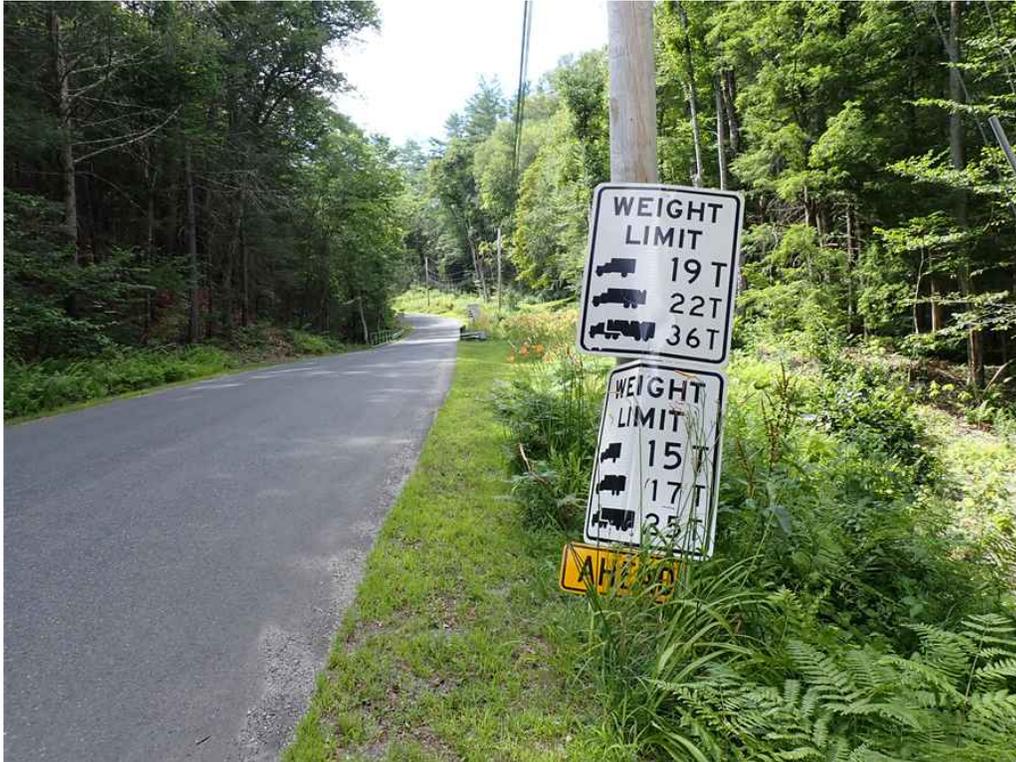
Photo 9: Advanced weight posting sign at south approach is bent, too low and tipped to the east.

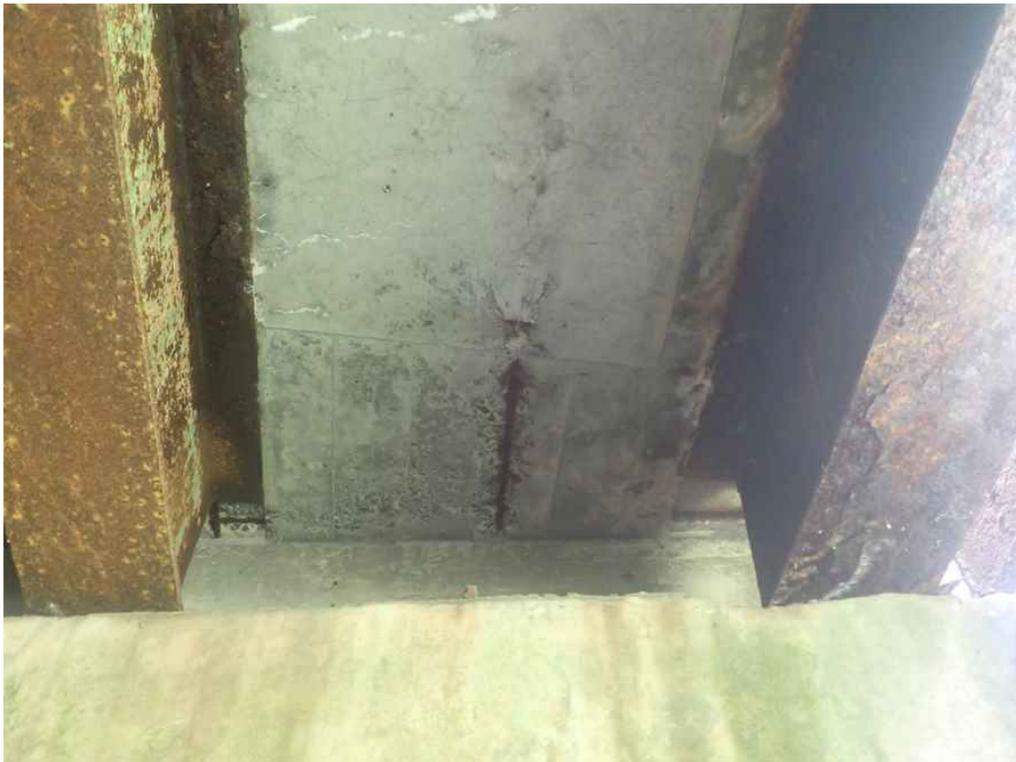
- Bay 1, between Diaphragms 1 and 2: 6" diameter x 1" deep spall.
- Bay 3, 4 and 5, at North Abutment: Up to 8" diameter x 1" deep spalls with exposed rebar.
- Bay 4, south of Diaphragm 1: 1'-0" diameter x 1" deep honeycomb.
- Bay 5, at North Abutment: 1'-6" long x 4" wide x 1" deep spall with exposed rebar (**Photo 10**).

Photo 10: Bay 5 at North Abutment, spall with exposed rebar.

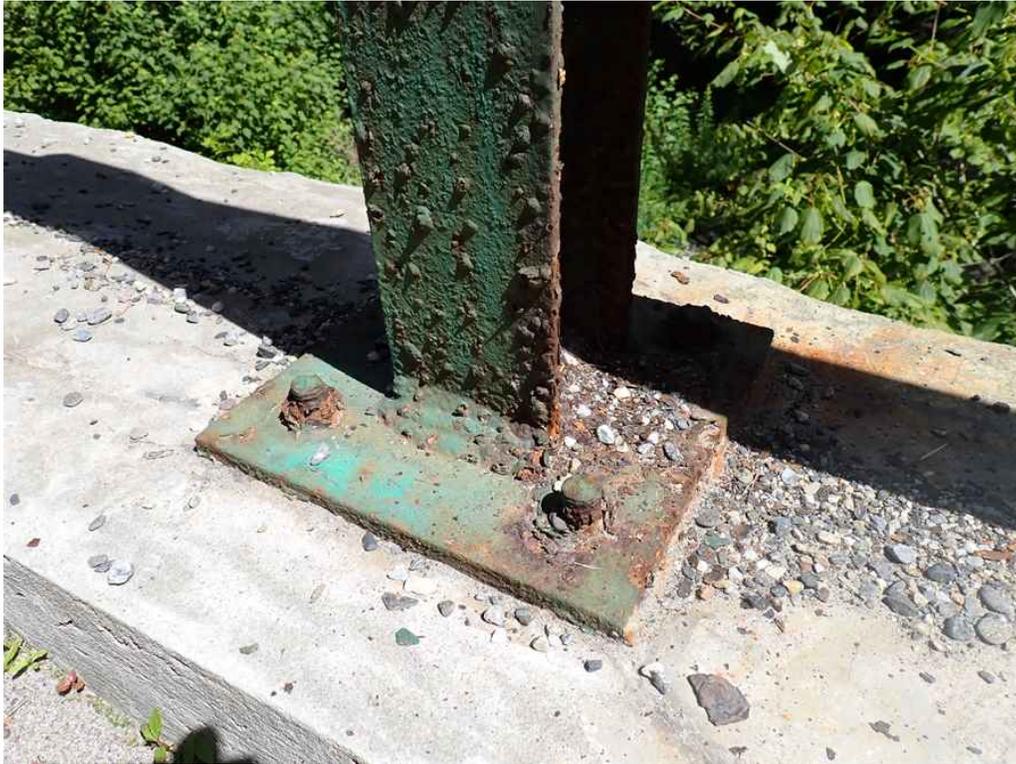
The railings have areas of peeling paint and moderate rust throughout. There are isolated undersized bolts at the baseplates. The anchor bolt nuts typically have up to 25% section loss with isolated locations up to 100% section loss (**Photo 11**). See the following for specific locations and conditions:

Photo 11: East Railing, 2nd post from south with section loss to anchor bolt nuts.

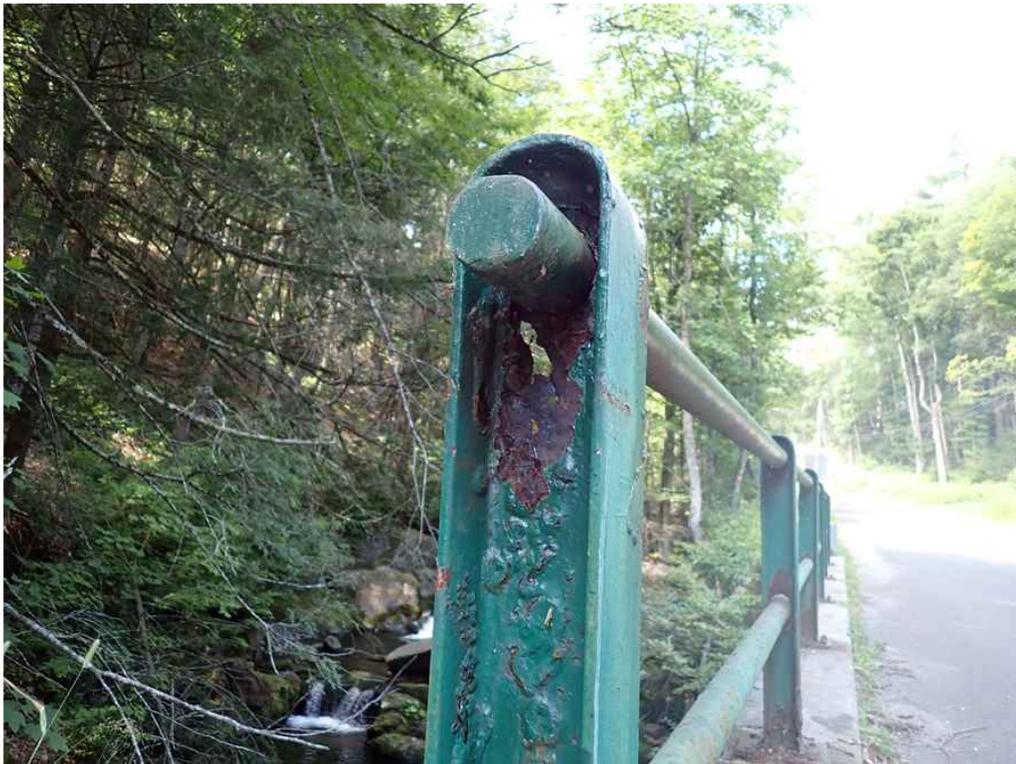
- **DEF = S-A: 1st post from south at web below top rail: Up to 2" high x 1/2" wide rust hole with adjacent knife edge remaining (Photo 12).**
- **DEF = S-A: 1st and 2nd post from south at base of flange: Up to 2" high x 1/2" wide rust hole with adjacent knife edge remaining (Photo 13).**
- 1st and 2nd post from south at base plate: Undersized bolts.
- **DEF = S-A: 2nd rail from south (bottom rail) near Post 3: Up to 3" long x 1-1/2" wide rust hole (Photo 14).**

Photo 12: West Railing, 1st post from south with rust hole in web.

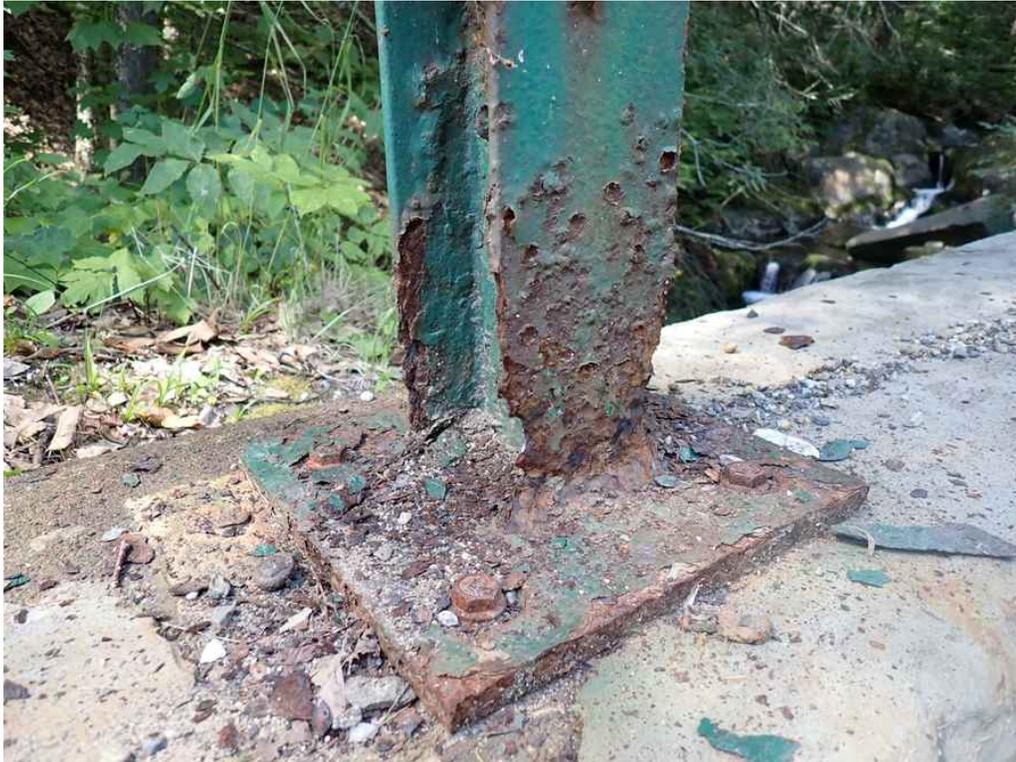
Photo 13: West railing, 1st post from south, with rust hole at base of flange.

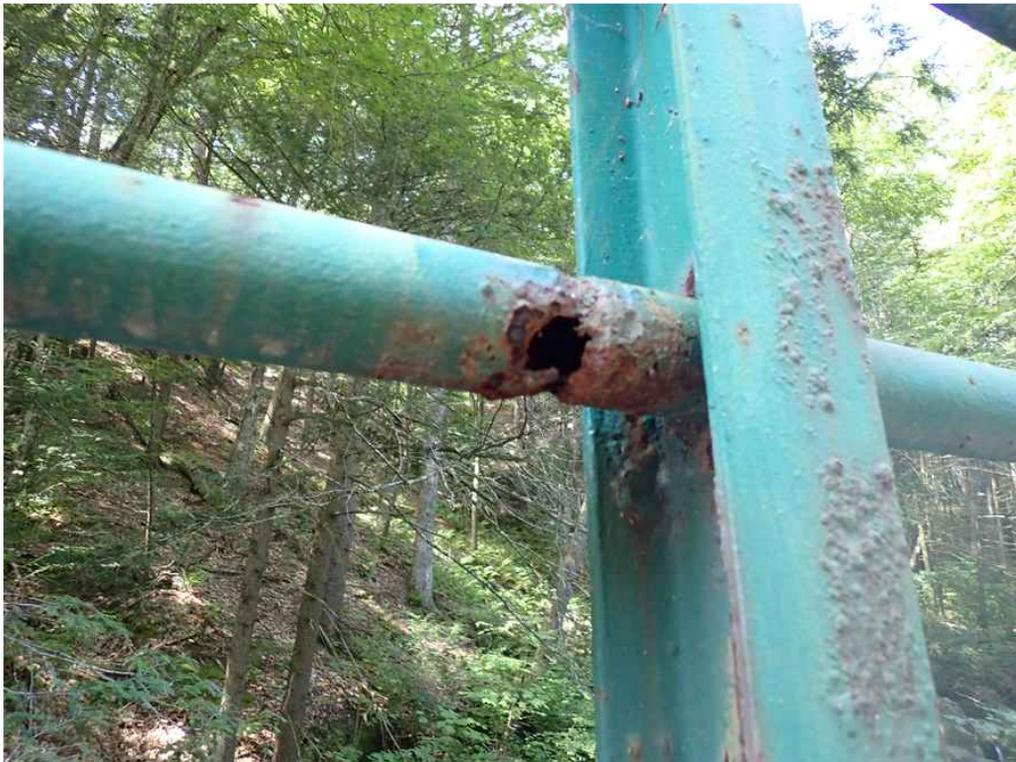
Photo 14: West Railing, 2nd rail from south near Post 3 with rust hole.

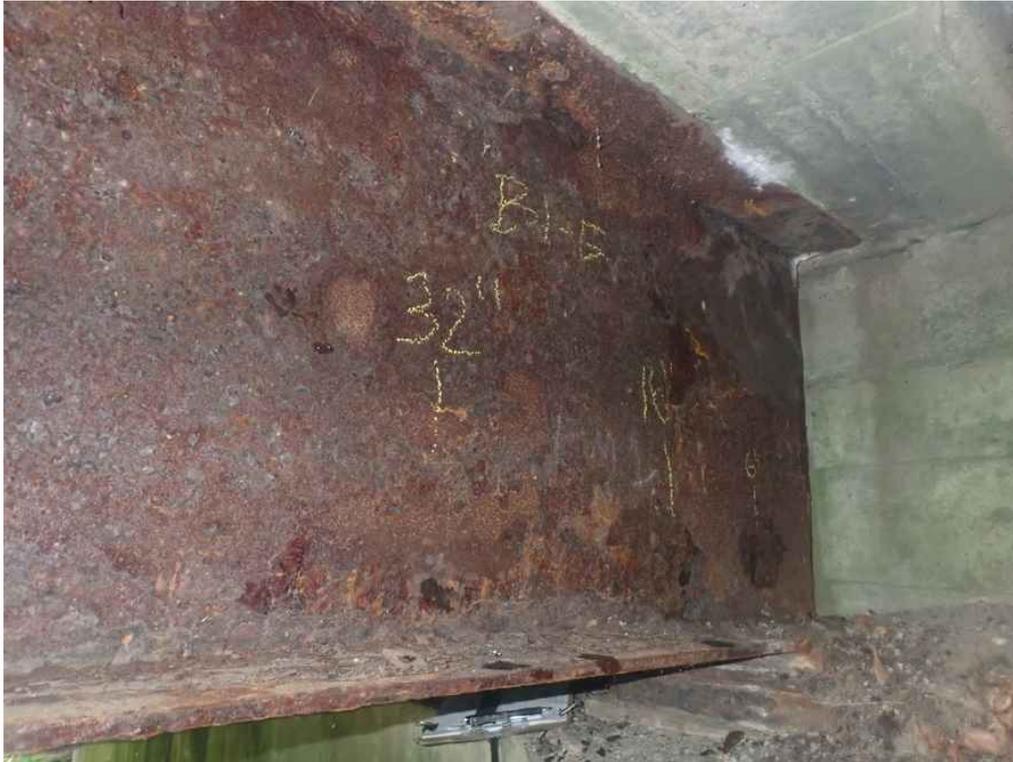
There is typically scattered freckled rust throughout the superstructure with isolated locations of failed paint (**Photos 8 and 15-18**). The remaining paint is chalked. See **Item 59.4 - Girders and Beams** for additional comments.

Photo 15: Beam 1, west face at South Abutment with section loss to web and bottom flange.

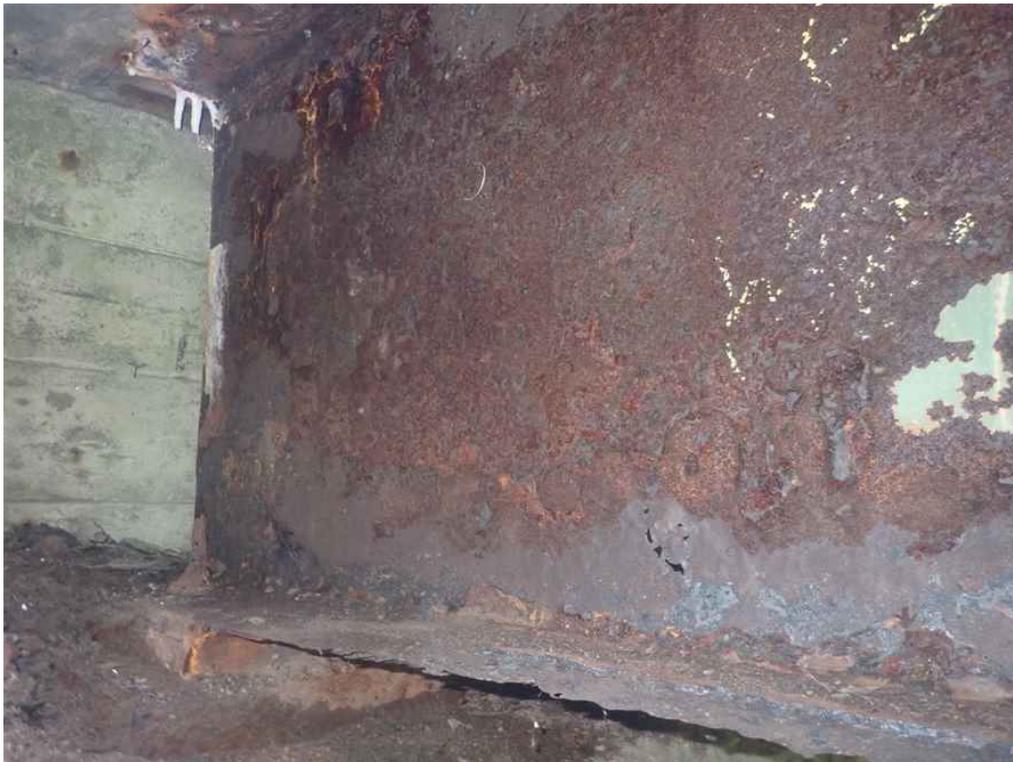
Photo 16: Beam 6, east face at South Abutment with section loss to web and bottom flange.

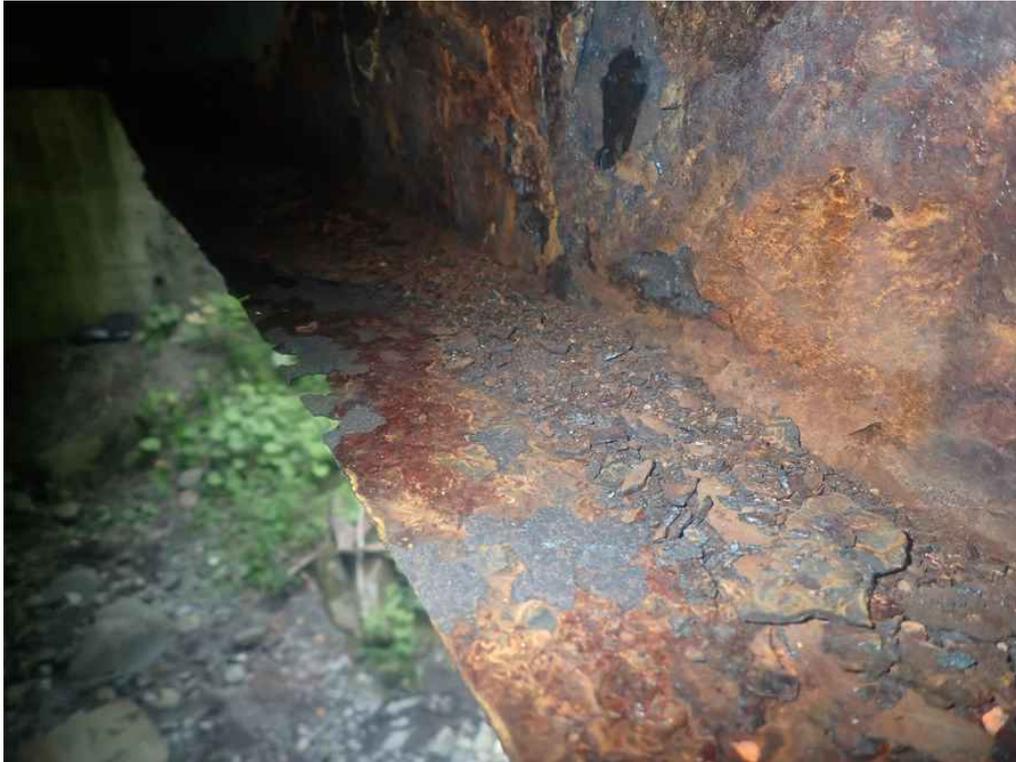
Photo 17: Beam 6, west face, 11' from South Abutment with section loss to bottom flange.

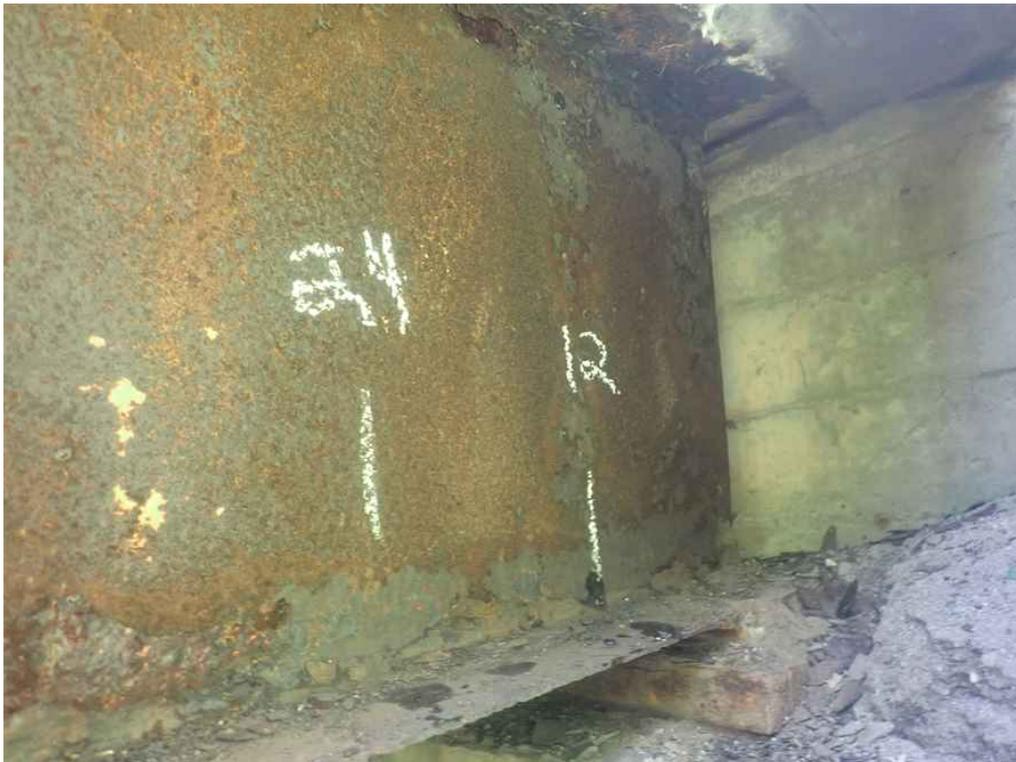
Photo 18: Beam 6, east face at North Abutment with section loss to web and bottom flange.

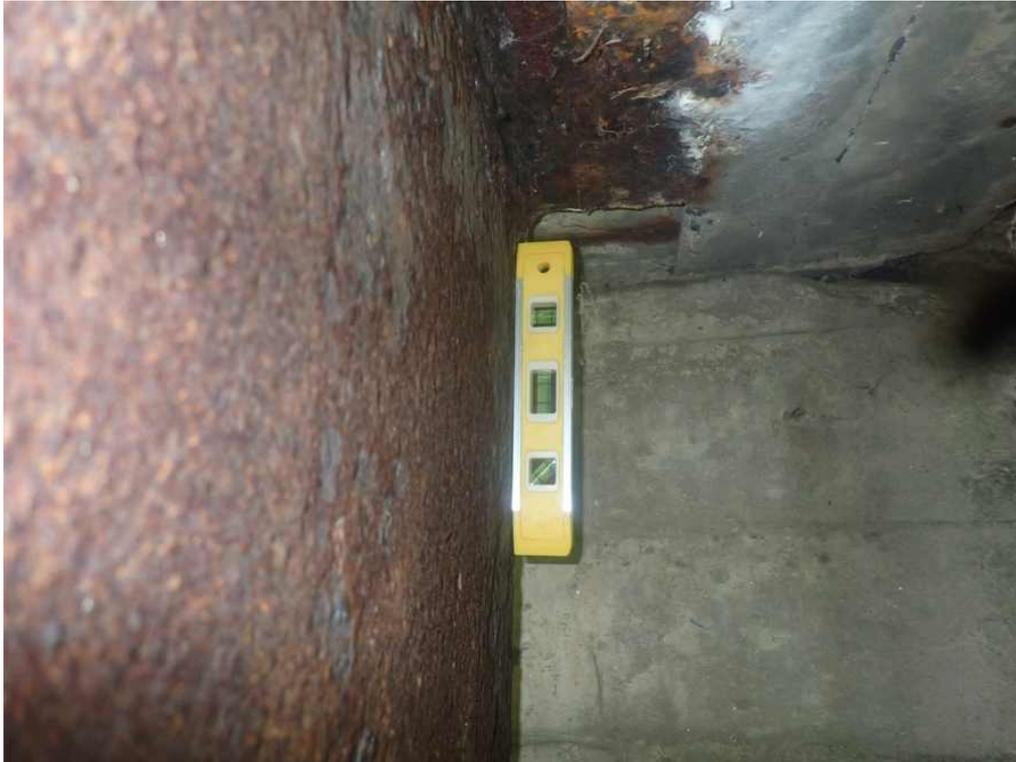
Photo 19: Beam 6, east face at North Abutment with minor out of plane bending at top of web.

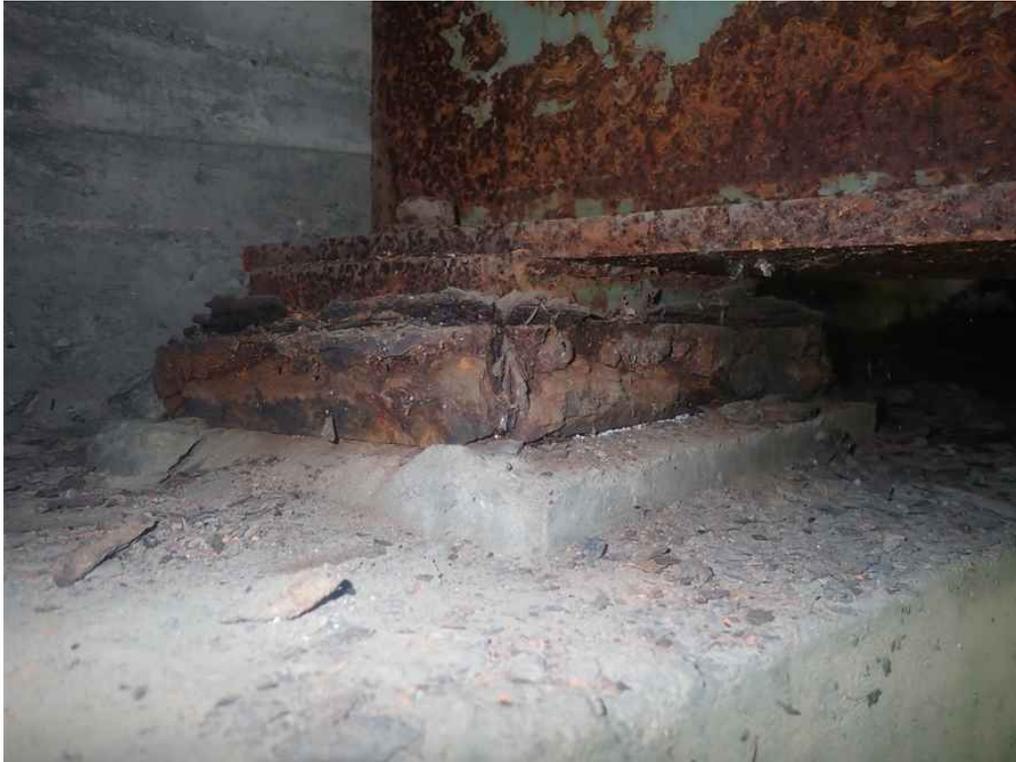
- Bearing 1: Heavy rust with up to 3/16" section loss to masonry and sole plate.
- Bearing 4, west side: Anchor bolt nut backed off 1-1/2" high.
- Bearing 5: Heavy rust with up to 3/16" section loss to masonry and sole plate (**Photo 21**).
- Bearing 6, southeast corner: 1" long x 1" wide undermining from scale (**Photo 22**). See **Item 60.1.b - Bridge Seats** for additional comments.
- Bearing 6: Heavy rust with up to 3/16" section loss to masonry and sole plate.
- Bearing 6, west and east side: Anchor bolt nut with section loss up to 90%.

Photo 21: Bearing 5 at North Abutment with heavy rust and section loss to masonry and sole plate.

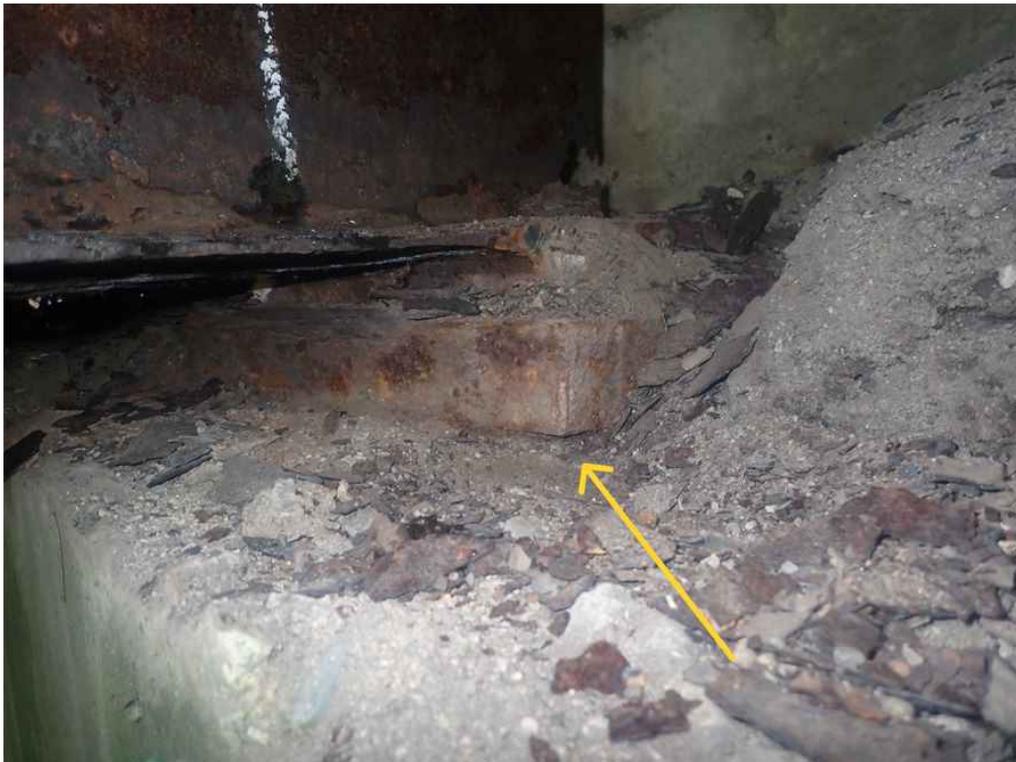
Photo 22: Bearing 6 at North Abutment, southeast corner undermined due to scale.

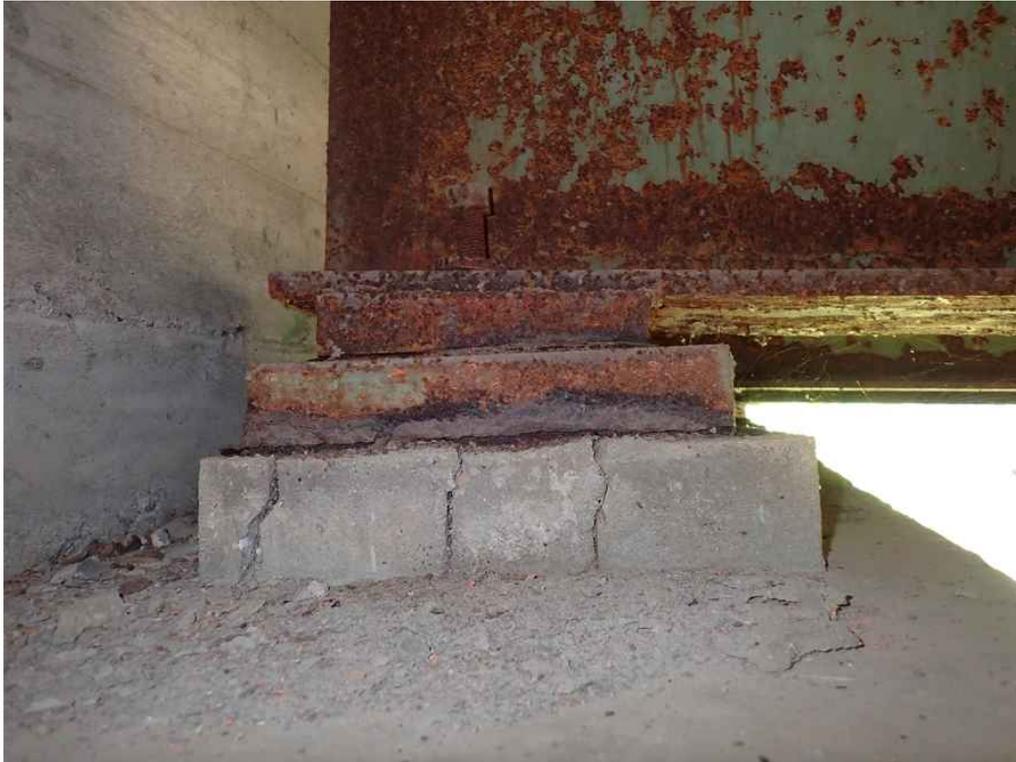
There are full height x up to 3/16" wide cracks in the Beam 4 pedestal at the North Abutment (**Photo 23**).

Photo 23: Beam 4 pedestal at North Abutment with wide cracks.

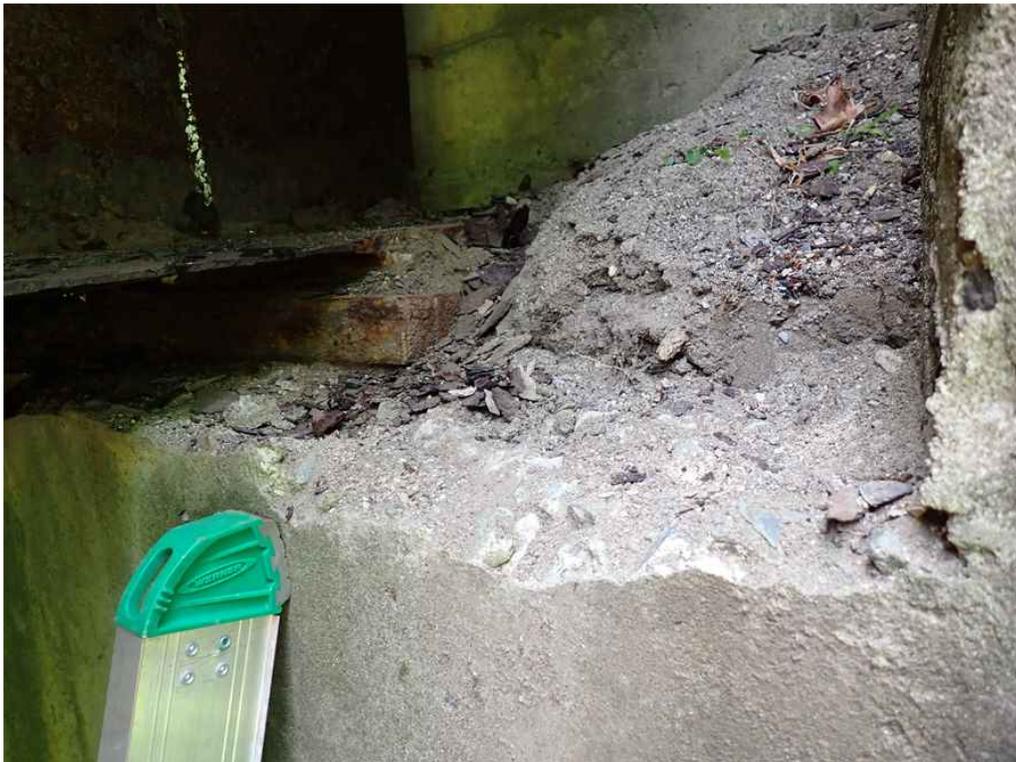
The bridge seats have heavy debris buildup at all four corners (**Photo 24**). There are scattered areas of scale. See the following for specific locations and conditions:

Photo 24: North Abutment bridge seat below Beam 6 with heavy debris buildup and scale.

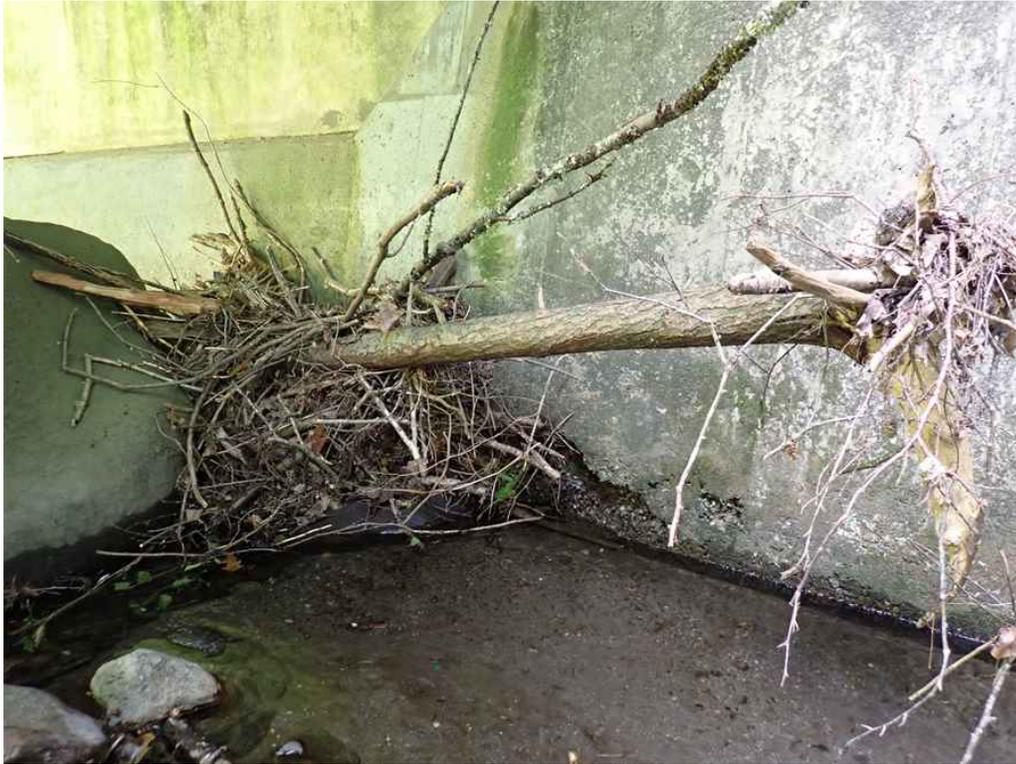
- Curtain wall below Bay 1: Full height vertical hairline crack with efflorescence.
- Curtain wall below Beam 1, at bottom: 4'-0" wide x 1'-6" high x 5" deep scale partially hidden by debris build up (**Photo 25**).
- Curtain wall below Beam 6, at bottom: 4'-6" long (north face) x 1'-4" wide (east face) x up to 5" high x up to 3" deep abrasion/undermining (**Photo 26**).

Photo 25: Curtain wall, below Beam 1, at bottom with scale partially hidden by debris.

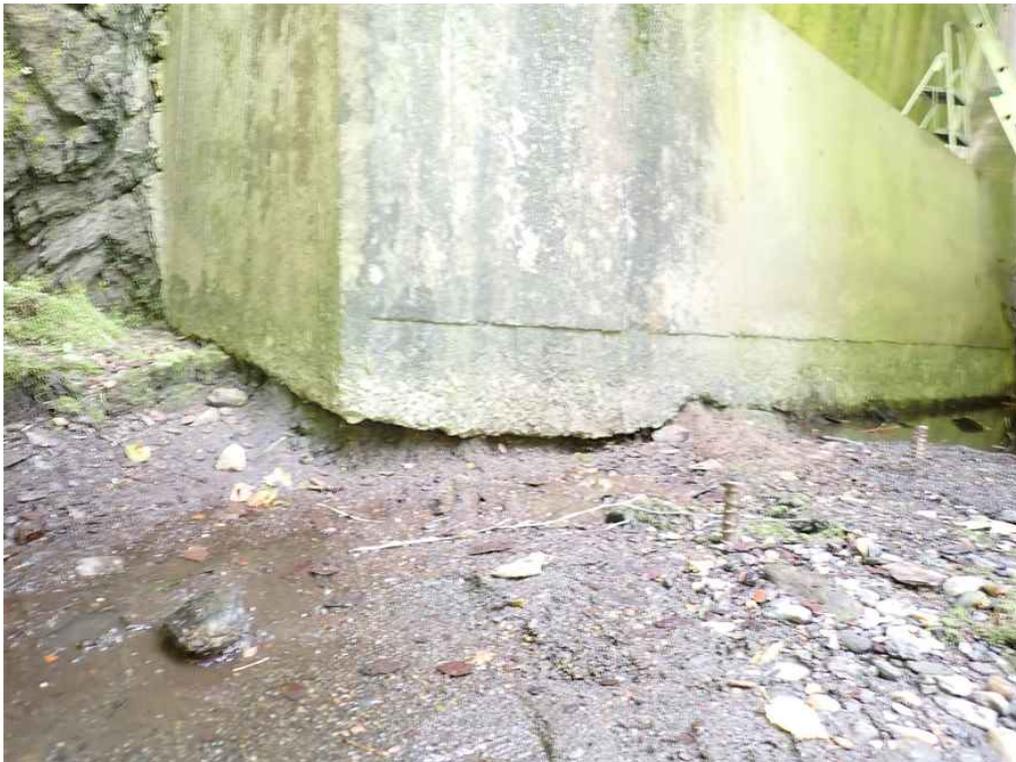
Photo 26: Curtain wall, below Beam 6, at bottom with abrasion/undermining.

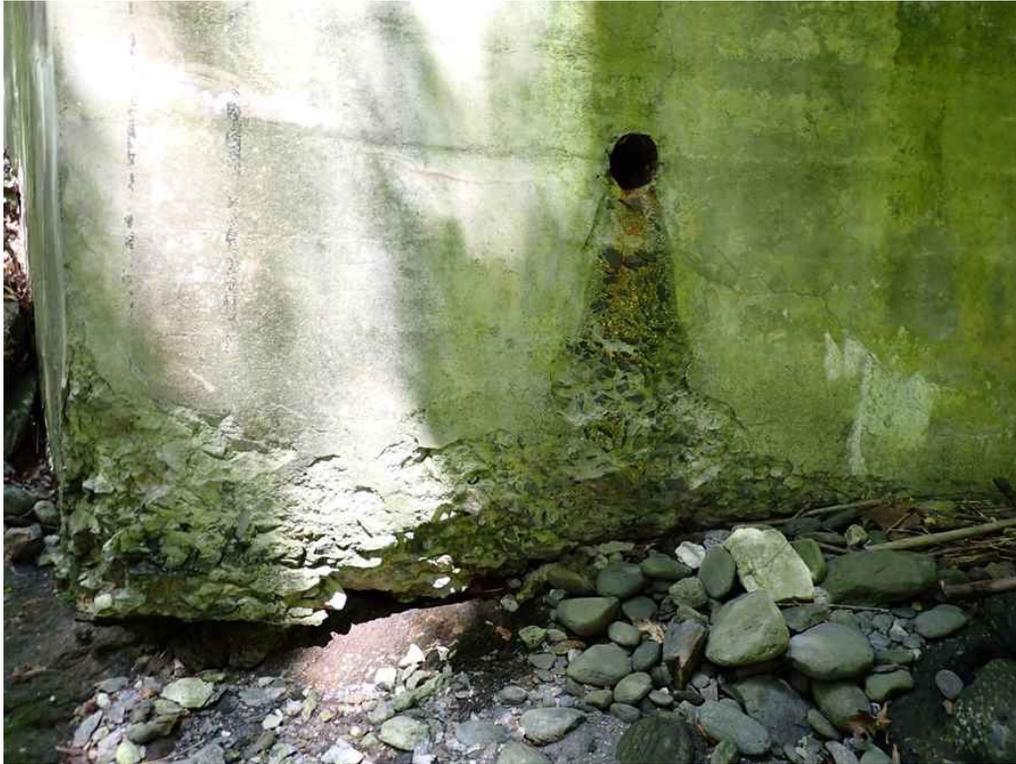
Photo 27: North Breastwall, Bay 1, below west weep hole with abrasion/undermining.

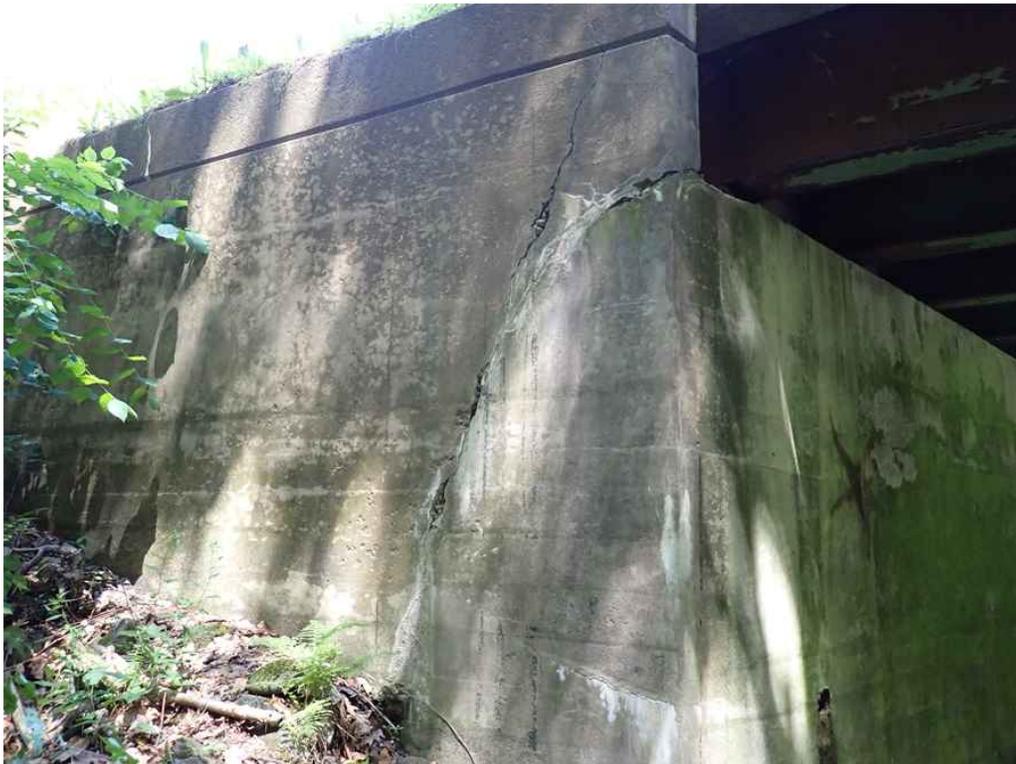
- At the cheekwall: Two (2) diagonal cracks, with efflorescence, up to 1/8" wide x full height with spalled areas up to 2" wide x 8" high x 1" deep (**Photo 28**).

Photo 28: Northwest Wingwall with diagonal cracks, efflorescence and spalls.

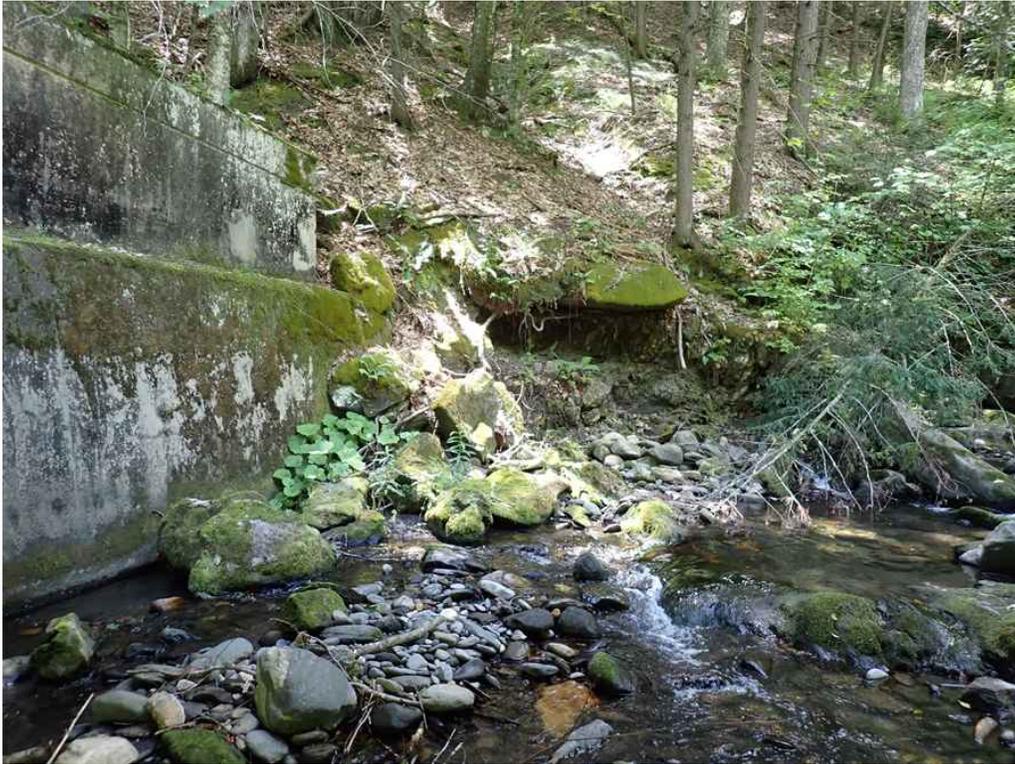
Photo 29: Southwest Embankment with erosion and missing rip-rap.

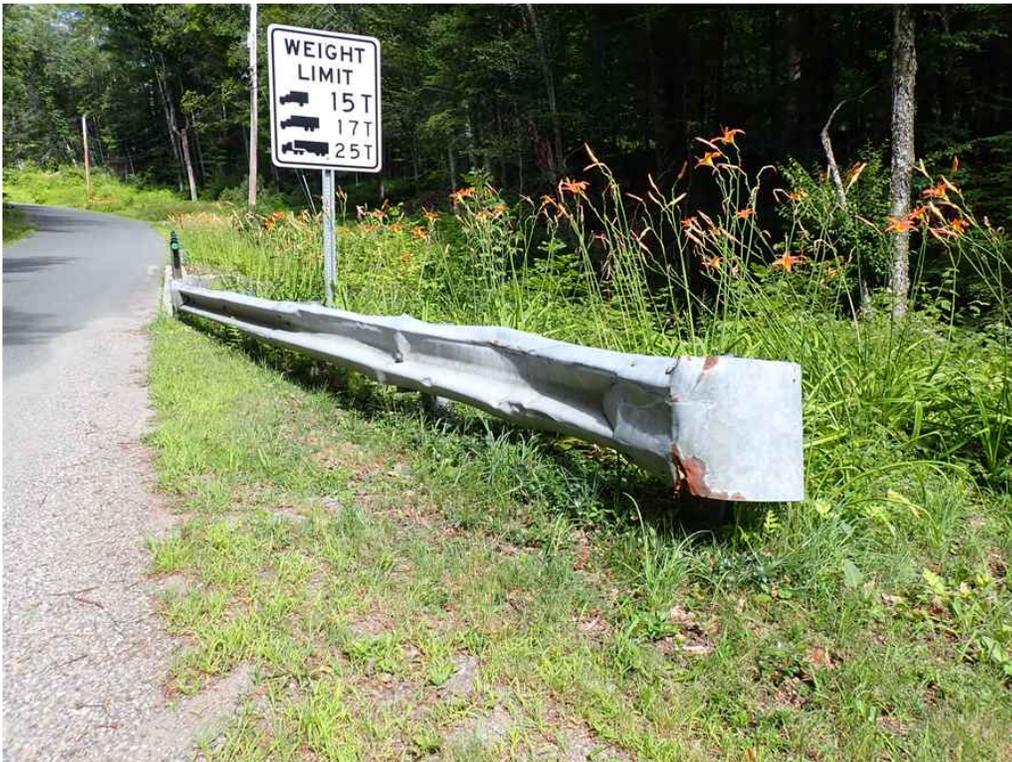
All guardrail ends have moderate to heavy collision damage (**Photo 30**).

Photo 30: Southeast Approach Guardrail with collision damage.
