STRUCTURES INSPECTION FIELD REPORT

ROUTINE & SPECIAL MEMBER INSPECTION

BR. DEPT. NO.
A-13-020

CITY/TOWN ASHFIELD	8-STRUCTURE NO. A13020-0FM-MUN-NBI	11-Kilo. POINT 000.000	41-STATUS P:POSTED	90-ROUTINE INSP. DATE JUL 7, 2025
07-FACILITY CARRIED HWY APPLE VALLEY	MEMORIAL NAME/LOCAL NAME SCHOOLHOUSE NO. 13	27-YR BUILT 1939	106-YR REBUILT 0000	YR REHAB'D (NON 106) 0000
06-FEATURES INTERSECTED WATER U BR CLESSON BK	26-FUNCTIONAL CLASS Rural Local	DIST. BRIDGE INSPECTION ENGINEER M. P.E. McCabe <i>Michael P.E. McCabe</i>		
43-STRUCTURE TYPE 302 : Steel Stringer/Girder	22-OWNER Town Agency	21-MAINTAINER Town Agency	TEAM LEADER R. Mancari <i>Reed Mancari</i>	
107-DECK TYPE 1 : Concrete Cast-in-Place	WEATHER Cloudy	TEMP. (air) 27°C	TEAM MEMBERS M. G. GINIS

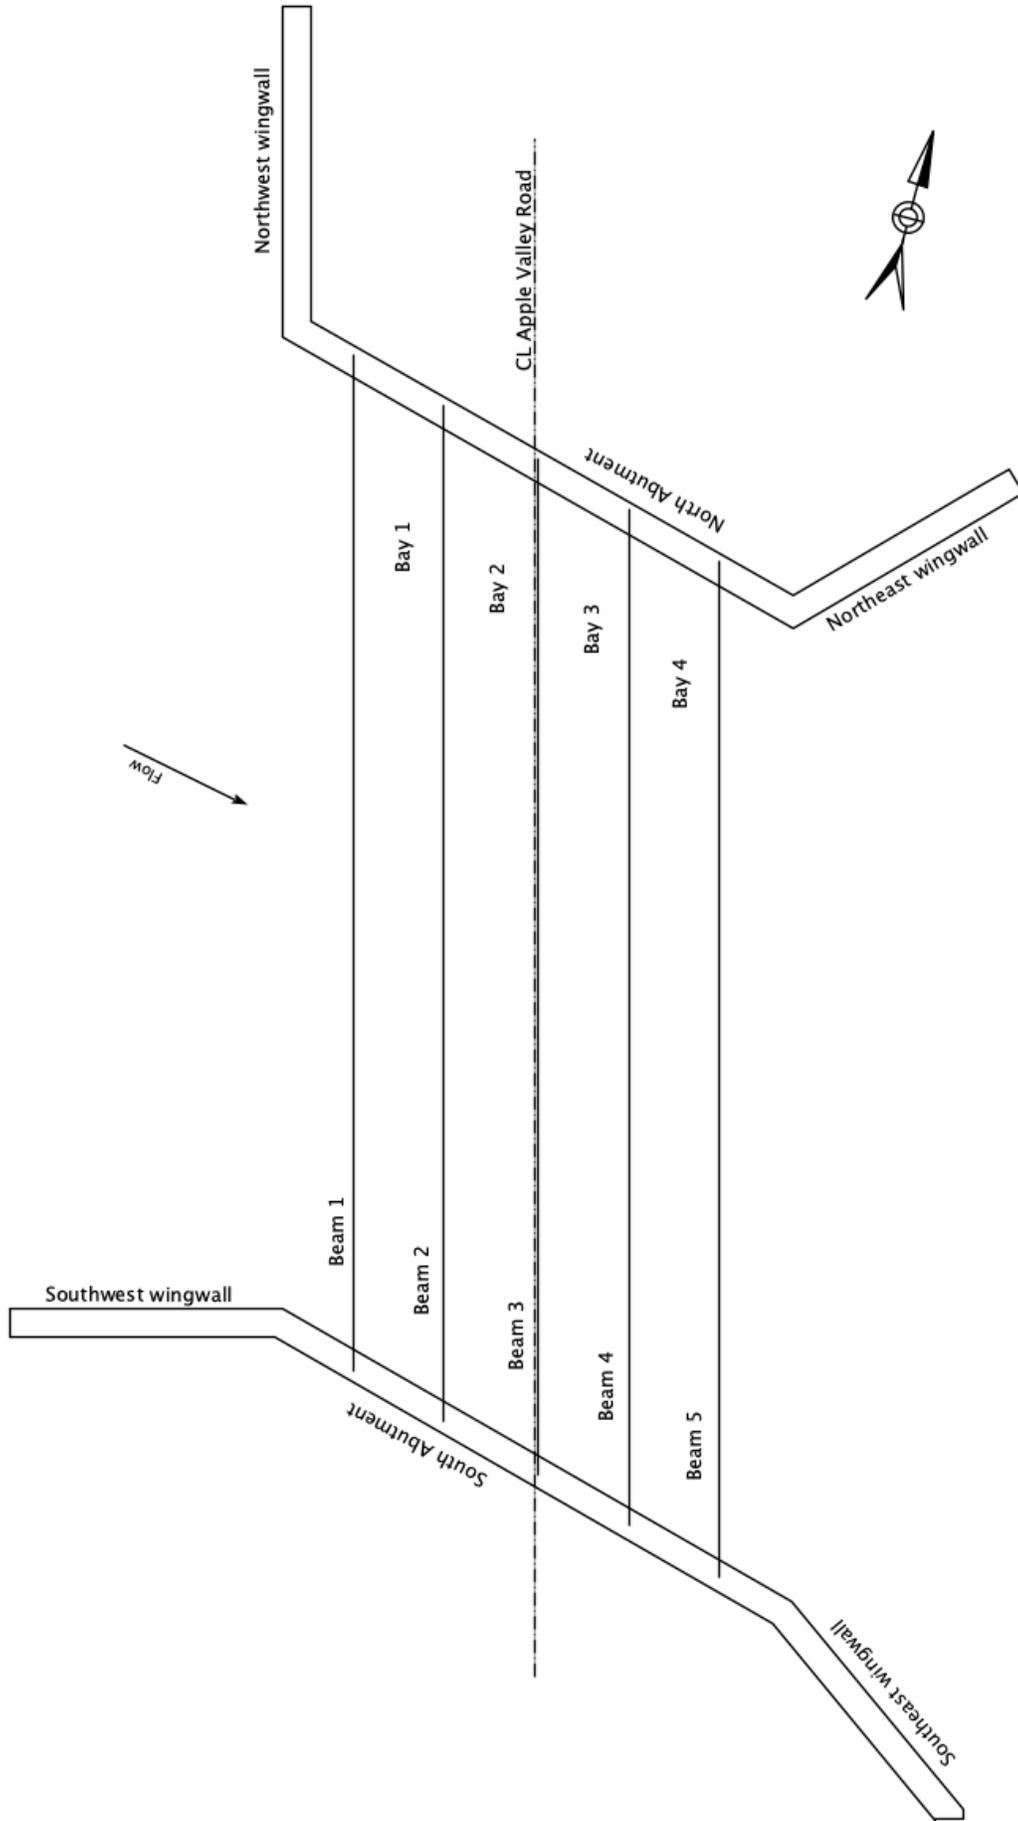
Sketch 1: Framing Plan.

Apple Valley Road travels north and south. Upper Branch of the Clesson Brook flows from west to east. This single span structure consists of five steel beams, supporting a reinforced concrete deck, with an asphalt wearing surface. The beams and bays are numbered from west to east, upstream to downstream, in accordance with the 2018 Repair Plans and the 2020 Rating Report. **See sketch 1 and photos 1 & 2.**

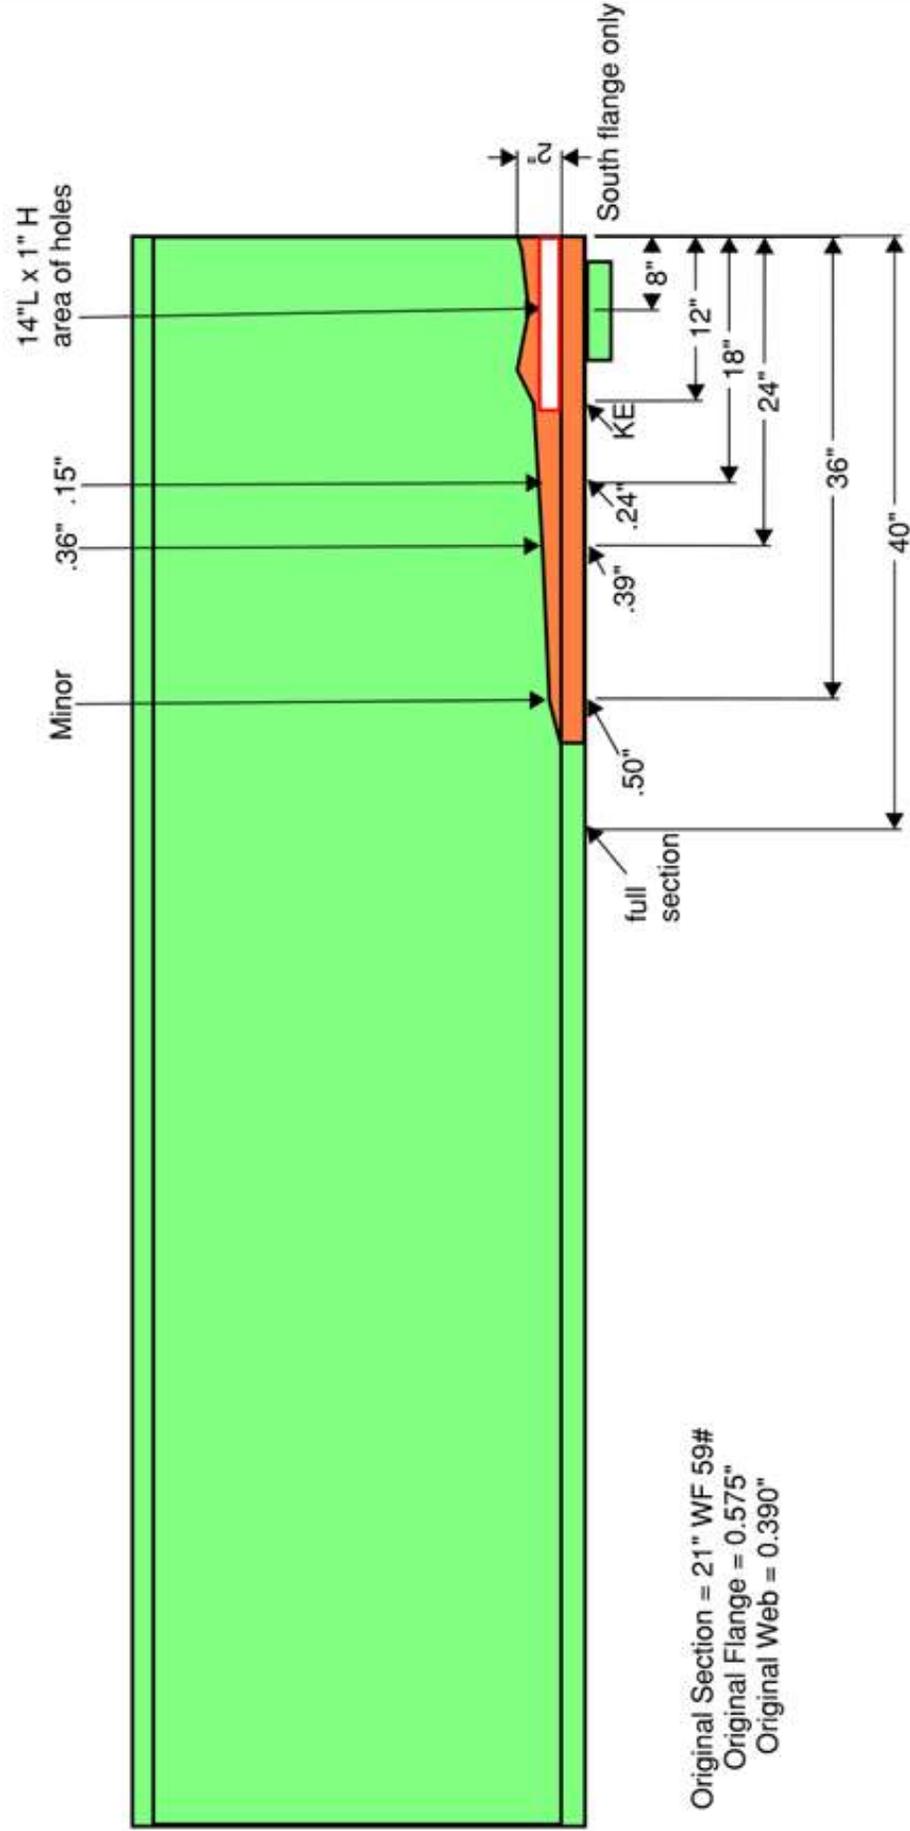
REASON: Severe section loss at beam 1, south end since last rating.

Beam 1, at the south end, there is section loss. **See sketch 2 and photo 4.**

Original Section = 21" WF 59#
Original Flange = 0.575"
Original Web = 0.390"

Sketch 2: Beam 1 south end section loss.

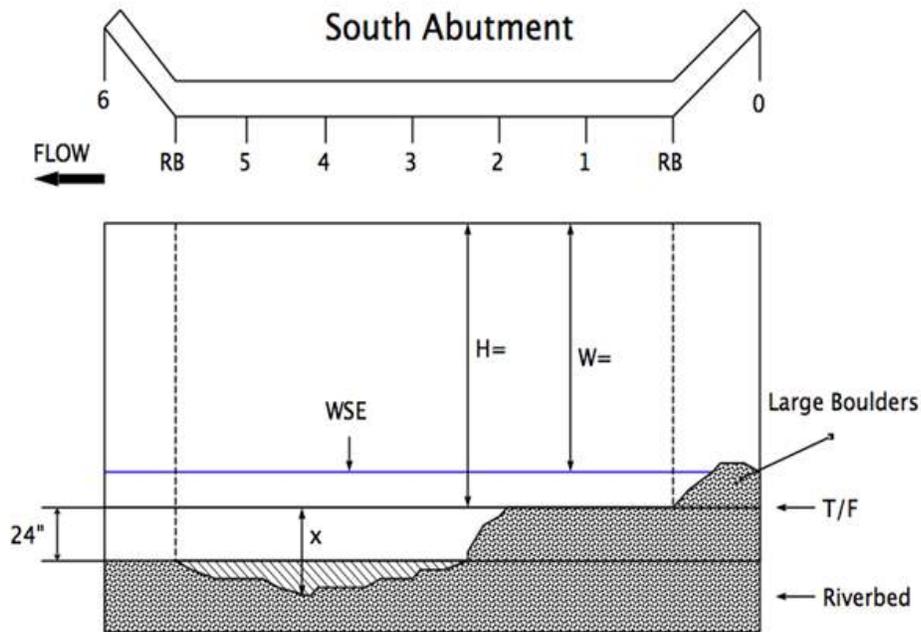
The south footing is exposed, full length with isolated areas of undermining. Most of the previously noted undermining has been filled in since the previous Routine Inspection Report, dated 7/18/2023. **See charts 1 - 3 and photo 5 & 6.**

The southeast wingwall footing is exposed, full length. The previously noted undermining has been filled in since the previous Routine Inspection Report, dated 7/18/2023. **See charts 1 - 3 and photo 7.**

The south 1/3 of the channel has scoured out along the south abutment, up to 6' deep, in accordance with the plan. **See charts 1 - 3 and photos 6 & 7.**

Chart 2: South footing exposure.

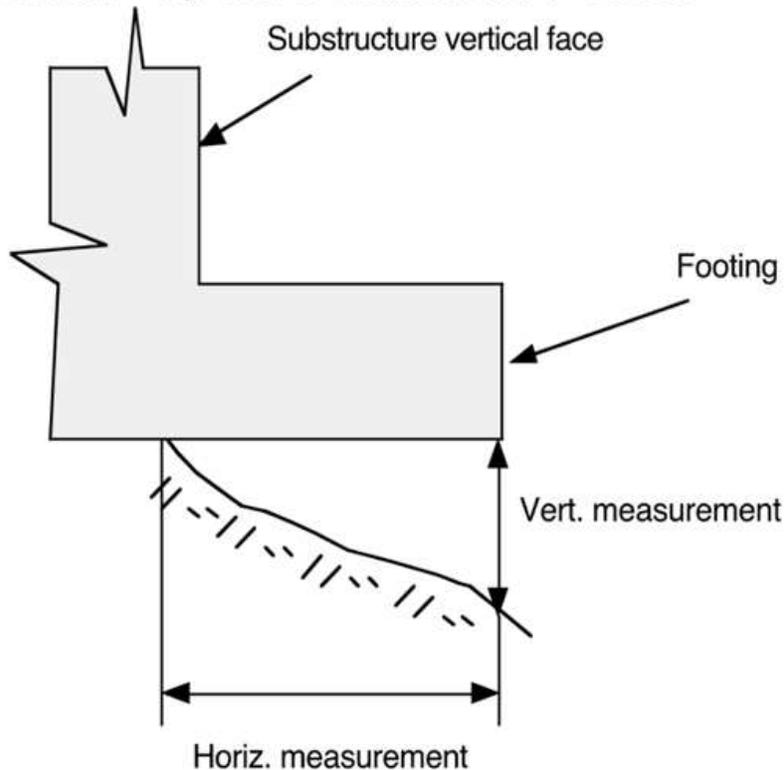
Refer to Item 60.1.j - Scour and chart 3.

Chart 3: Undermining of the south abutment.

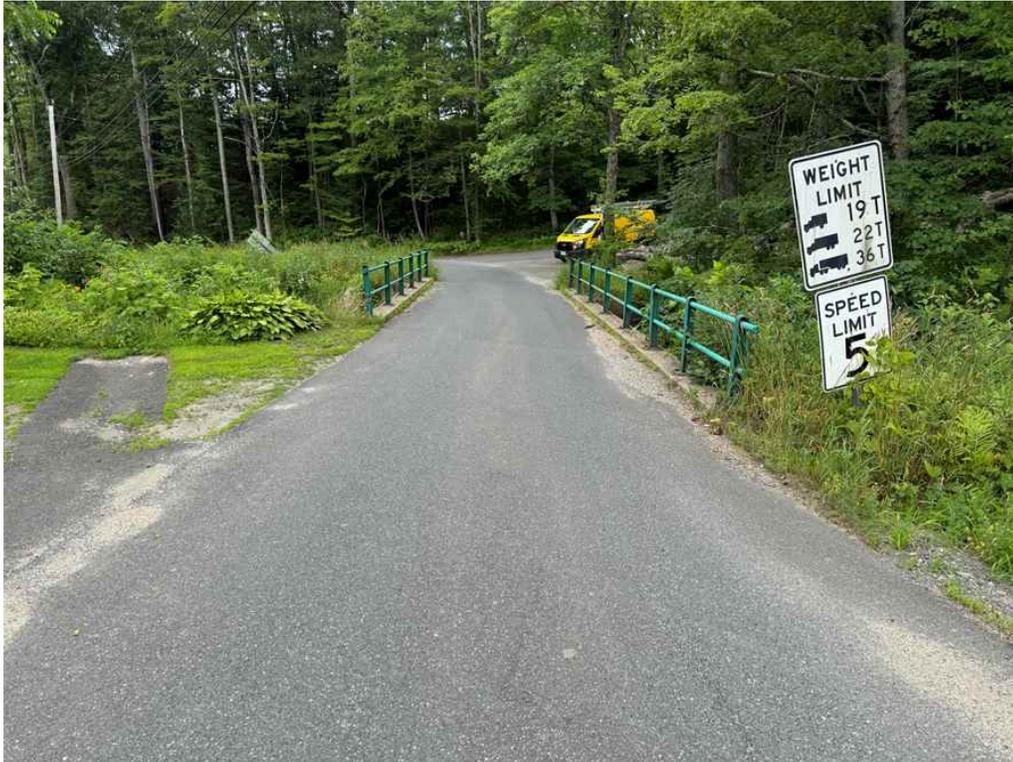
The north at bridge posting is partially covered by vegetation and tipped towards the roadway. **See photo 1.**

There are no transitions in place. **See photo 1.**

There is no approach guardrail in place. **See photo 1.**

There are no approach guardrail ends in place. **See photo 1.**

Photo 1: General topside, looking south.

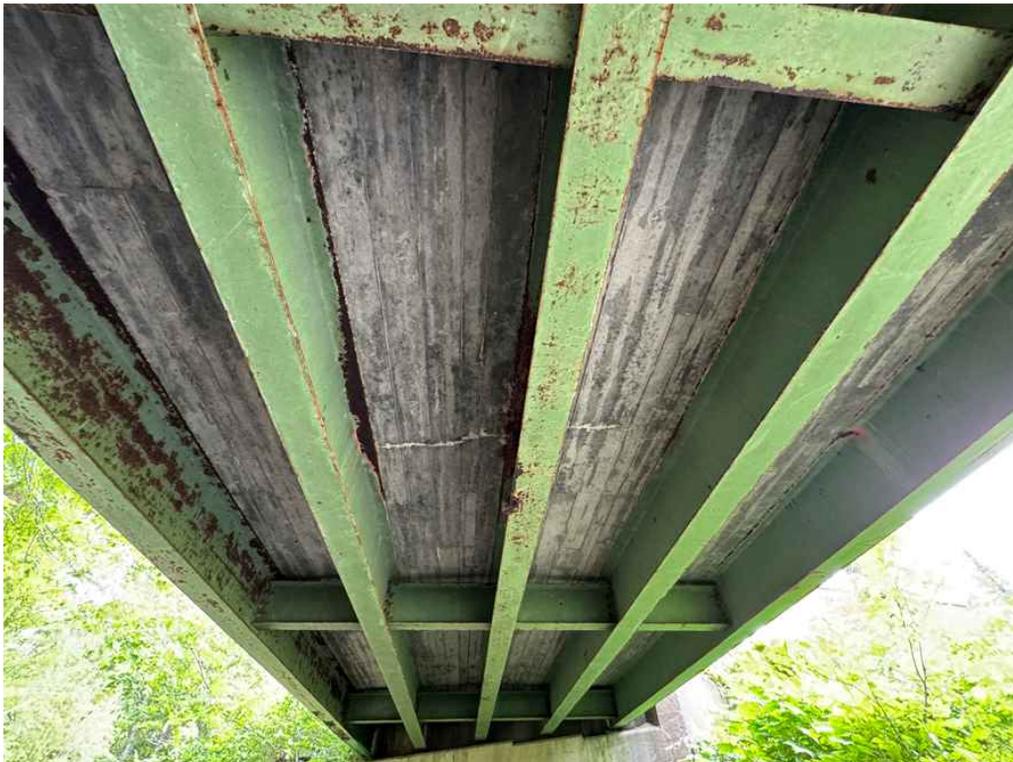
In bays 2 & 3, at 10' from the south end, there are several transverse hairline cracks with efflorescence. **See photo 2.**

The entire superstructure is chalked, with areas of peeling paint and rusting. **See photo 2.**

Photo 2: General underside, looking south.

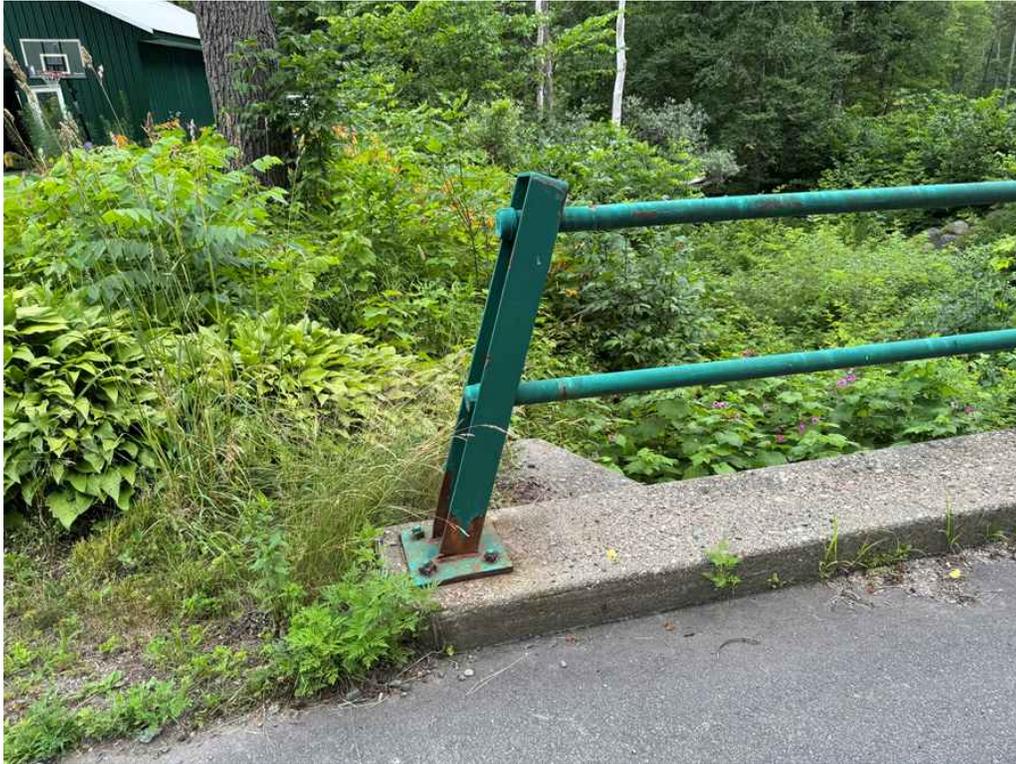
At the east railing the north post is bent to south. **See photo 3.**

Photo 3: Bent northeast post.

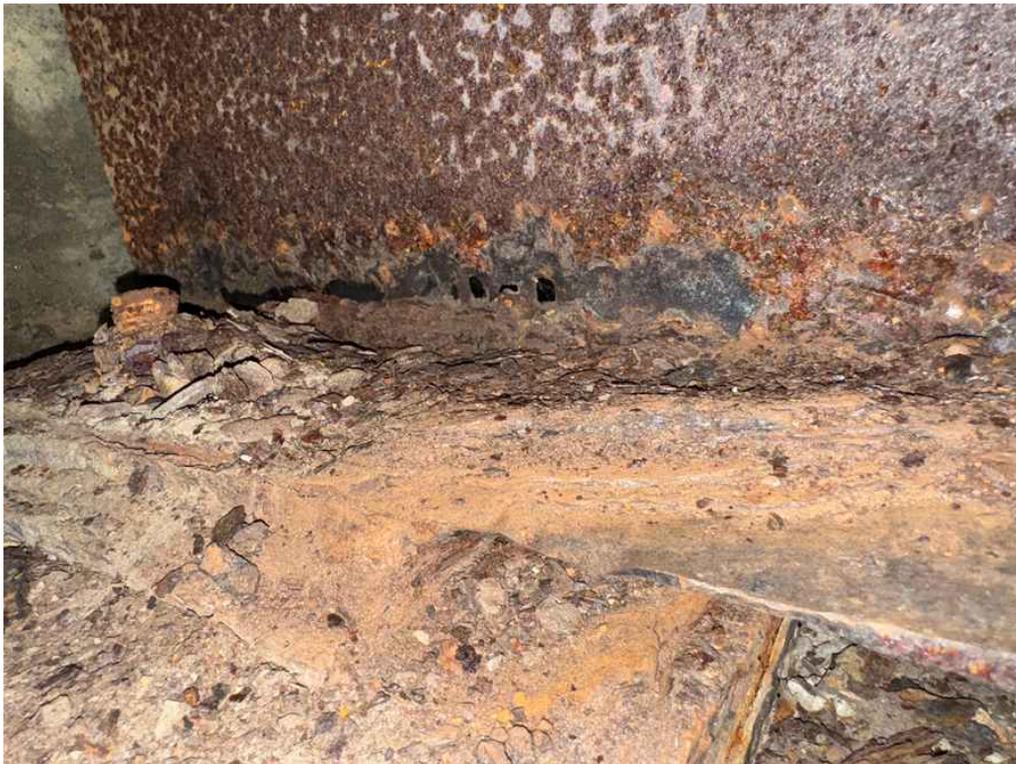
Bearing 1, at the south abutment, is heavily rusted with delamination and pack rust. **See photo 4.**

At the beam ends, there is widespread failure. Beam 1 is the worst. **See photo 4.**

Photo 4: Beam 1 south end section loss.

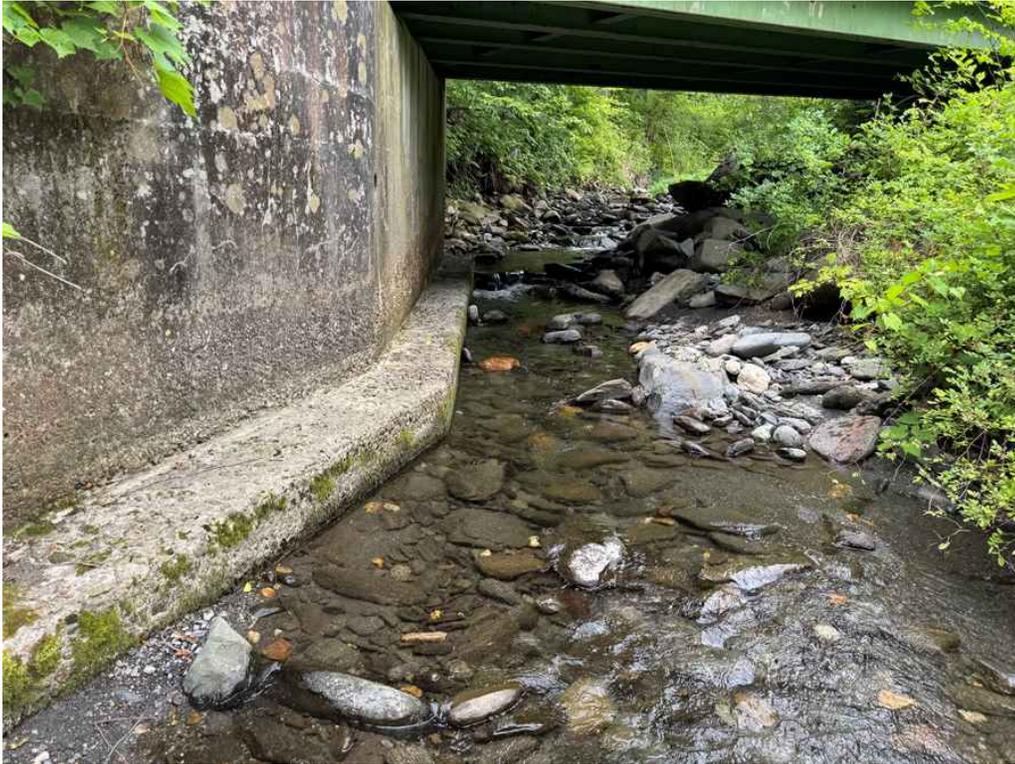
The south breastwall and southeast wingwall footings are exposed, full length, with minor abrasion. **See photos 5 - 7.**

Photo 5: South footing exposed.

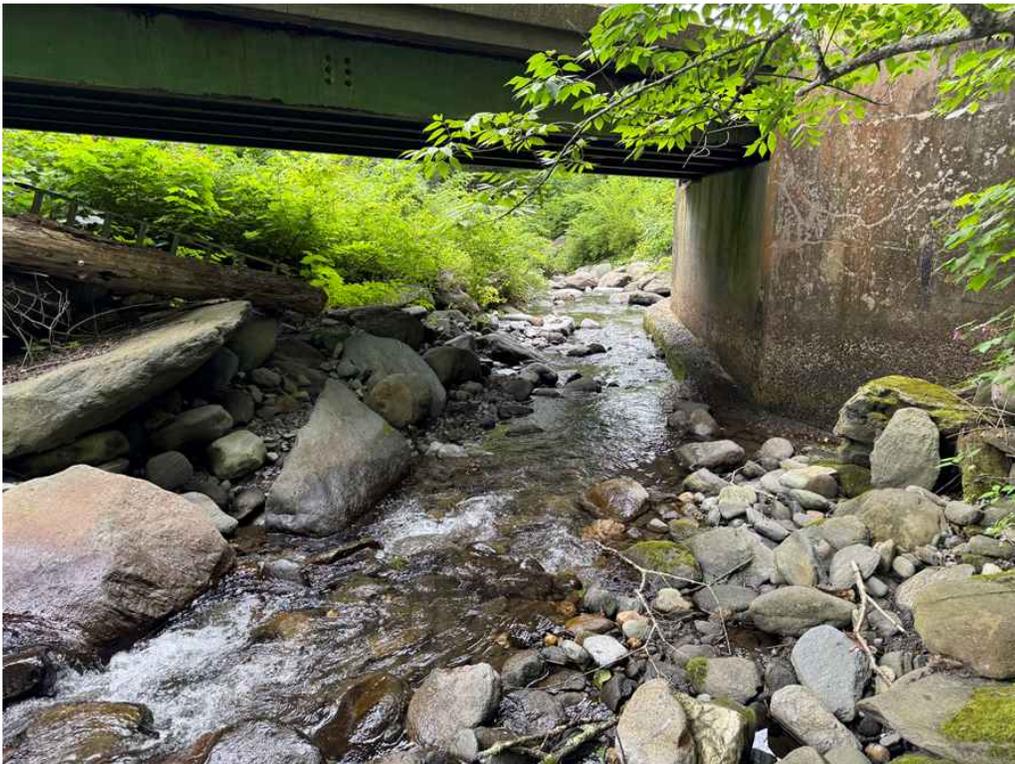
The stream favors the south side of the channel. **See photos 6 & 7.**

In the center of the channel, there are large boulders that are causing the stream to favor the south side. **See photo 6.**

Photo 6: Overall view of the channel, looking downstream. Note the exposed south footing.

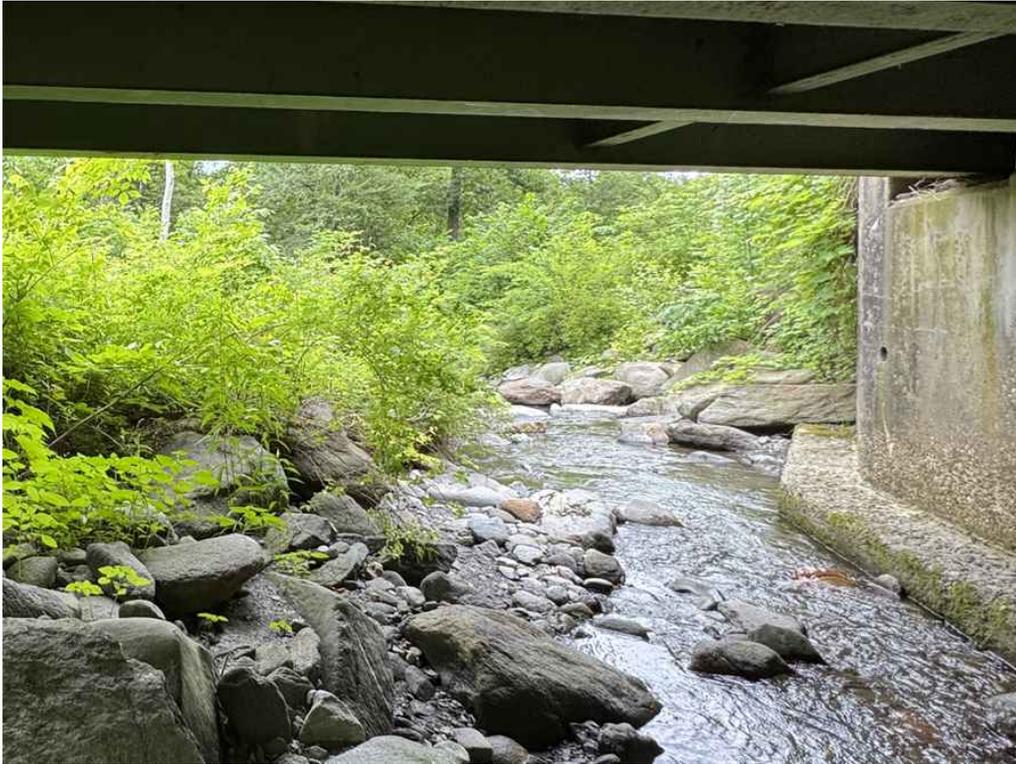
The southeast embankment is eroding near the toe of the wingwall, with exposed fill and unstable boulders in this area. **See photo 7.** The Jersey barrier resting on this fill is tipped toward the brook.

The boulders (rip-rap) in place at the toe of the southeast wingwall are starting to slough into the brook. **See photo 7.**

Photo 7: Settled boulders in the southeast embankment and exposed wingwall footing.

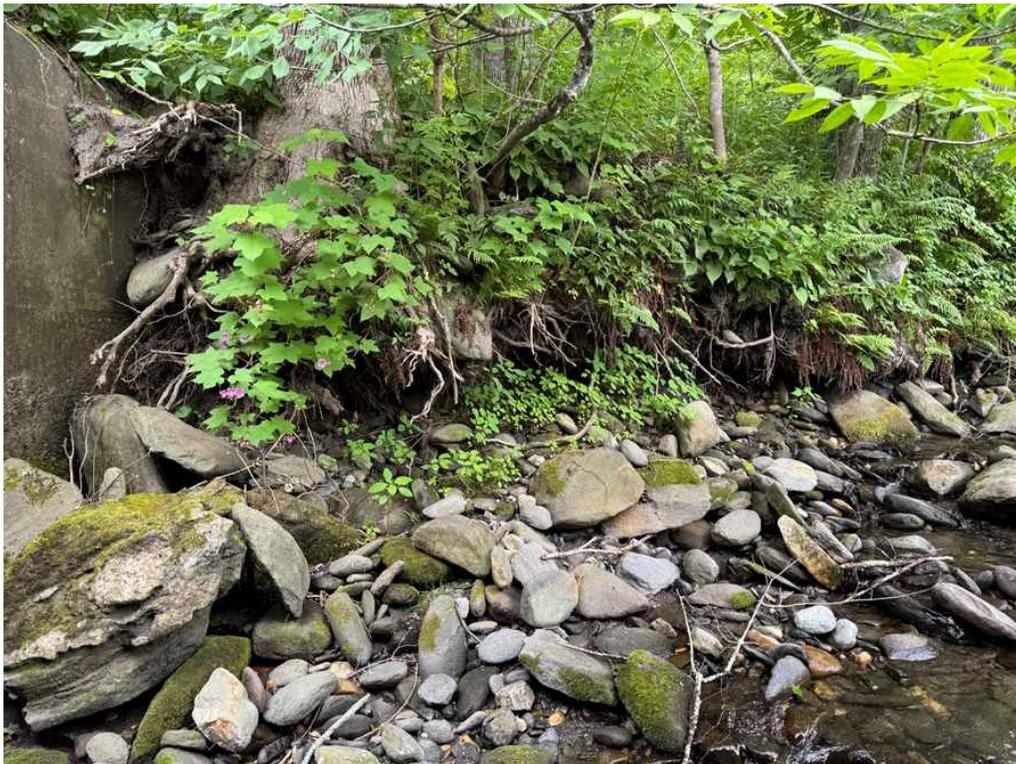
The southwest embankment has moderate erosion, up to 7' high x 5' cut back x 40" deep. **See photo 8.**

Photo 8: Erosion along the southwest embankment.
