CITY/TOWN ASHFIELD	B.I.N. C40	BR. DEPT. NO. A-13-041	8.-STRUCTURE NO. A13041-C40-MUN-BRI	INSPECTION DATE MAR 21, 2025
-------------------------------------	-----------------------------	---	--	---

Baptist Corner Road travels east and west. Drakes Brook flows from north to south. This single span structure consists of a stone masonry arch, which has been widened to the south with a concrete slab, supporting fill, with an asphalt wearing surface. Report notes are taken from south to north, downstream to upstream, in accordance with the 2015 Bridge Inspection Handbook. **See Sketch 1 and Photos 1 & 2.**

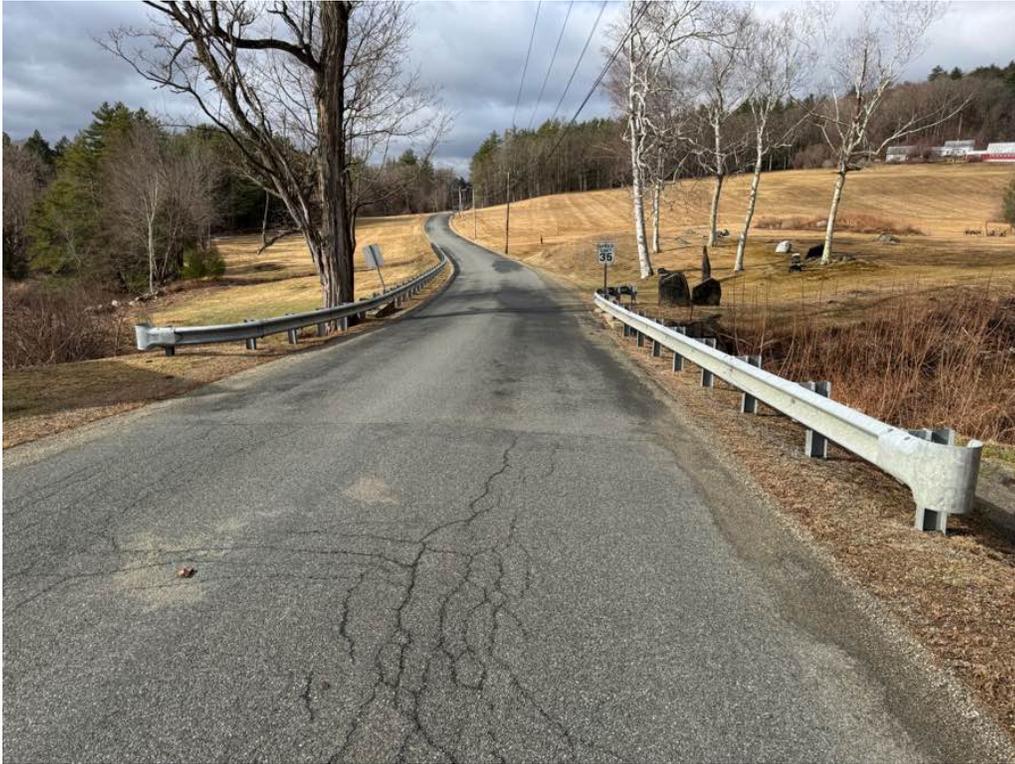
Photo 1: General topside, looking west.

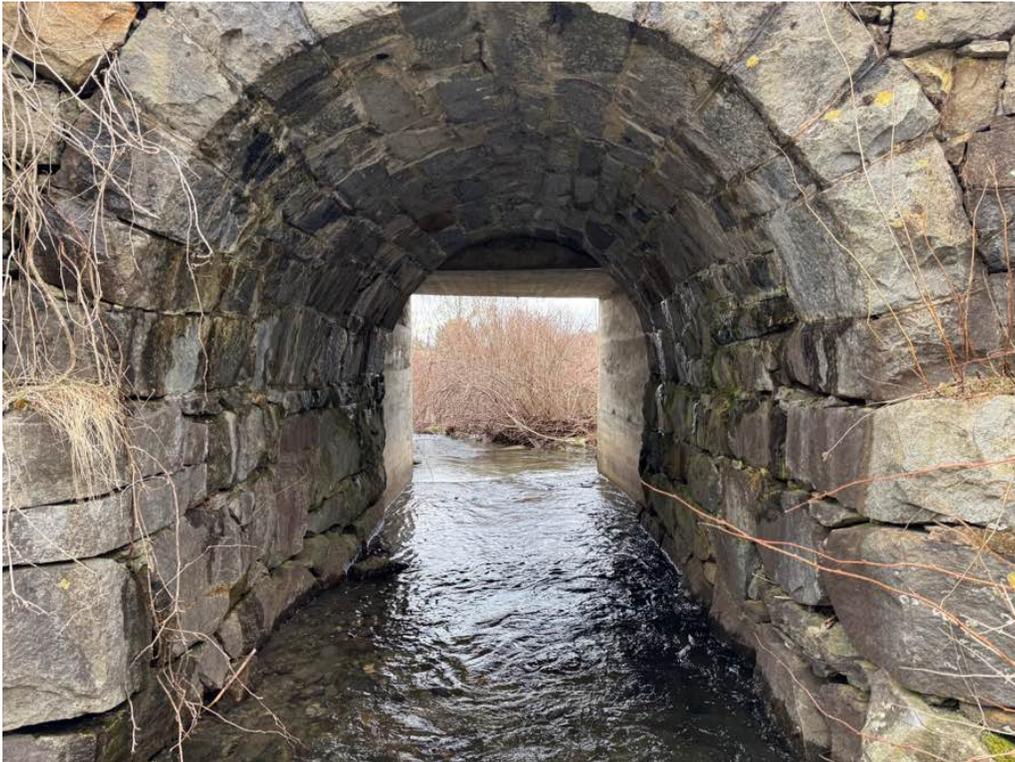
Photo 2: General underside, looking south.

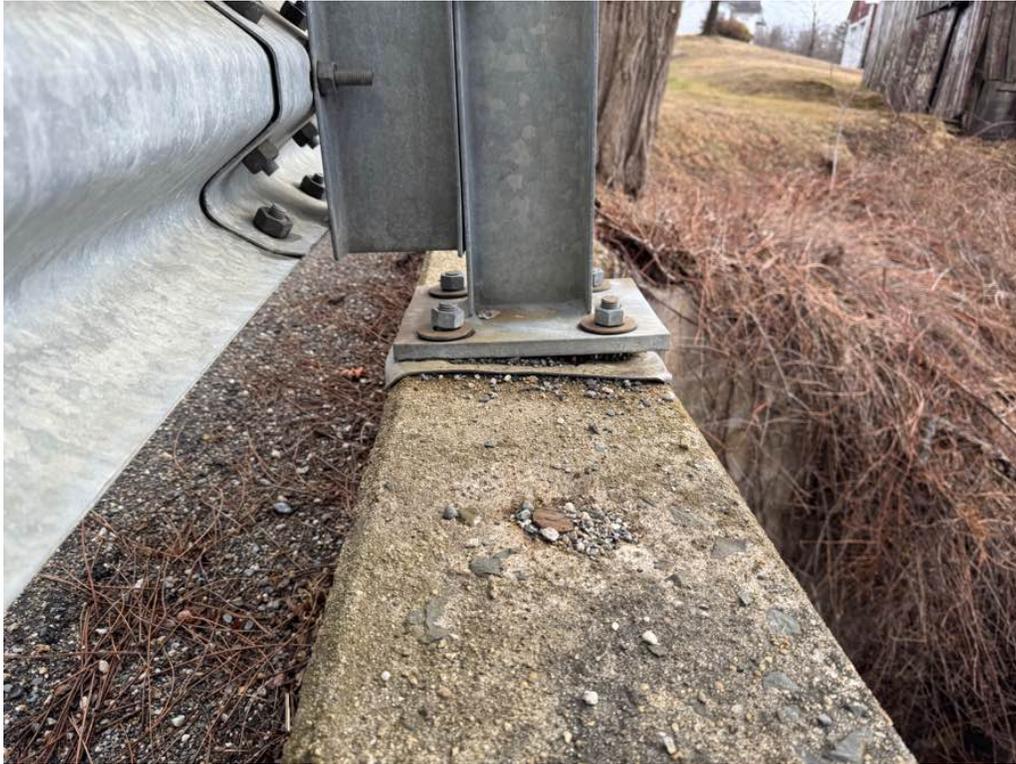
In the south railing, the west post is tipped towards the road, with a gap under the baseplate, up to 1-1/4" high. **See Photo 3.**

Photo 3: Railing post tipped.

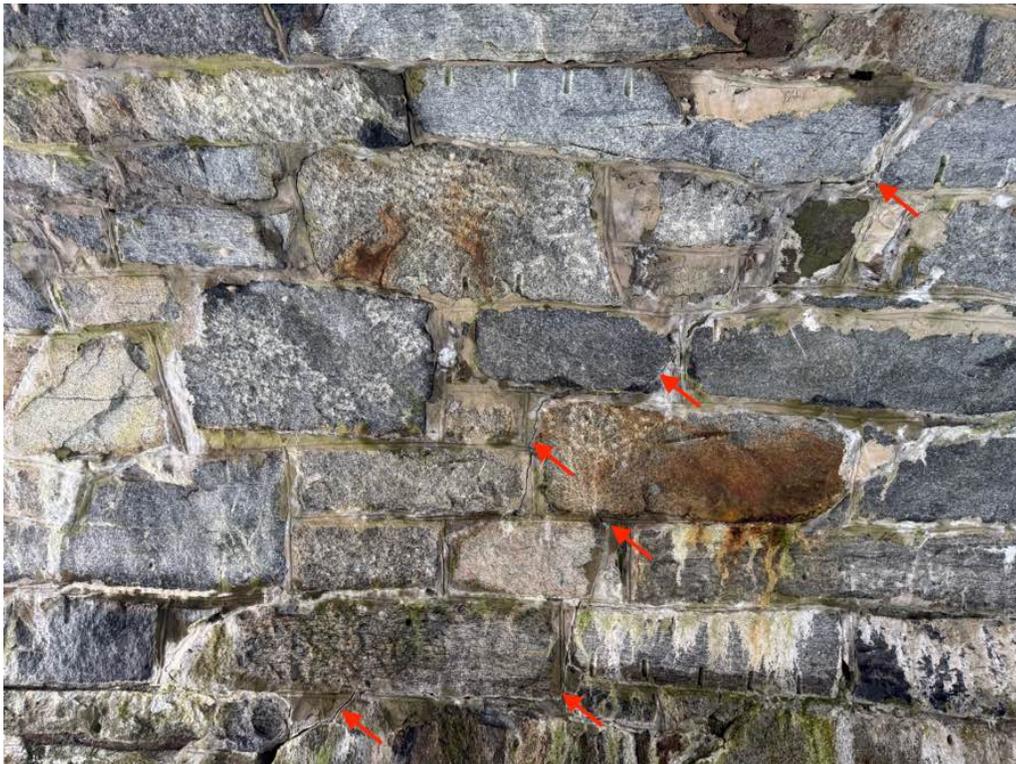
At 10' from the north end, there is a transverse crack through the mortar joints, full culvert width x 1/16" wide, that extends into the breastwalls. **See Photo 4.**

Photo 4: Masonry arch with continuous cracks through mortar and stones.

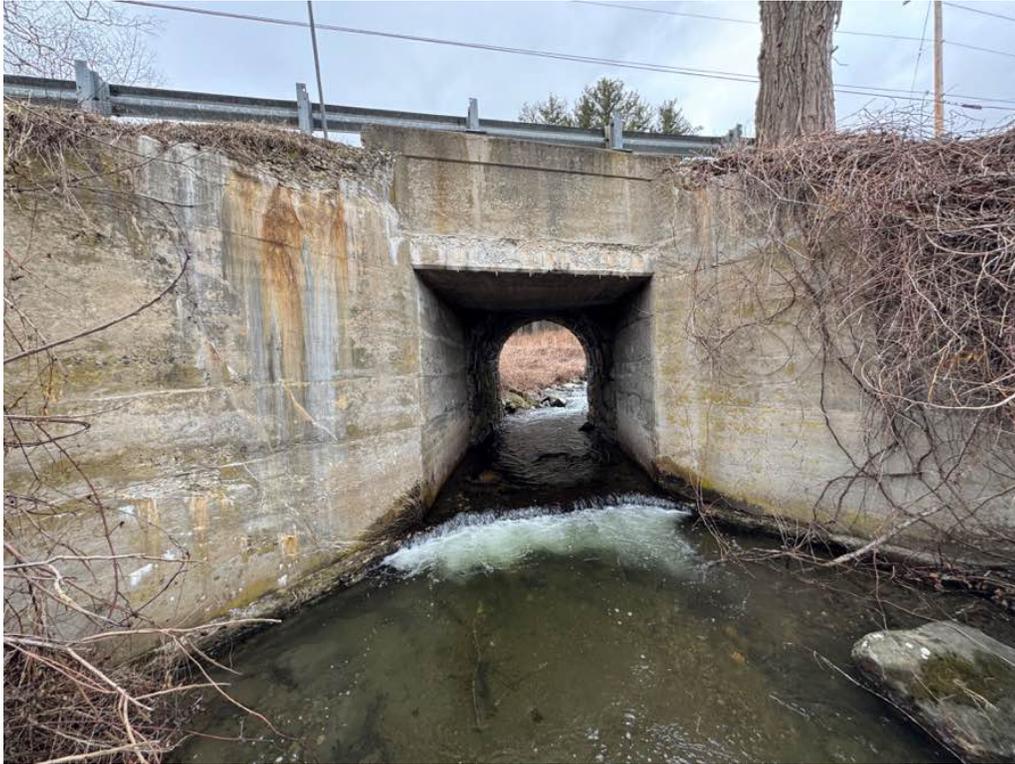
On the south fascia, there is moderate scaling, full length x up to full height x 1" deep, with heavy efflorescence. **See Photo 5.**

Both south wingwalls are cast in place concrete. Along the top, there are areas of moderate to severe scaling, up to 2" deep (isolated). At the interface with the breastwalls, at the bottom there is moderate abrasion. **See Photo 5.**

At the outfall, there is a cast in place concrete weir / sill that is undermined on the downstream face, full width x up to 12" high x up to 24" penetration. **See Photo 5.** The weir has moderate abrasion.

At the downstream end, both concrete wingwall footings are exposed, full length x up to full height. **See Photo 5.** Adjacent to the outfall, the west footing has undermining, 6' wide x up to 4" high x up to 11" penetration. The east footing has undermining, 4' wide x up to 1" high x up to 11" penetration.

The downstream channel has a scour pool, approximately 20' diameter x up to 3' deep. This scour pool is causing undermining. **See Photo 5.** Refer to Item 60.1.j - Scour.

Photo 5: Downstream channel with scour pool. Also note scaling in slab fascia and at the top of the wingwalls.

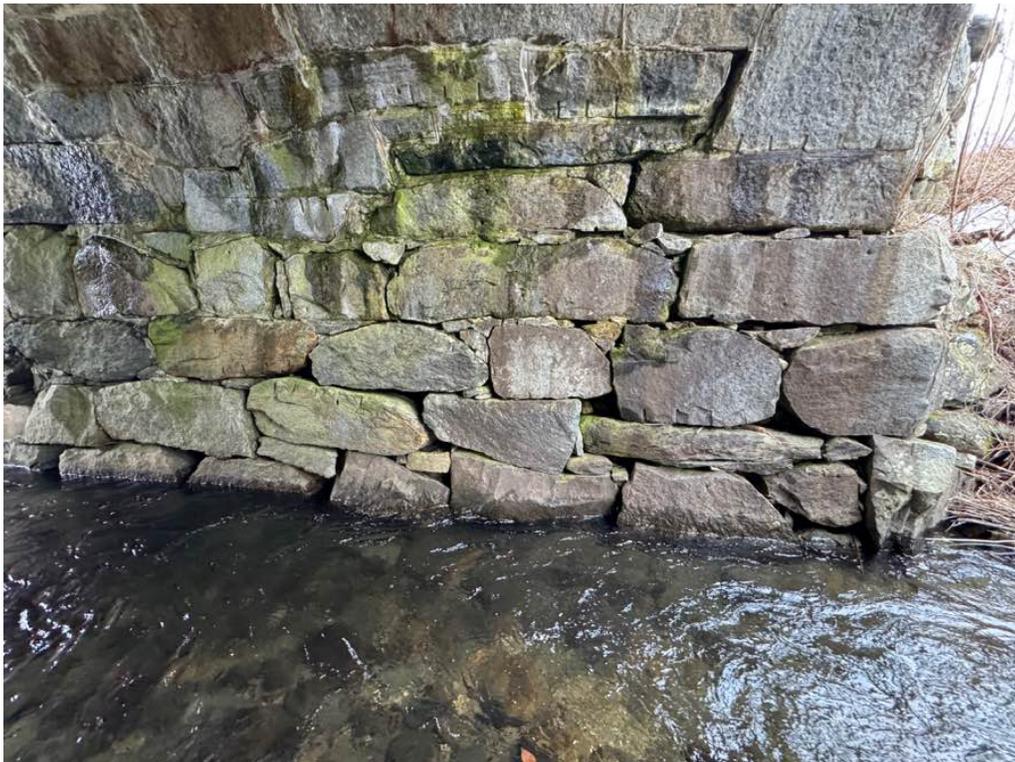
Both breastwalls have areas of cracked and missing mortar, leaving voids, up to 22" deep, and loose stones. The worst areas are along the bottoms of the breastwalls. **See Photo 6.**

Photo 6: West masonry breastwall with voids and missing mortar (typical).

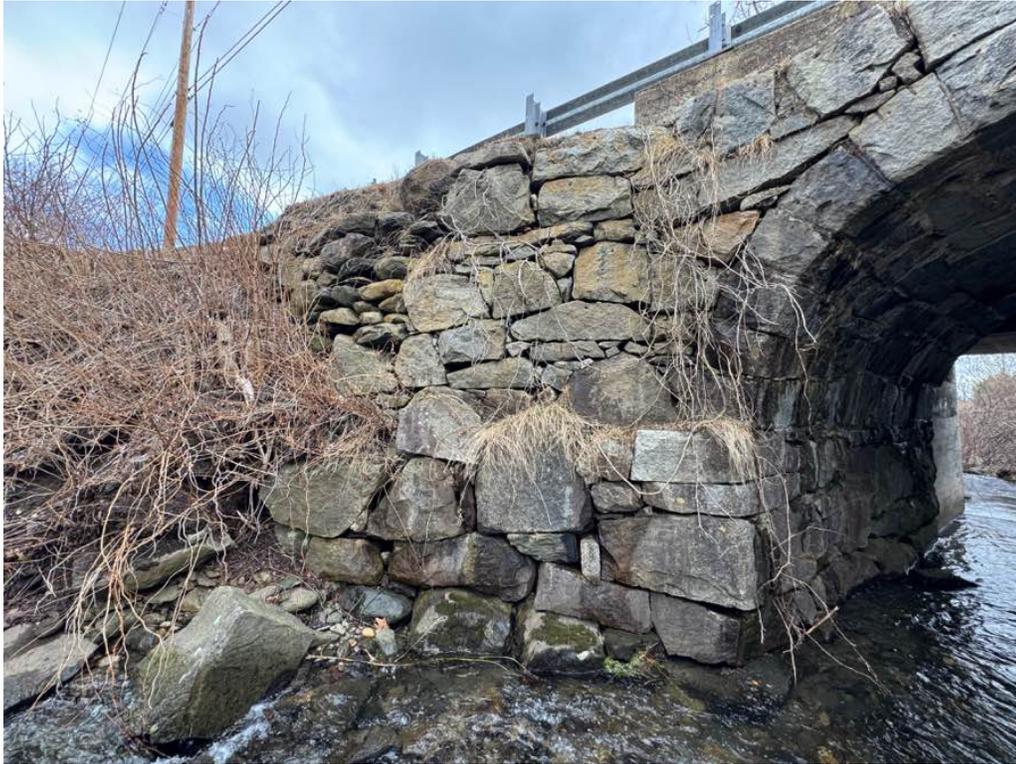
Both north wingwalls are dry stacked stone. There are areas of minor to moderate bulging. **See Photo 7.**

Photo 7: Northeast wingwall with minor bulged areas.

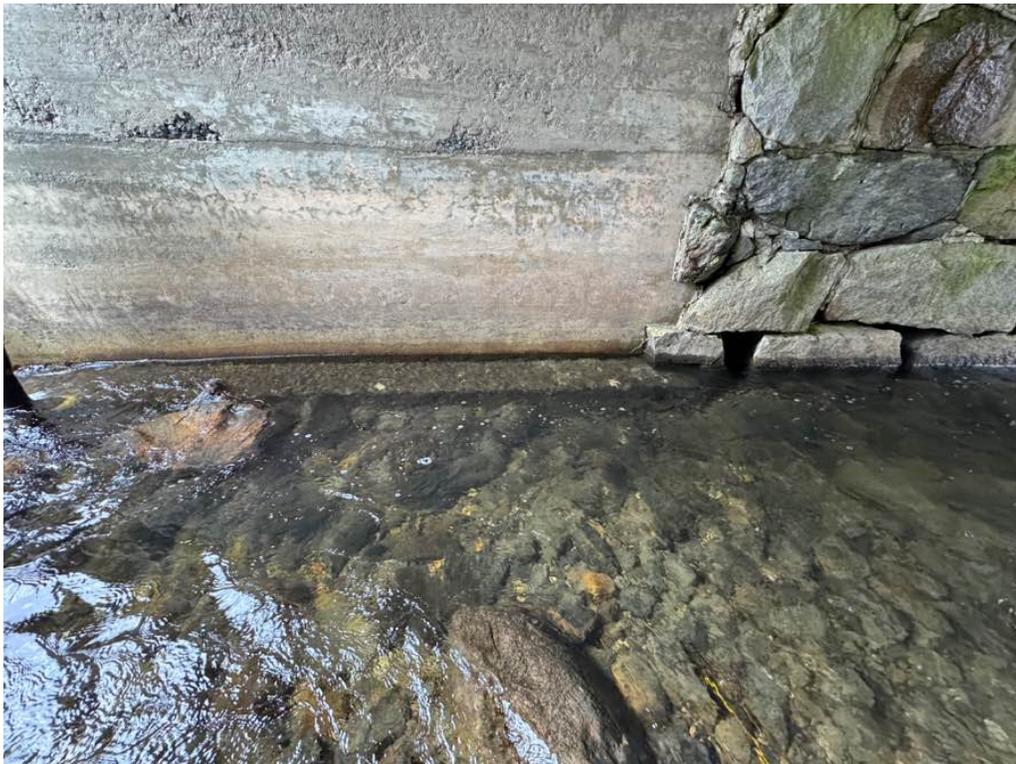
The footings along the concrete breastwalls and both south wingwalls have moderate to severe abrasion. **See Photos 5 & 8.**

Both concrete breastwall footings are exposed, full length. The west is exposed up to 12" high. **See Photo 8.** The east is flush with the streambed.

Photo 8: Exposed west footing in concrete slab section.
