STRUCTURES INSPECTION FIELD REPORT

B.I.N.
C41

CULVERT INSPECTION

| CITY/TOWN ASHFIELD | 8.-STRUCTURE NO. A13042-C41-MUN-BRI | 11-Kilo. POINT 000.000 | 41-STATUS A:OPEN | 90-ROUTINE INSP. DATE MAR 20, 2025 |

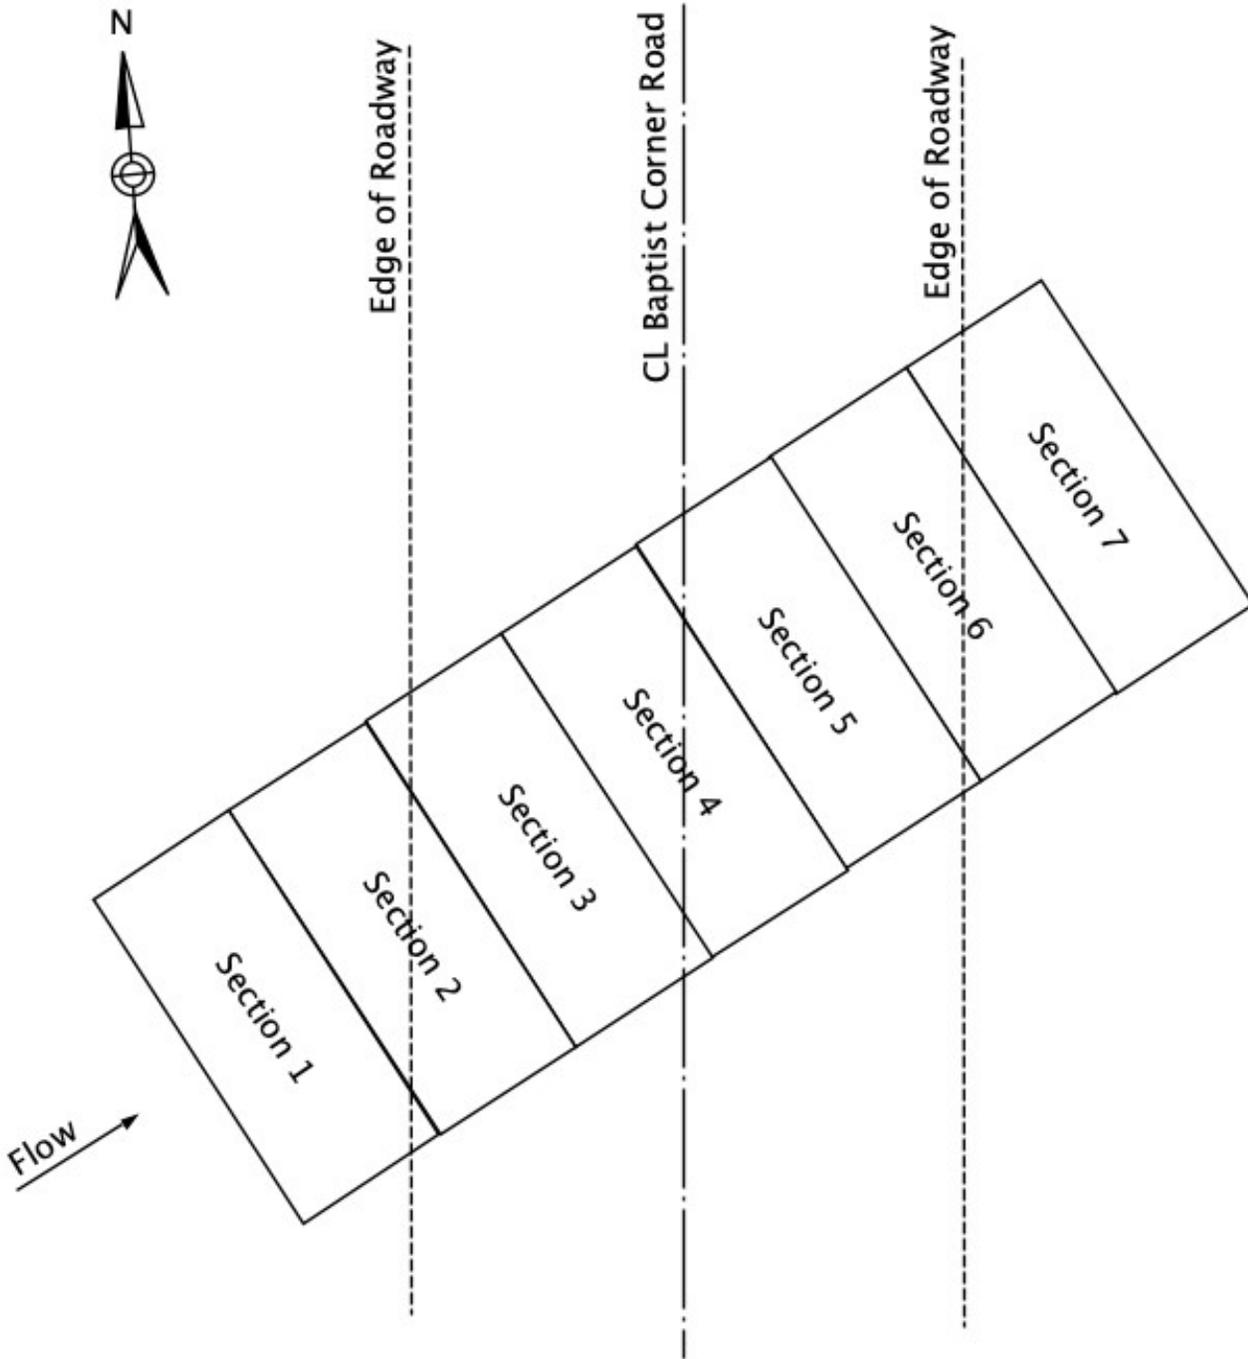
Sketch 1: Framing Plan.

Baptist Corner Road travels north and south. South River flows from west to east. This single span culvert consists of a precast concrete box in seven sections, supporting fill, and an asphalt wearing surface. Sections are numbered from west to east, upstream to downstream, in accordance with the 2015 Bridge Inspection Handbook. **See Sketch 1 and Photos 1 & 2.**

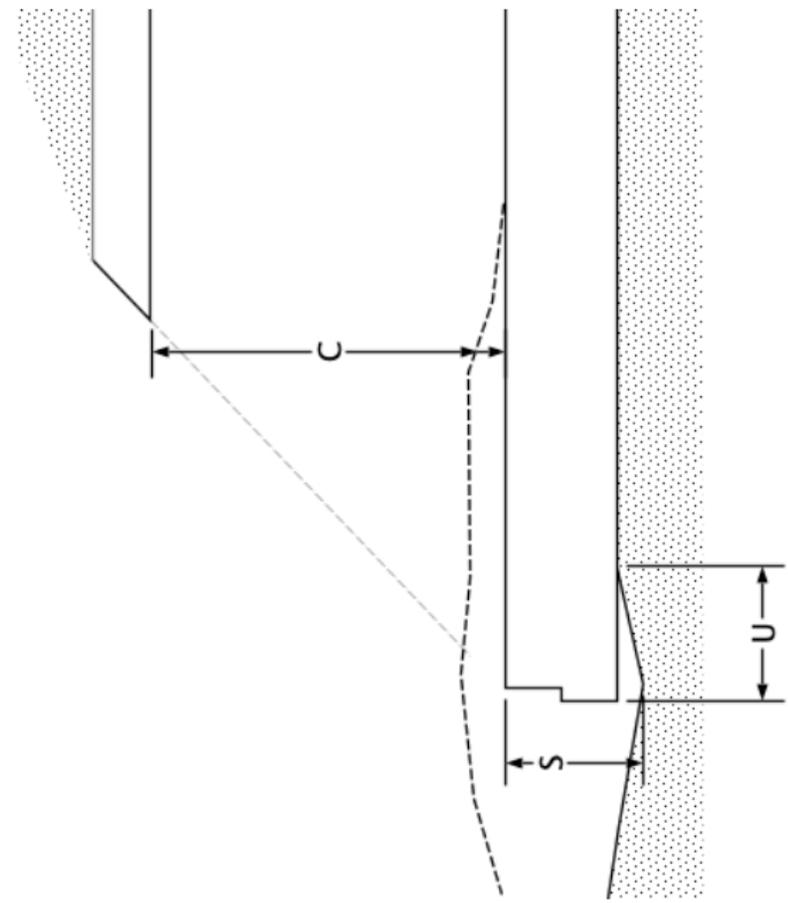
Chart 1: Channel profile readings.

At the upstream end, the floor is exposed, full width x up to 4" high.

For channel profile / scour measurements, **refer to Chart 1.**

For channel profile readings, **refer to Chart 1.**

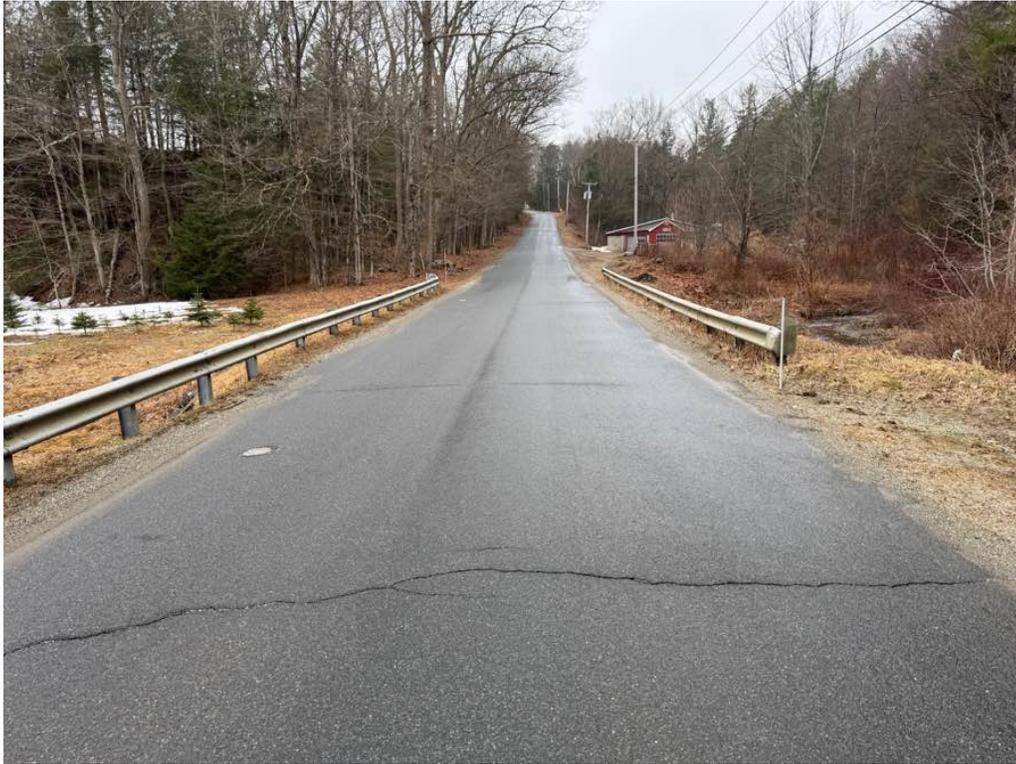
The north approach has two transverse cracks, up to full roadway width x 1/4" wide. **See Photo 1.**

Photo 1: General topside, looking south.

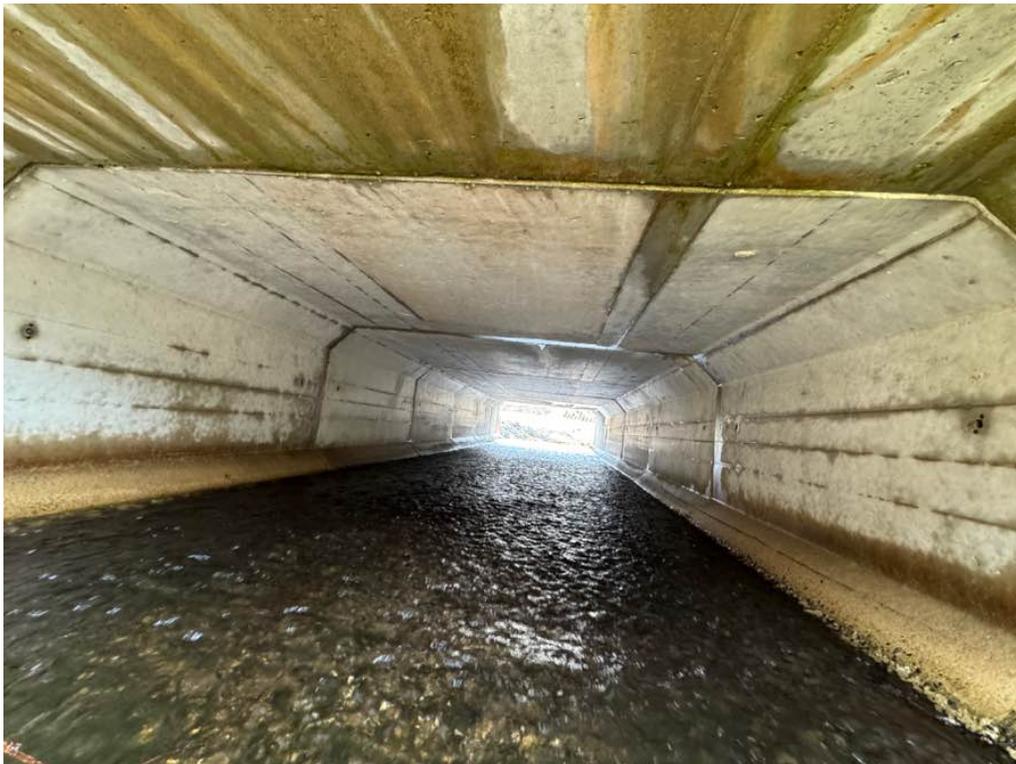
There is active leakage at several of the joints between sections. **See Photo 2.**

Photo 2: General underside, looking east.

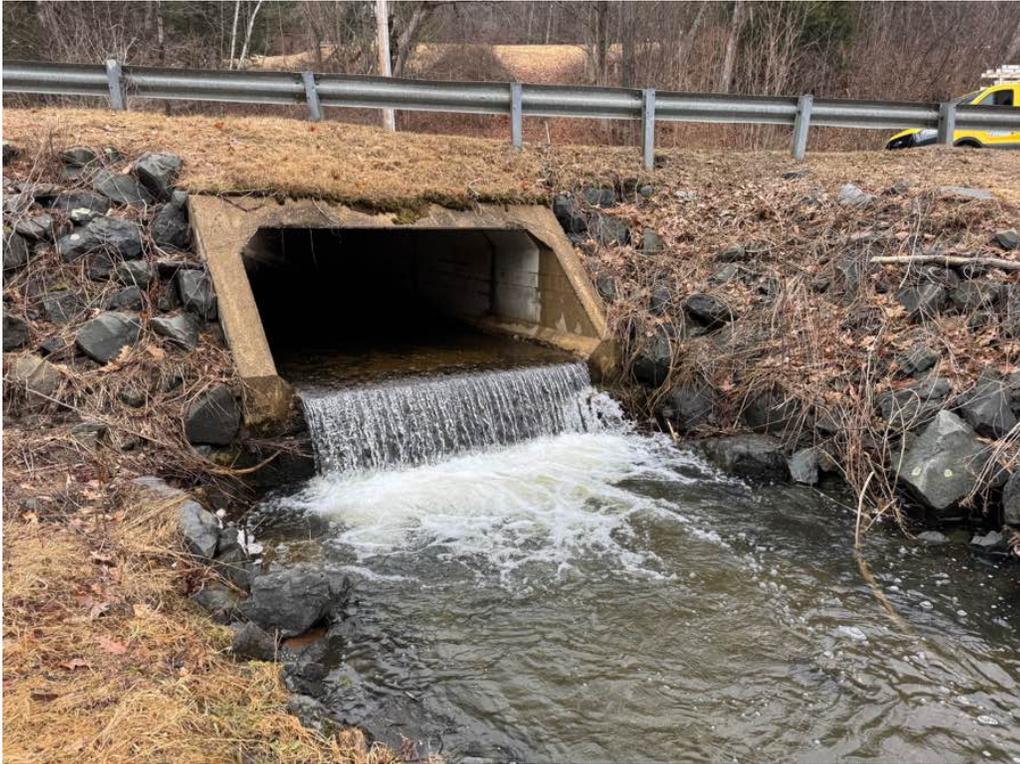
At the downstream end, there is a plunge pool, with the floor end face exposed, full culvert width. **See Photo 3.**

At the structure outfall, the downstream channel has a plunge pool, approximately 10' diameter x 28" deep. **See Photo 3.**

Photo 3: Downstream plunge pool.
