STRUCTURES INSPECTION FIELD REPORT

ROUTINE & SPECIAL MEMBER INSPECTION

BR. DEPT. NO.
A-13-024

CITY/TOWN ASHFIELD	8-STRUCTURE NO. A13024-0EF-MUN-NBI	11-Kilo. POINT 000.000	41-STATUS P:POSTED	90-ROUTINE INSP. DATE MAR 21, 2025
07-FACILITY CARRIED HWY WILLIAMSBURG	MEMORIAL NAME/LOCAL NAME	27-YR BUILT 1938	106-YR REBUILT 0000	YR REHAB'D (NON 106) 0000
06-FEATURES INTERSECTED WATER CREAMERY BROOK	26-FUNCTIONAL CLASS Major Collector	DIST. BRIDGE INSPECTION ENGINEER <i>Michael P. McCabe</i> M.P.E. McCabe		
43-STRUCTURE TYPE 302 : Steel Stringer/Girder	22-OWNER Town Agency	21-MAINTAINER Town Agency	TEAM LEADER T. Franciosa <i>[Signature]</i>	PROJ MGR Michael Baker Intl Inc <i>[Signature]</i>
107-DECK TYPE 1 : Concrete Cast-in-Place	WEATHER Cloudy	TEMP. (air) 0°C	TEAM MEMBERS M. MAZZU

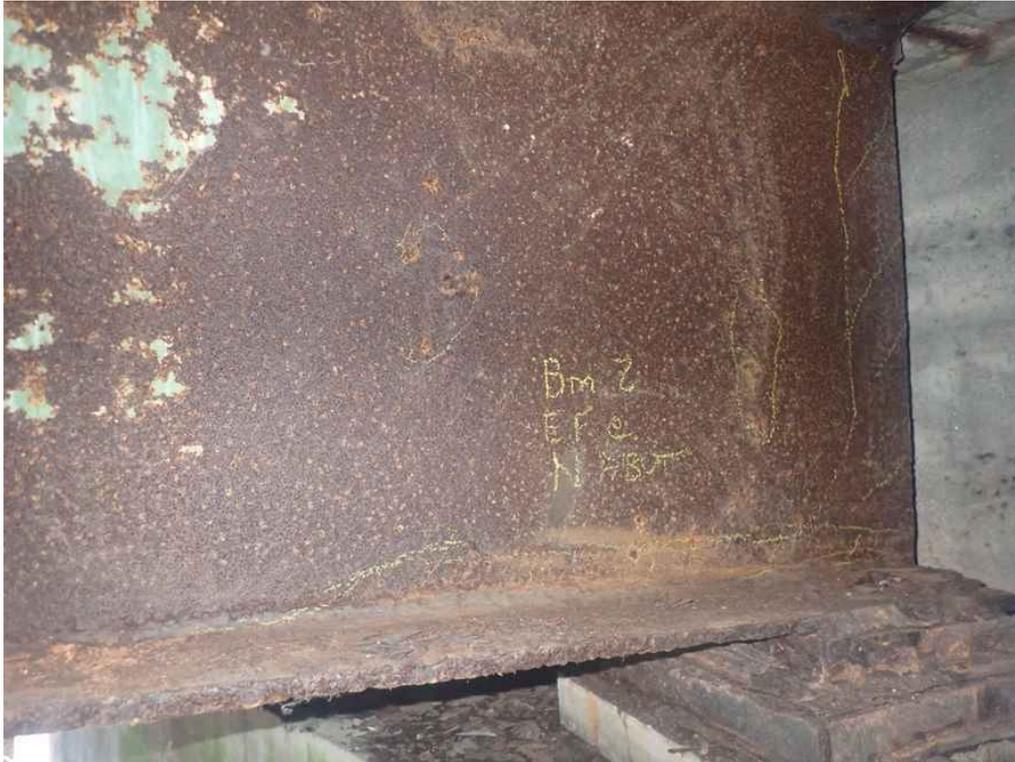
Photo 17: Beam 2, East Face, at North Abutment.

- Top flange at South Abutment: 5'-6" long x 1-1/4" high gap between top flange and deck.
- Near mid-span: 5'-0" long area of minor section loss.
- Web and bottom flange at North Abutment: Section loss **(Sketch 3 and Photo 17)**.
