STRUCTURES INSPECTION FIELD REPORT

ROUTINE & SPECIAL MEMBER INSPECTION

BR. DEPT. NO.
A-13-014

Structure A-13-014 (0FN) carries Apple Valley Road over the Upper Branch of Clesson Brook in the Town of Ashfield (**Sketch 1**). The bridge is a simple single span structure comprised of six (6) steel beams, supporting a reinforced concrete deck overlaid with an asphalt wearing surface.

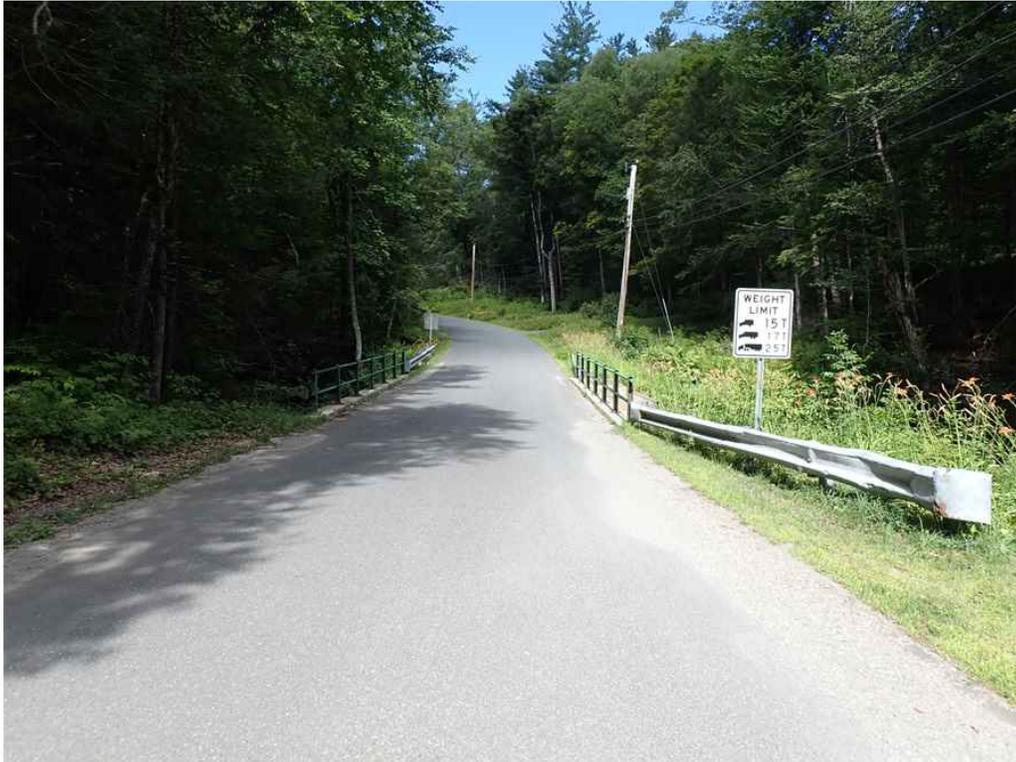
Photo 3: Bridge from South Approach, looking northwest.

The bridge has a posted weight restriction for 15 tons on two axles, 17 tons on three axles and 25 tons on five axles. There is an At-Bridge weight posting sign at both approaches (**Photos 3 and 5**). The Advance weight posting sign at the South Approach is not at the preceding intersection, is bent, too low and tipped to the east (**Photo 9**). The Advance weight posting sign at the North Approach (Scott Rd) is missing.

The southwest section has no guardrail (**Photos 3 & 4**).

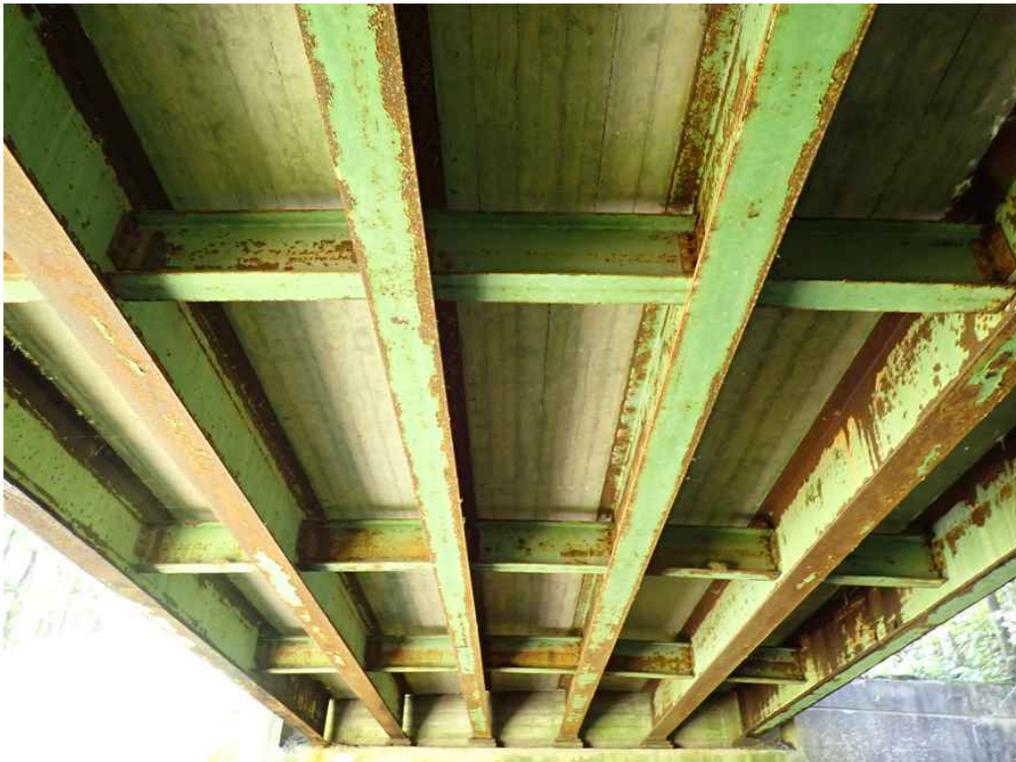
Photo 8: Typical underside, looking south.

There is typically scattered freckled rust throughout the superstructure with isolated locations of failed paint (**Photos 8 and 15-18**). The remaining paint is chalked. See **Item 59.4 - Girders and Beams** for additional comments.
